SIB 11 08 21

2024-04-01

Recall 21V-907: Exhaust Gas Recirculation (EGR) Cooler – N57T High Temperature

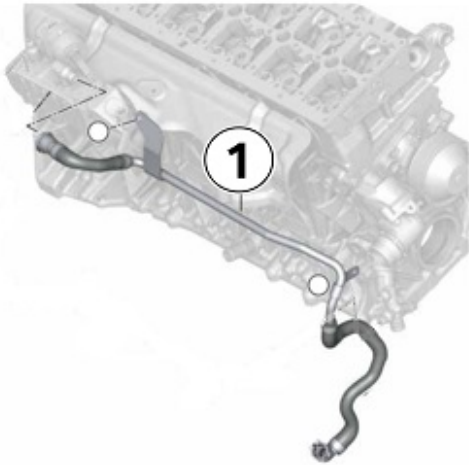
Important: The repair instruction specifies cleaning of the intake pipe and temp sensor during the cooler replacement. This instruction must be followed to prevent contamination or damage to the intake system after repairs. It is recommended to use brush set P/N 83 19 2 298 237.

- Replace the coolant pipe from the Auxiliary EGR cooler to the coolant pump distribution block (1)

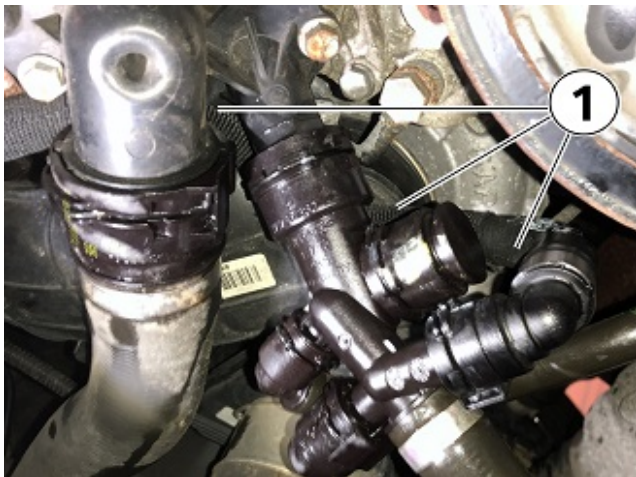
- NOTE: The new coolant line P/N 11 14 7 827 410 is routed in a different location than the original line (1)

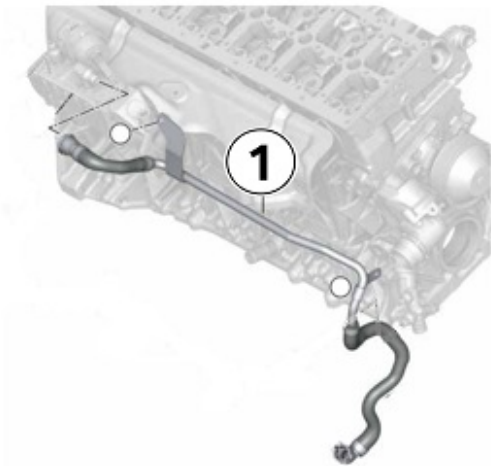
Important: The repair instruction specifies cleaning of the intake pipe and temp sensor during the cooler replacement. This instruction must be followed to prevent contamination or damage to the intake system after repairs. It is recommended to use brush set P/N 83 19 2 298 237.

- Replace the coolant pipe from the Auxiliary EGR cooler to the coolant pump distribution block (1)
