December 2021

Safety Recall Y86 / NHTSA 21V-919 Seat Recliner Pull Strap

2022 (WS) Wagoneer/Grand Wagoneer

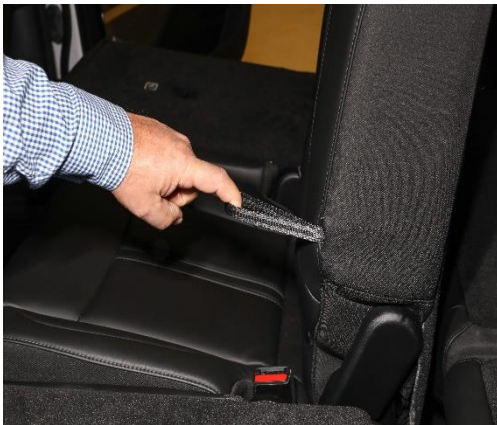
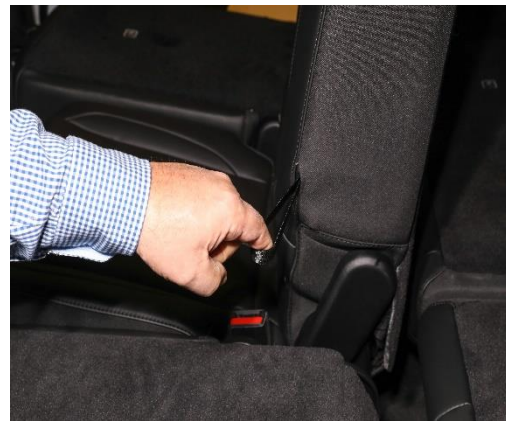
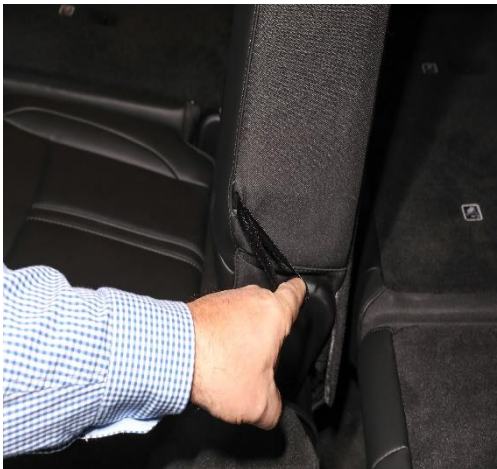
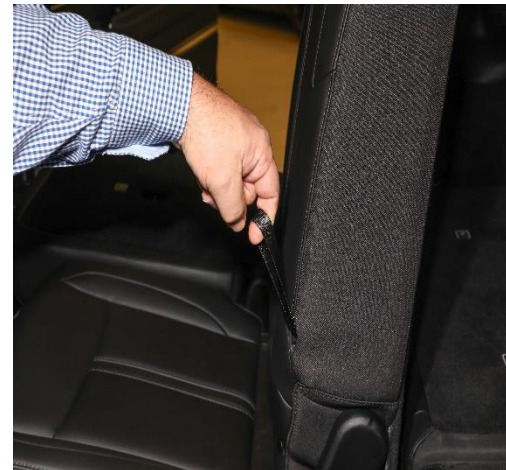
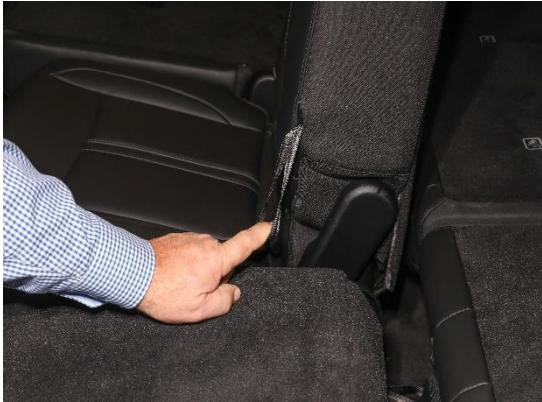
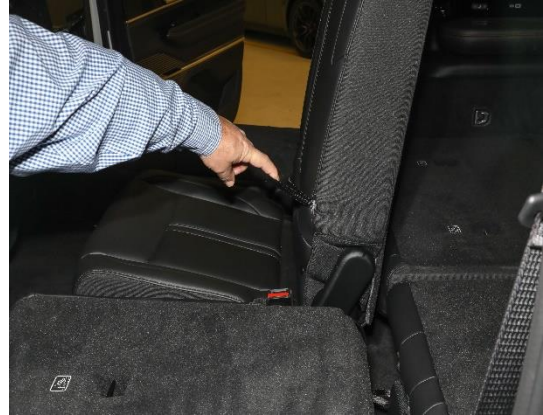
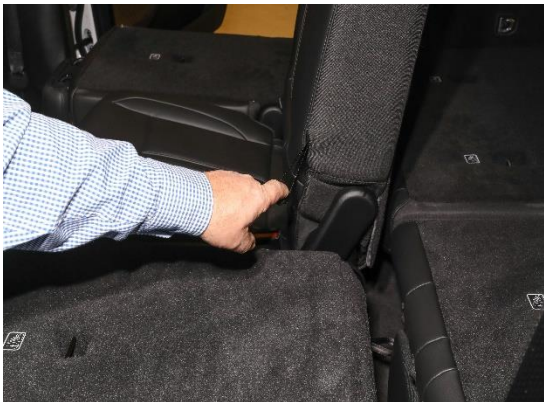
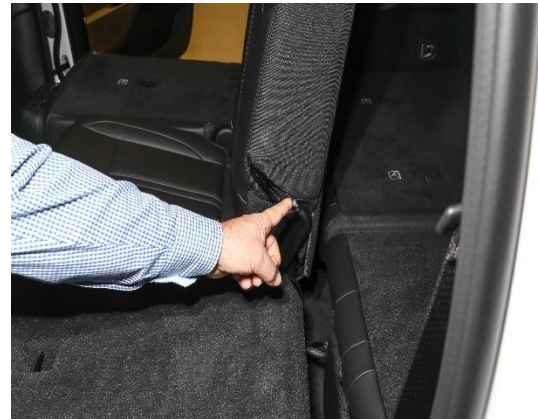
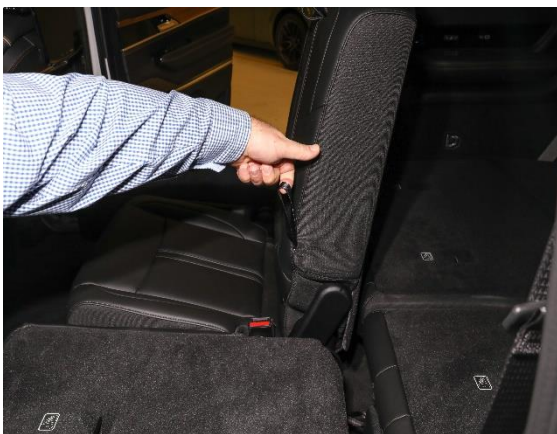
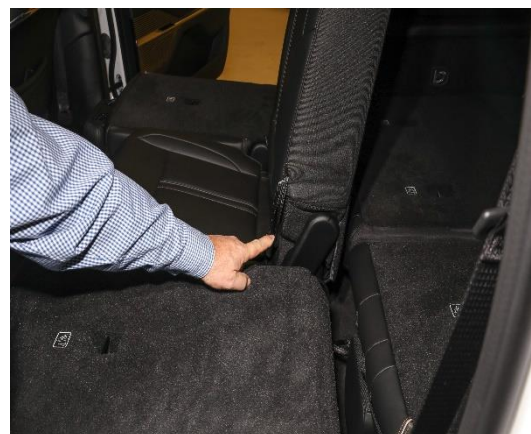
1. Recline the driver's side second row seat.
2. Grasp the second row middle seat recline pull strap and pull on the strap in various **45 degree angles** assuring the seat is able to recline and latch in all directions, **repeat this procedure 3 times in all different directions as shown in (Figure 1-11).**

3. Did the seat back recline release and latch after pulling on the strap repeating 3 consecutive times in different directions?
 - If yes, no further service is required return the vehicle to the customer.
 - If **NO**, proceed to section **B. Second Row Seat Pull Strap Replacement Procedure.**

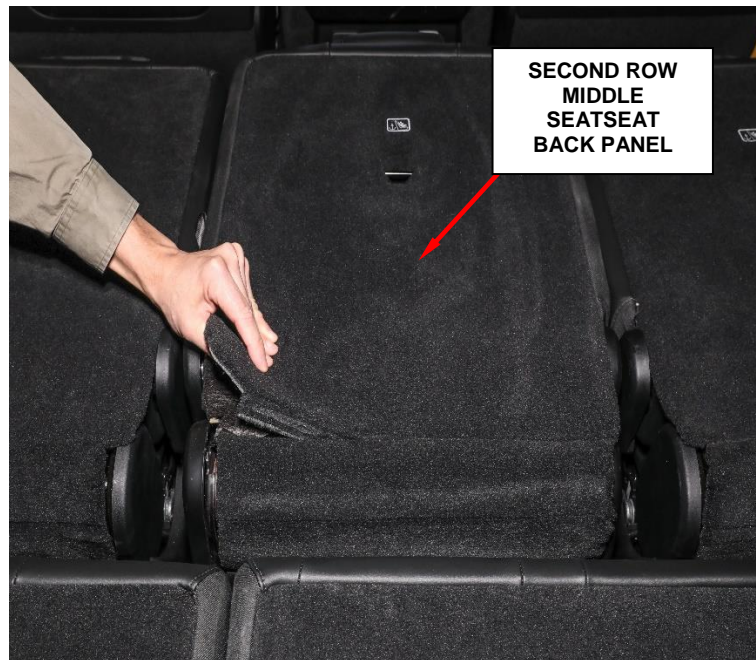
Figure 11 – Seat Back Panel

1. Remove Second row middle seat back panel (Figure 11).

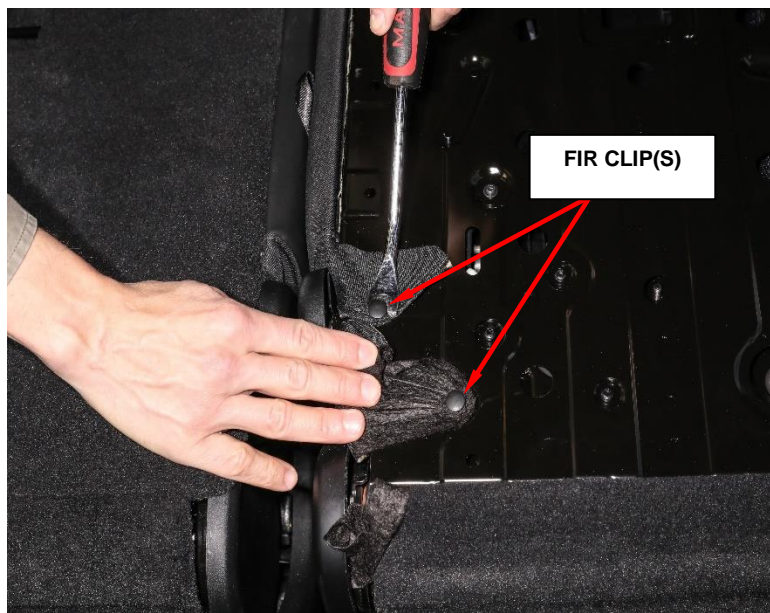
Figure 12 – Fur Clip Removal

2. Using a trim release tool, remove both fir clips (Figure 12).

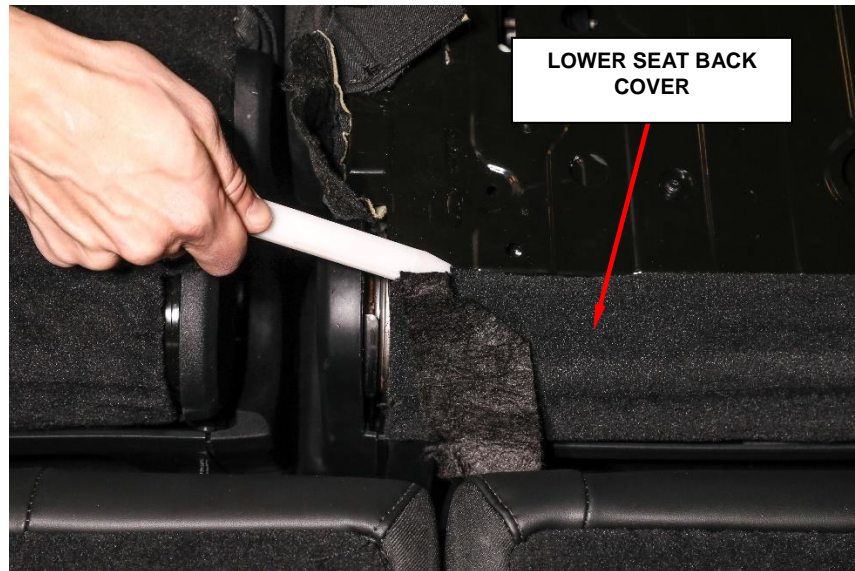
Figure 13 – “J” Channel

3. Using a trim stick, release the lower seat back cover from the “J” channel on the seat back (Figure 13).

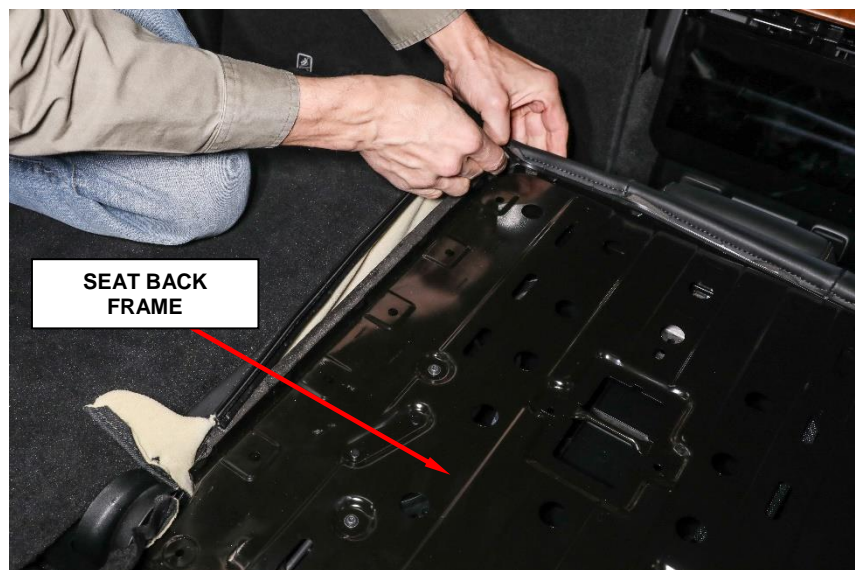
Figure 14 – Seat Back Cover

4. Release the seat back cover from the seat back frame (Figure 14).

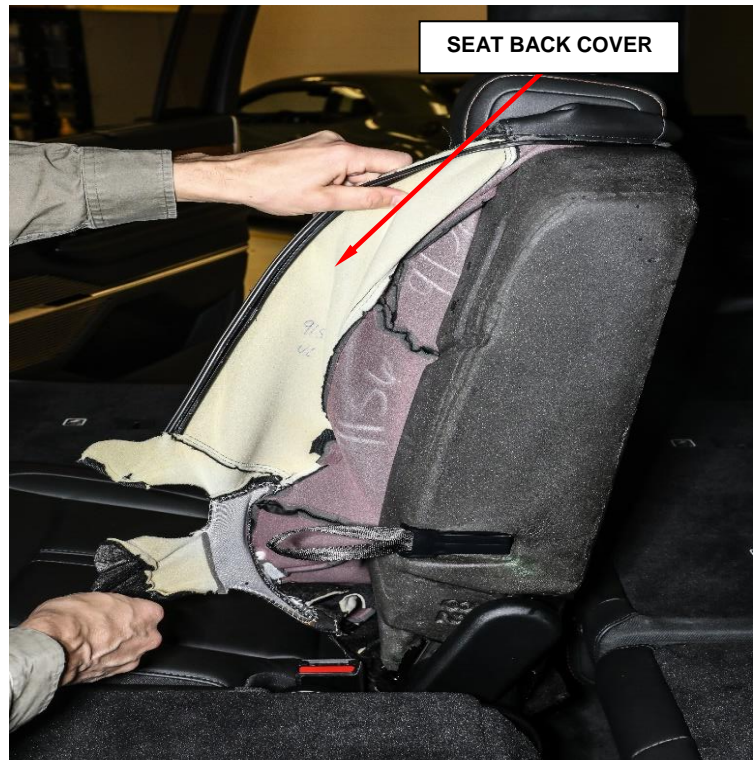
Figure 15 – Seat Back

5. Carefully peel the left side (Strap Side) seat back cover forward (Figure 15).

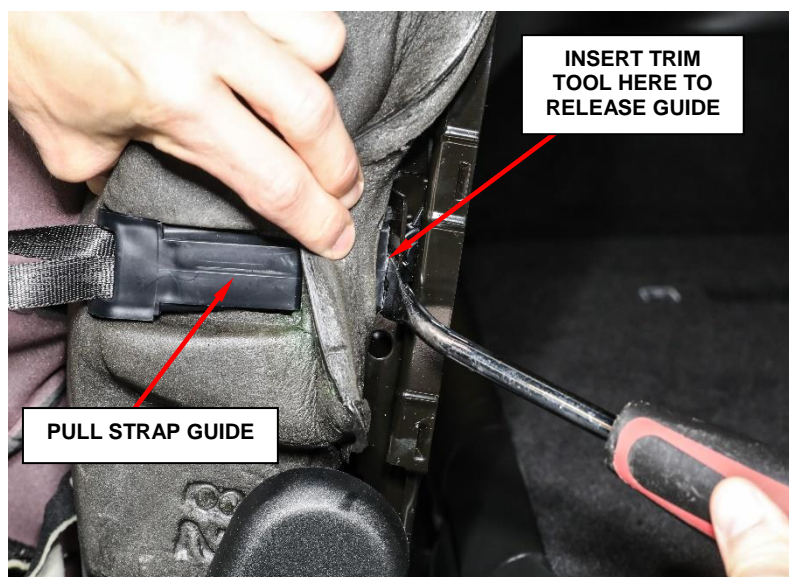
Figure 16 – Pull Strap Guide

6. Using a trim release tool, release the pull strap guide from the seat frame bracket (Figure 16).

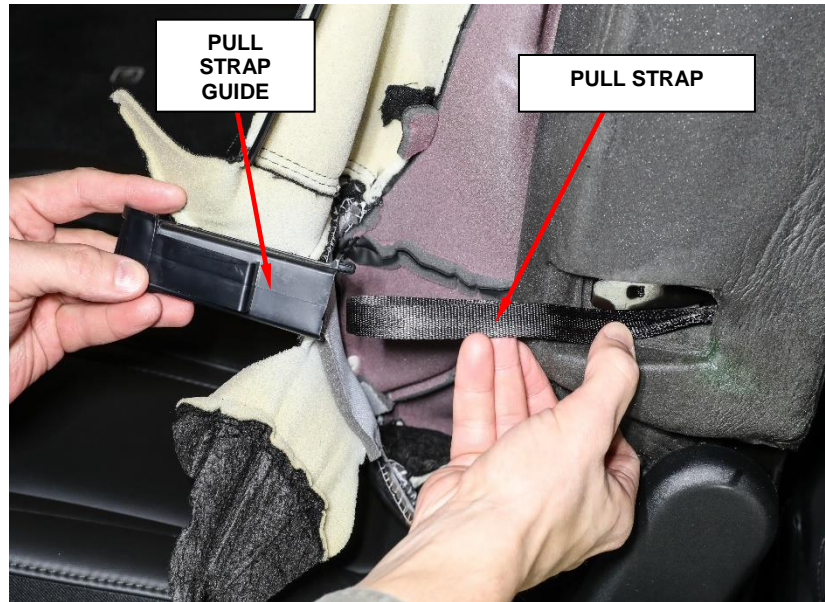
Figure 17 – Pull Strap Guide

7. Remove the pull strap guide (Figure 17).

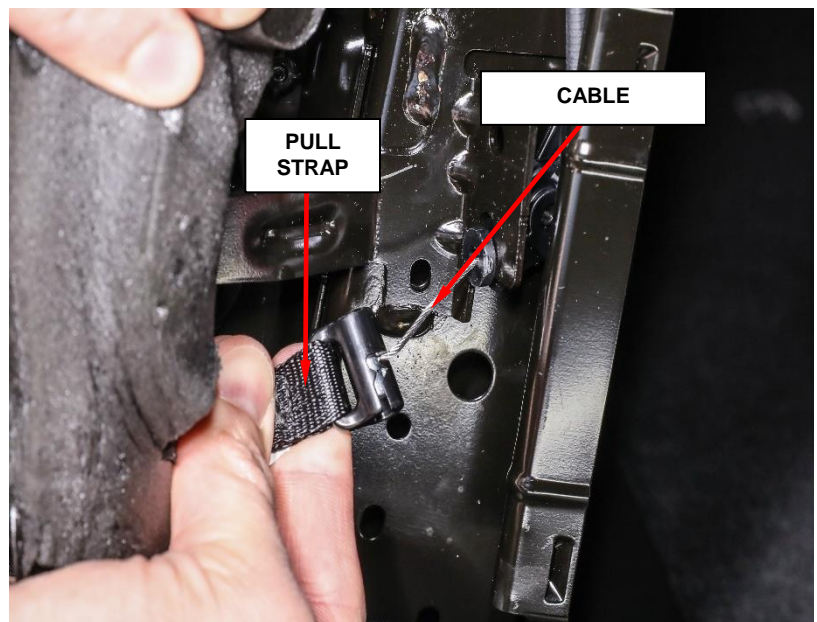
Figure 18 – Pull Strap Release

8. Carefully peel the foam cushion and release the pull strap from the cable, and **DISCARD** the pull strap (Figure 18).

9. Attach the **NEW** pull strap to the cable and reposition the foam cushion in place (Figure 18).
10. Slide the pull strap guide over the **NEW** pull strap.

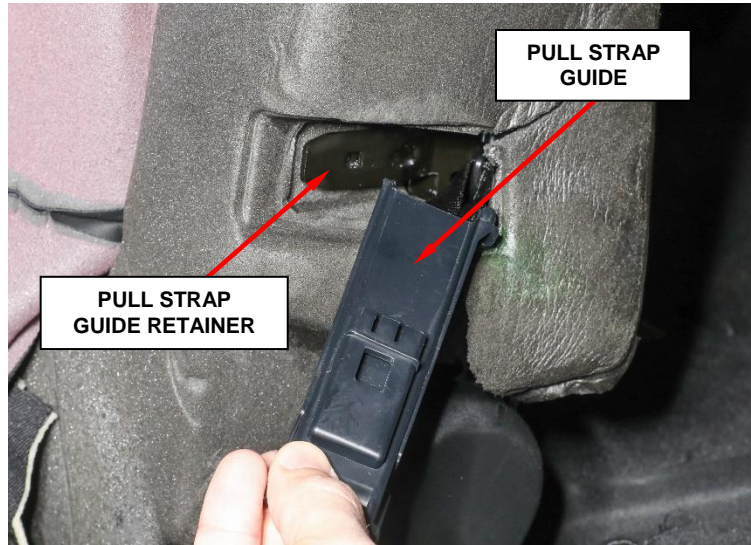
Figure 19 – Pull Strap Guide Retainer

11. Align the pull strap guide to the seat back frame retainer and push it in place to the seat back frame (Figure 19).

NOTE: Guide has a locating point that must be aligned to seat back frame.

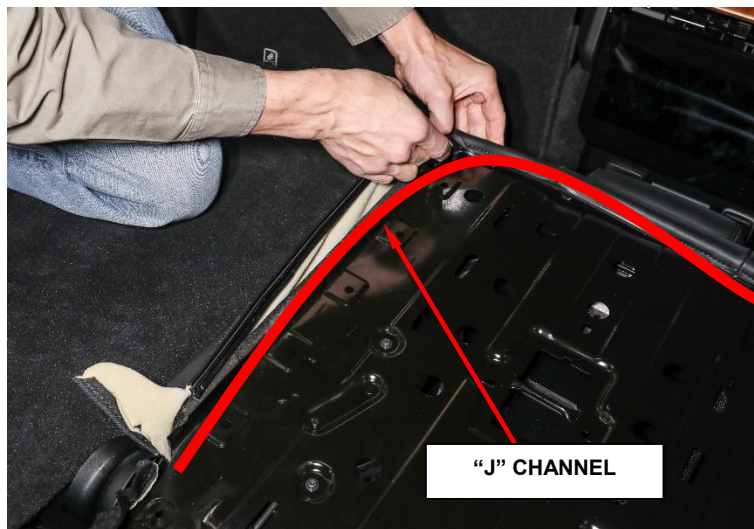
Figure 20 – Seat Cover Installation

12. Reinstall seat back cover to seat frame “J” channel (Figure 20).

NOTE: Seat Cover must be fully engaged to the “J” channel on the seat back frame.

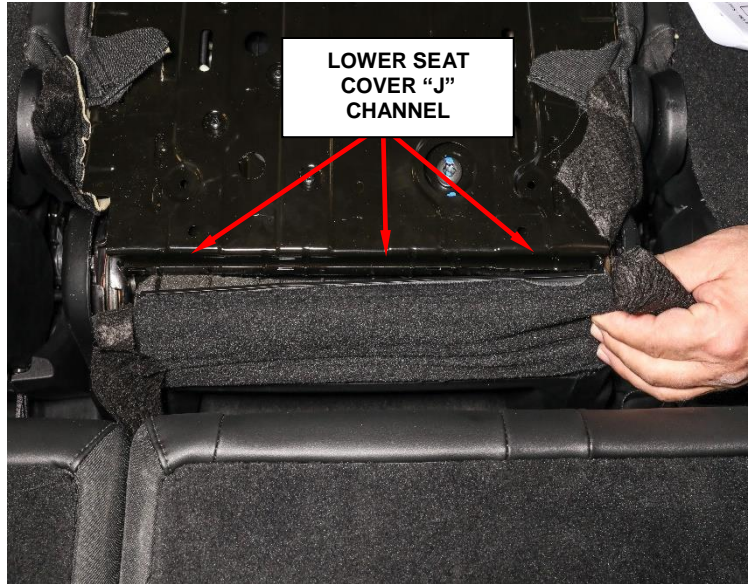
Figure 21 – Lower Seat Cover to “J” Channel

13. Reattach the lower seat cover to the “J” channel to the frame (Figure 21).

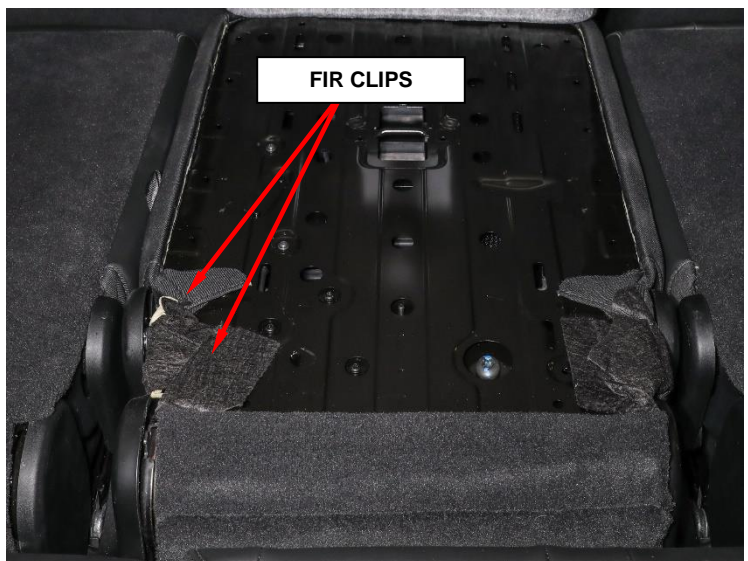
Figure 22 – Fir Clip Installation

14. Using 2 **NEW** fir clips, attached the left lower seat cover to the frame (Figure 22).

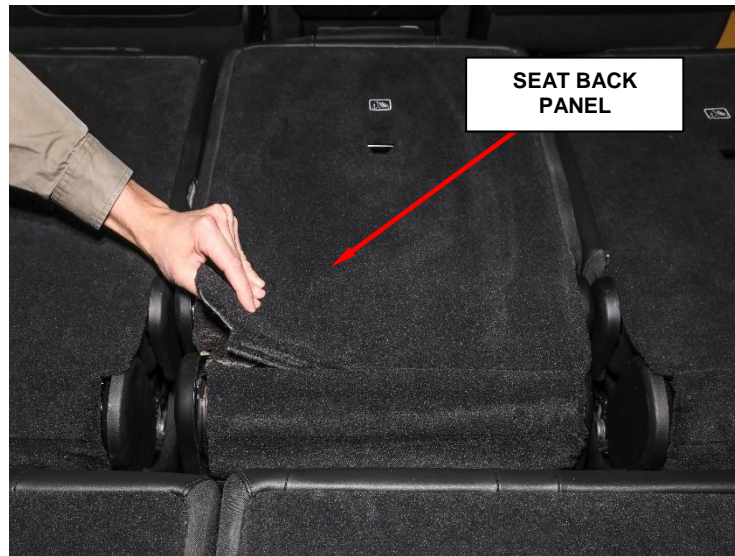
Figure 23 – Seat Back Panel Installation

15. Align and reinstall the seat back panel in the seat back groove (Figure 23).

NOTE: Be sure seat back panel is fully seated into the frame groove.
