TECHNICAL INSTRUCTIONS

SAFETY RECALL 21TH01

Potentially Defective Power Steering Gear Assemblies

Certain 2007-2021 Model Year Tundra
Certain 2008-2022 Model Year Sequoia

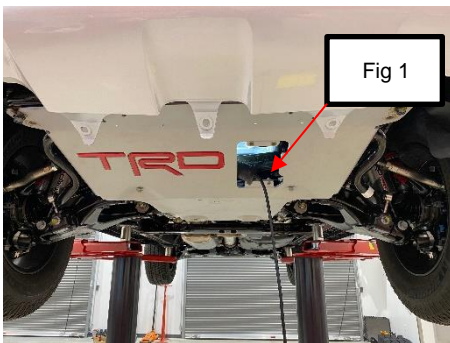
TRD Skid Plate Only Open Access Door

NOTE (Fig1): For TRD Skid plates **ONLY** remove oil access door for inspection.

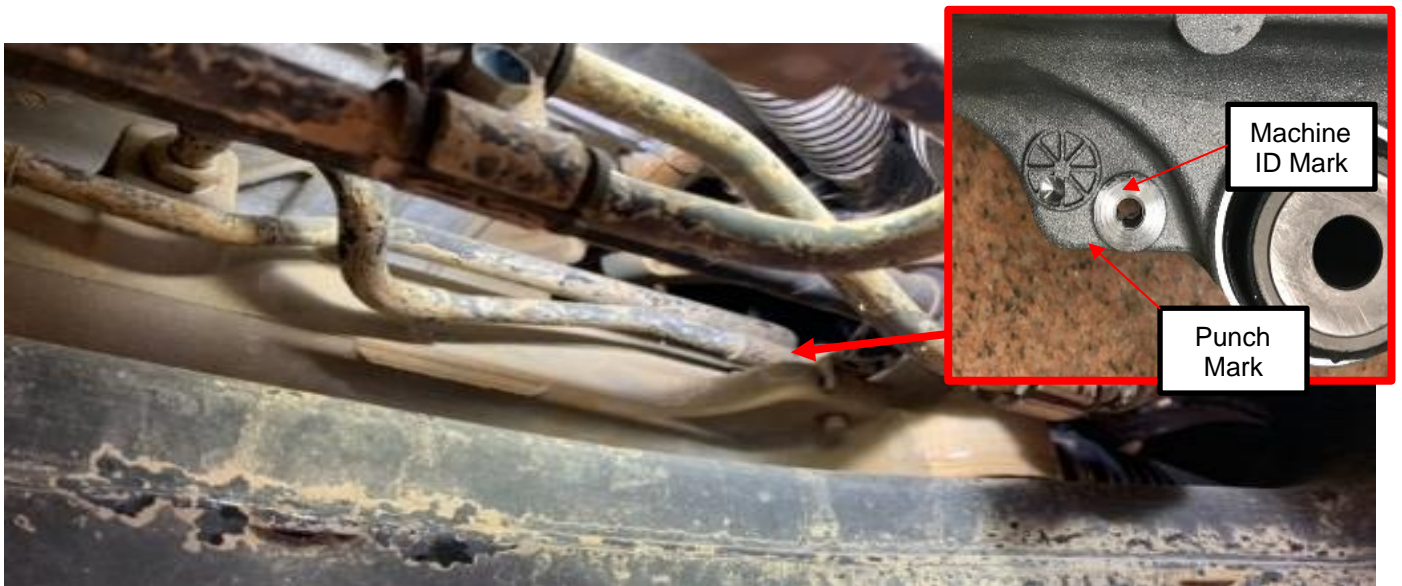
- Locate the cast circle on top of the steering gear housing as shown in the picture below
- Take a picture of the machine ID mark

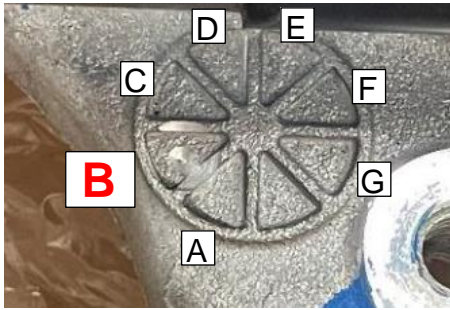
Fig 1

Fig 1. Shows an image without the use of a mirror.

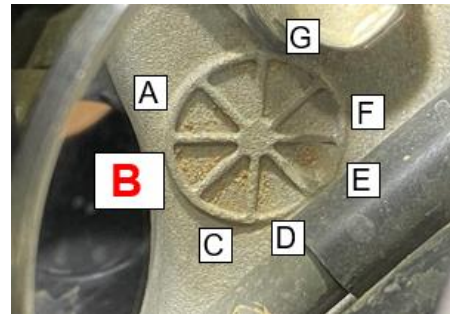
Fig 2 Shows an image with a mirror. Also note if you take picture in selfie mode it will be a mirrored image.

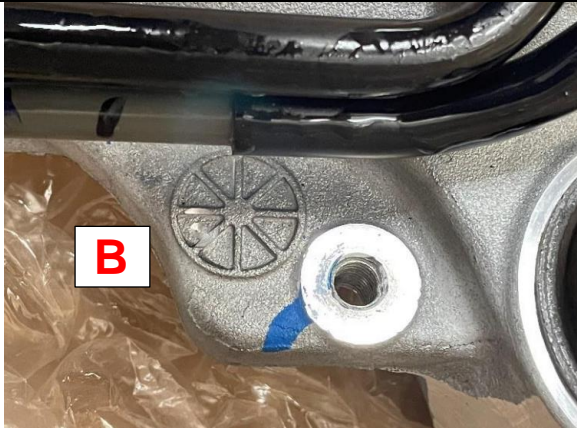
Location B top view

Location "B" is located next to the steering gear radius edge shown. This is critical for inspection; ensure you make correct judgement.

Examples of NG Location B (Replacement required)

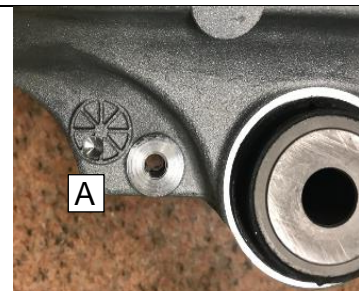
Location "A" top view

Example of Ok Locations (No Replacement needed)

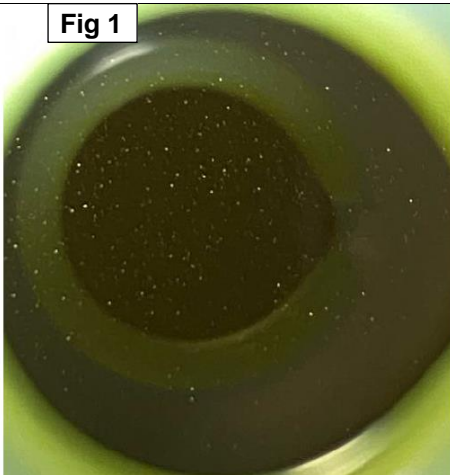
Fig 1 shows fluid with metallic debris

- If reservoir is found empty or metallic debris is found take picture of condition. It will be required for parts release.

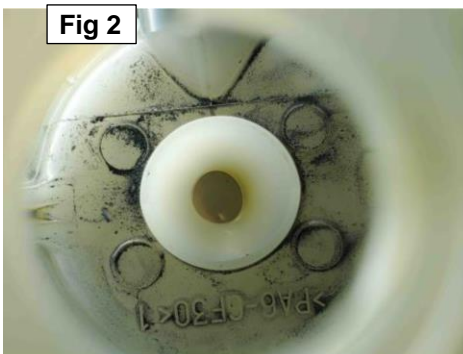
Fig 2 shows an empty reservoir with metallic debris.
