(Revision 4) February 2026

Safety Recall Y99 / NHTSA 21V-925 Side Air Bag Inflatable Curtain Inflator

2021 (DS) Ram 1500 Pickup
2021 - 2022 (DJ) Ram 2500 Pickup
2021 - 2022 (D2) Ram 3500 Pickup

The Side Air Bag Inflatable Curtain (SABIC) on about 168 of the above vehicles may have been built with an inflator with out of specification propellant gas mass. SABIC assemblies with low gas mass may result in non-deployment or low/slow deployment and high gas mass may result in aggressive deployment of the air bag, which may increase the risk of occupant injury in certain crashes.

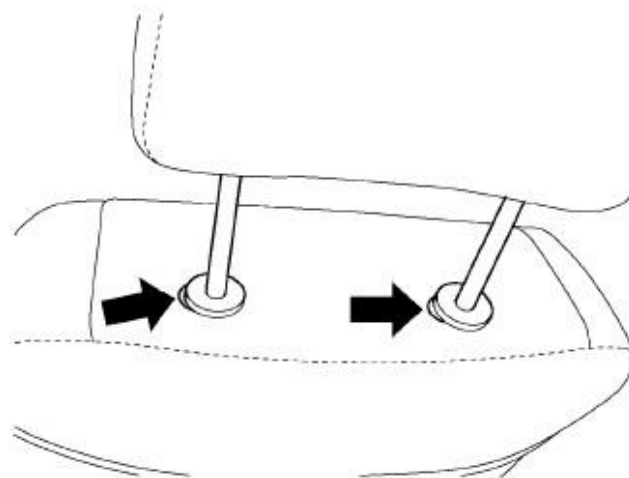
3. Push in the buttons on front seat headrest sleeves then pull the headrest up and remove (Figure 2).

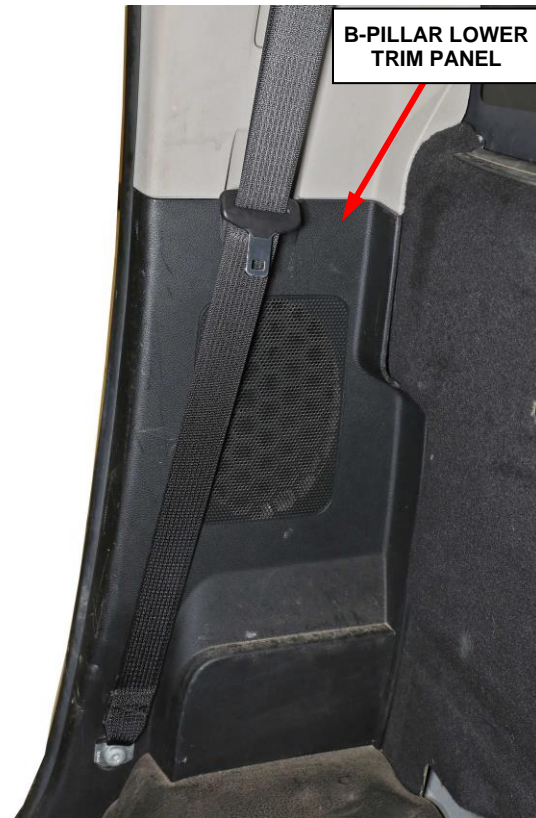
Figure 3 – B-Pillar Lower Trim Panel

5. Release the upper retaining clips of the B-pillar lower trim panel to allow for removal of the B-pillar upper trim panel (Figure 3).

47. Install and tighten the screw that secures the B-pillar upper trim panel then install the airbag applique cover (Figure 5).
48. Remove and **DISCARD** the bolt retainer and the bolt from the seat belt turning loop, save the spacer washer for reuse (Figure 14).
49. Using a **NEW** bolt and reusing the spacer washer, install the turning loop then tighten the bolt to 40 N·m (30 ft. lbs.) (Figure 4).
50. Install the turning loop cover (Figure 4).
51. Position the B-pillar lower trim panel and engage the retaining clips fully (Figure 3).

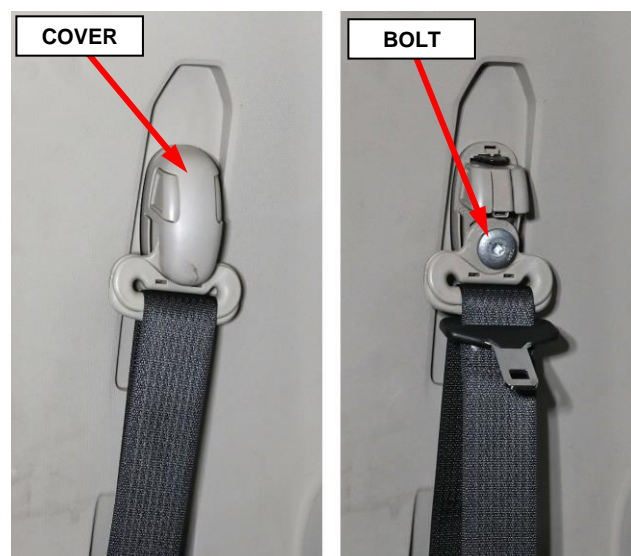
Figure 4 – Seat Belt Turning Loop

6. Separate the seatbelt turning loop cover then remove the turning loop bolt (Figure 4).

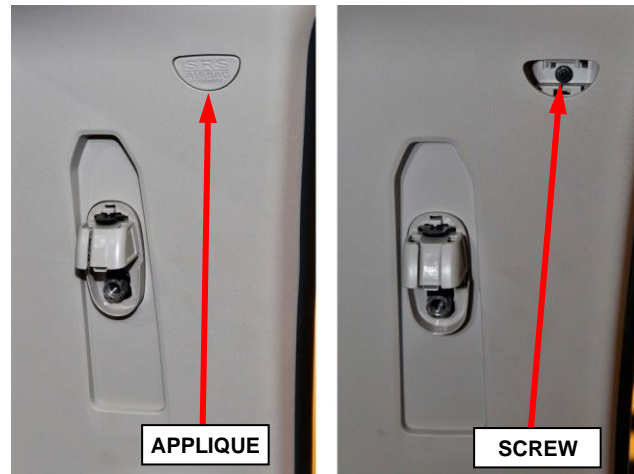
Figure 5 – B-Pillar Upper Trim Panel Fastener

- Using a trim stick or equivalent, release the B-pillar airbag applique then remove the screw that secures the upper trim panel (Figure 5).

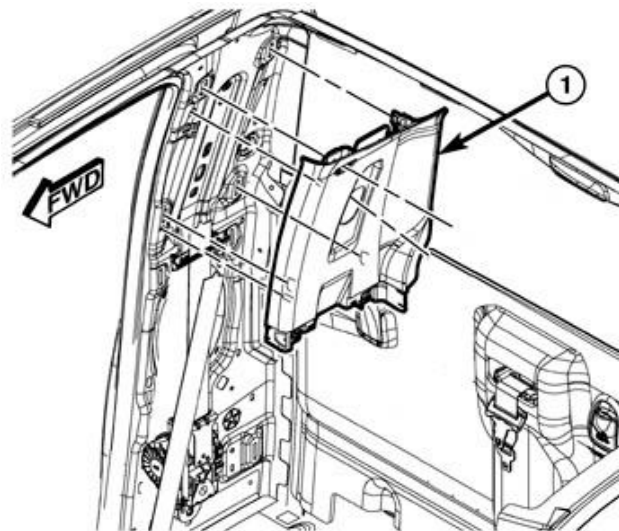
Figure 6 – B-Pillar Upper Trim Panel

- Release the retaining clips and remove the B-pillar upper trim panel (1) (Figure 6).

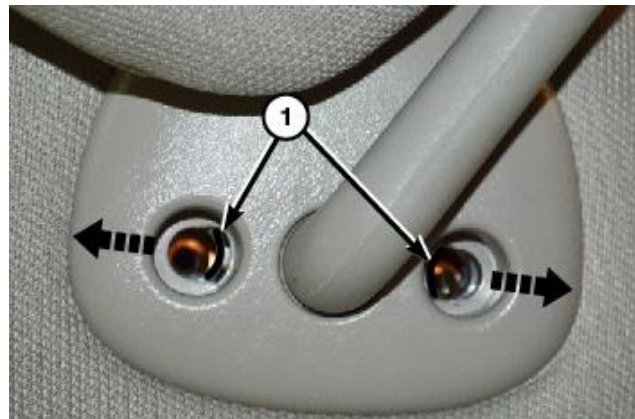
Figure 8 – Visors

Using a small flat bladed tool or equivalent, release the retaining tabs (1) and separate the visor from the headliner (Figure 8).

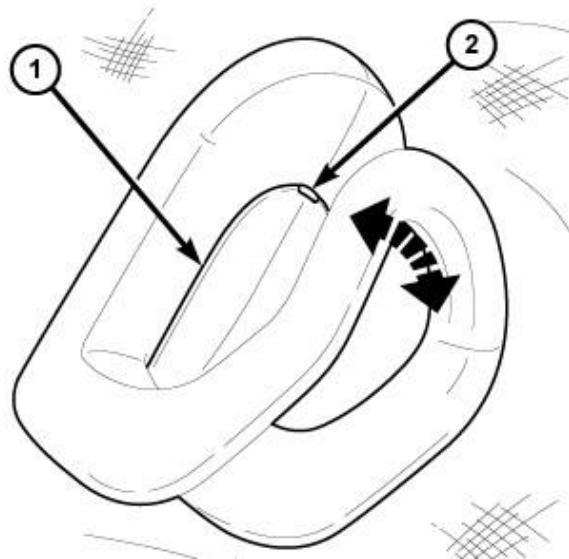
Figure 9 – Coat Hook

14. Using a small flat bladed tool, open the coat hook screw cover (2) then remove the screw and coat hook (Figure 9).

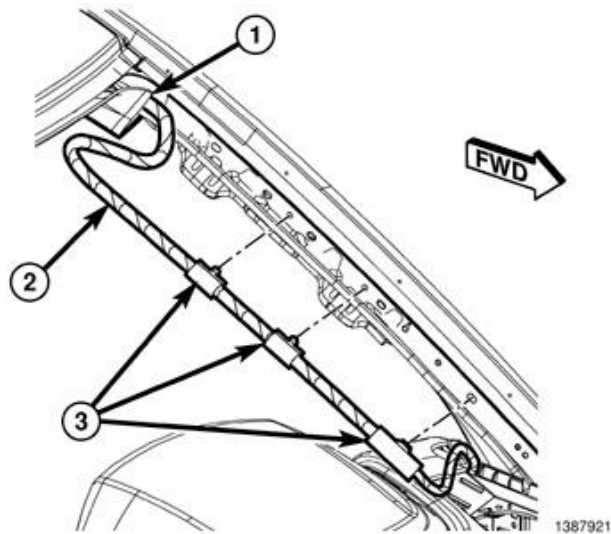
Figure 10 – Headliner Harness

15. As necessary, release the headliner wiring harness clips (3) from the A-pillar to allow enough wiring harness slack for lowering the headliner (Figure 10).

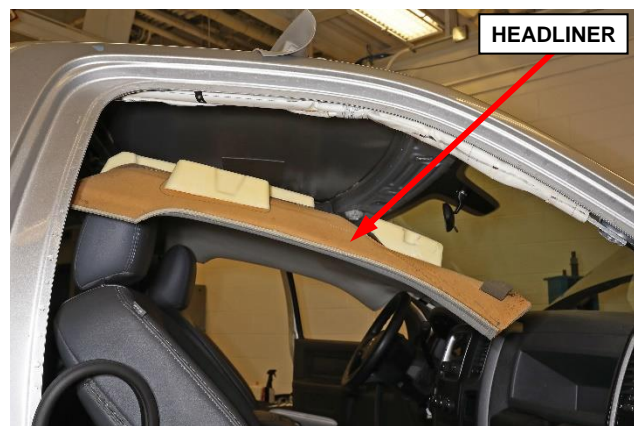
Figure 11 – Headliner

17. Carefully lower the headliner allowing it to rest on the seat backs and instrument panel (Figure 11).

CAUTION: Disconnect any wiring harness electrical connectors as necessary to allow enough wiring harness slack for lowering headliner. It will not be necessary to remove the headliner from the vehicle.

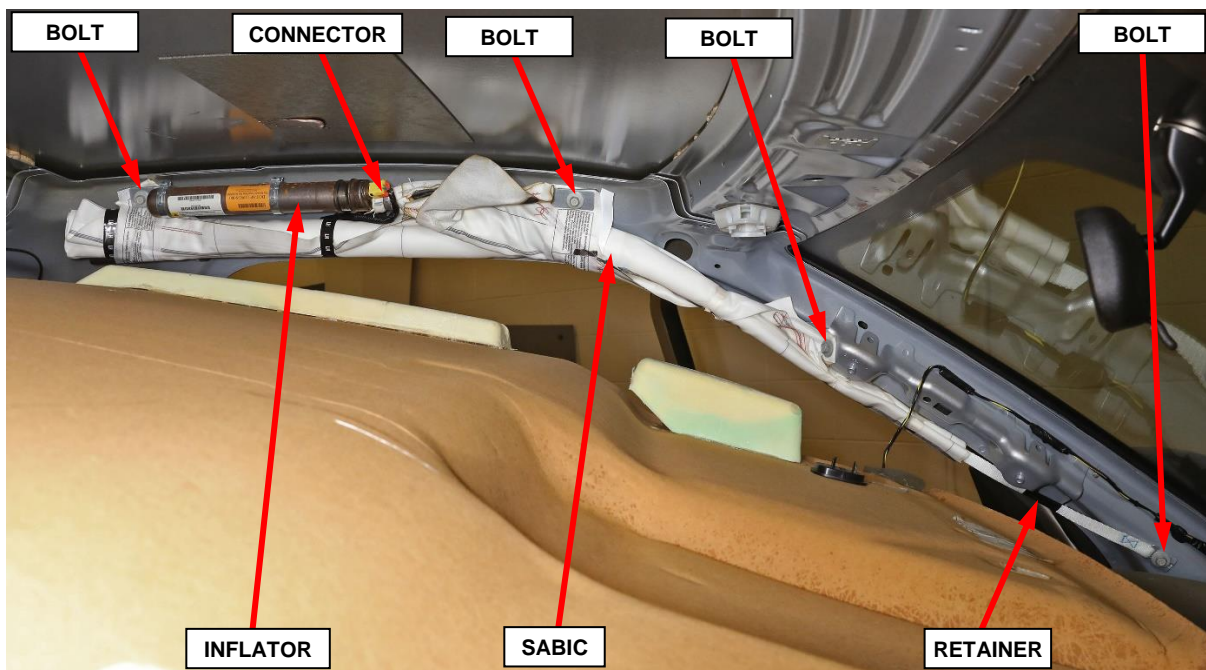
**Figure 12 – SABIC**

23. Remove the SABIC from the vehicle as a unit and **DISCARD** following local ordinances and recommended procedures for handling and disposal of non-deployed supplemental restraints. Provided packaging is not authorized for the transport of the recalled SABIC Module. Parts will need to be either deployed on-site or transported in alternative approved containers.

24. Check to be certain that the two spring nuts are properly installed in the inner roof rail and that they are in good condition.
25. Position the **NEW SABIC** into the vehicle as a unit (Figure 12).

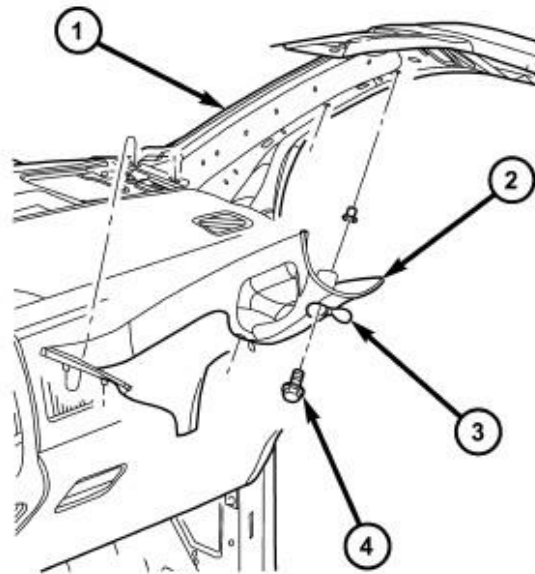
1. Using a small flat-bladed tool, carefully open the two fastener covers (3) located in the A-pillar trim panel (2) (Figure 15).
2. Remove the two bolts (4) that secure the A-pillar trim panel to the A-pillar (1) and remove the trim panel (Figure 15).

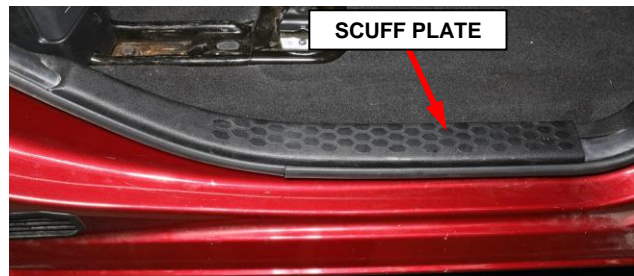
Figure 17 – Door Sill Scuff Plates

6. Release the front and rear door sill scuff plates on either side of the B-pillar lower trim panel to allow for removal of the B-pillar lower trim panel (Figure 17).

51. Install the B-pillar upper trim panel (1) and engage the retaining clips fully (Figure 20).
52. Install the grab handle bolts (3) and tighten to 5 N·m (44 in. lbs.). Close the fastener covers (2) (Figure 20).
53. Remove and **DISCARD** the bolt retainer and bolt from the seat belt turning loop, save the spacer washer for reuse (Figure 35).
54. Using a **NEW** bolt and reusing the spacer washer, install the turning loop then tighten the bolt to 40 N·m (30 ft. lbs.) (Figure 19).
55. Install the seat belt turning loop cover (Figure 19).
56. Position the B-pillar lower trim panel and engage the retaining clips fully (Figure 18).
57. Position the front and rear door sill scuff plates and engage the retainers (Figure 17).

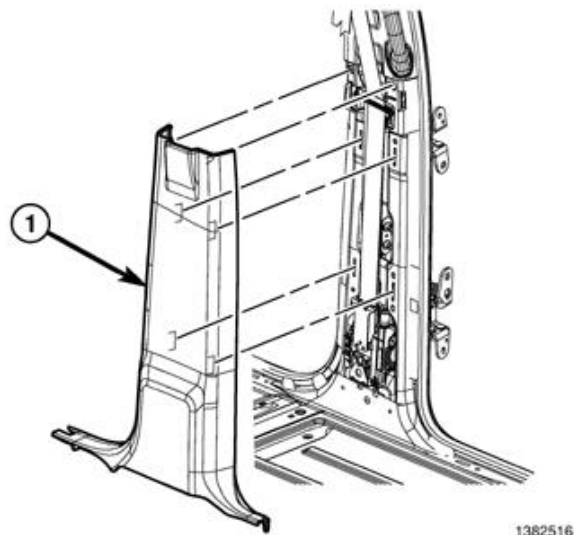
7. Release the retaining clips and remove the B-pillar lower trim panel to allow for removal of the B-pillar upper trim panel (Figure 18).

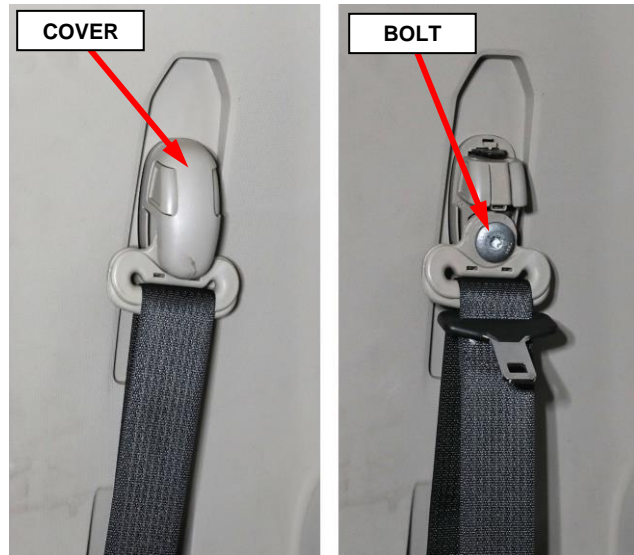
Figure 19 – Seat Belt Turning Loop

8. On the B-pillar, separate the seatbelt turning loop cover then remove the turning loop bolt (Figure 19).

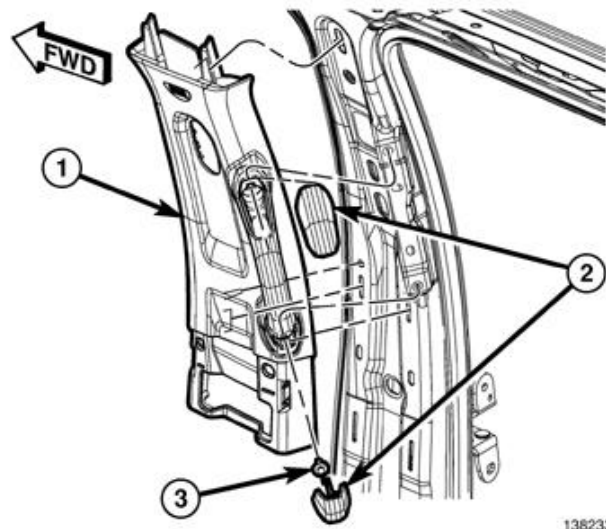
Figure 20 – B-Pillar Upper Trim Panel

9. On the B-pillar, use a small flat-bladed tool to carefully open the two fastener covers (2) located on the grab handle (Figure 20).

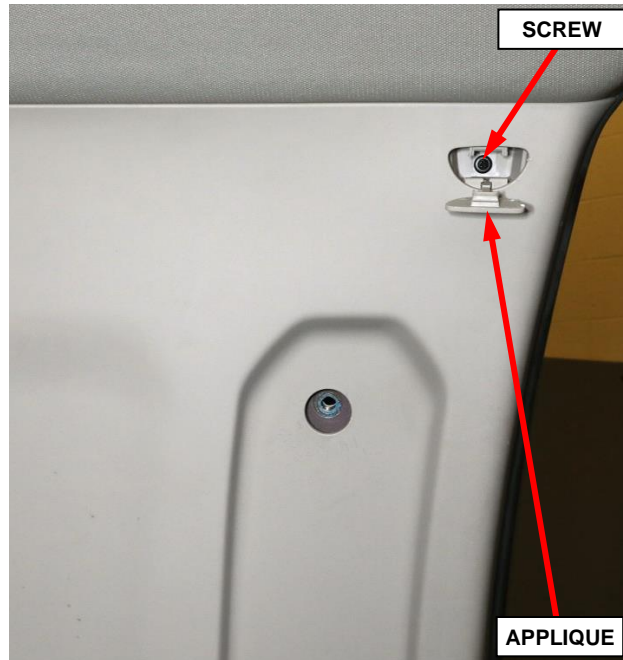
Figure 23 – C-Pillar Upper Trim Panel

14. Using a trim stick or equivalent, release the C-pillar airbag applique then remove the screw that secures the upper trim panel (Figure 23).

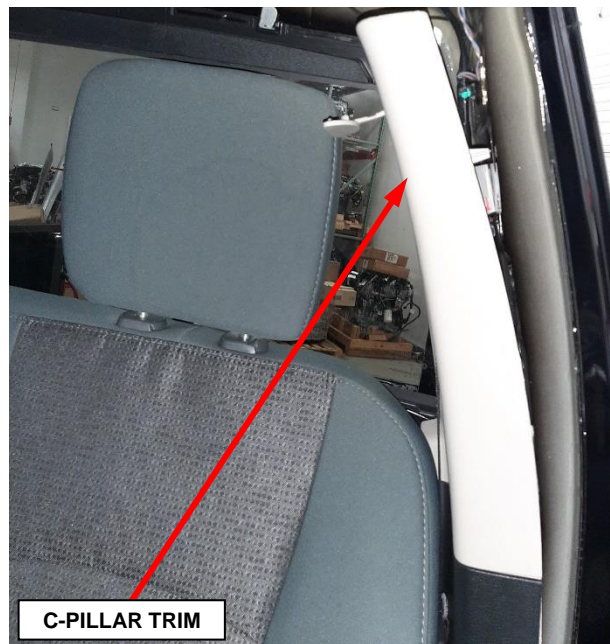
Figure 24 – C-Pillar Upper Trim Panel

15. Release the retaining clips and tilt the top of the C-pillar upper trim panel inward (Figure 24).

45. Position the upper trim to the C-pillar then engage the retaining clips (Figure 24).
46. Install and tighten the screw that secures the C-pillar upper trim panel. Then install the airbag applique (Figure 23).
47. Remove and **DISCARD** the bolt retainer and bolt from the seat belt turning loop, save the spacer washer for reuse (Figure 34).
48. Using a **NEW** bolt and reusing the spacer, install the turning loop then tighten the bolt to 40 N·m (30 ft. lbs.) (Figure 22).

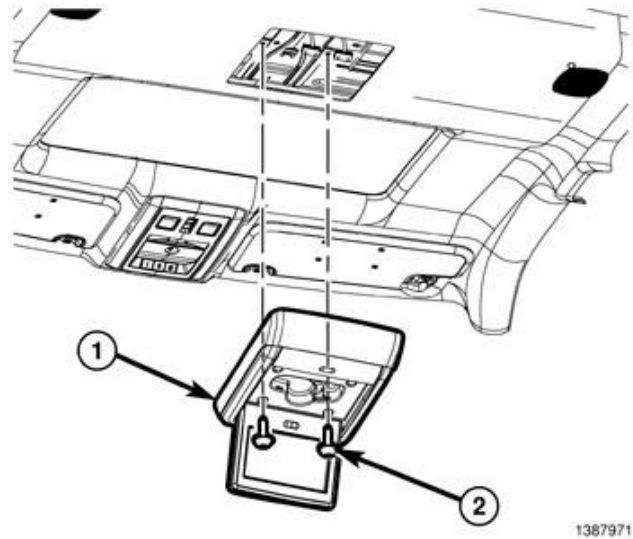
Figure 25 – Rear Seat DVD Monitor

16. If equipped with DVD monitor, remove the screws (2) and separate the monitor (1) from the roof (Figure 25).

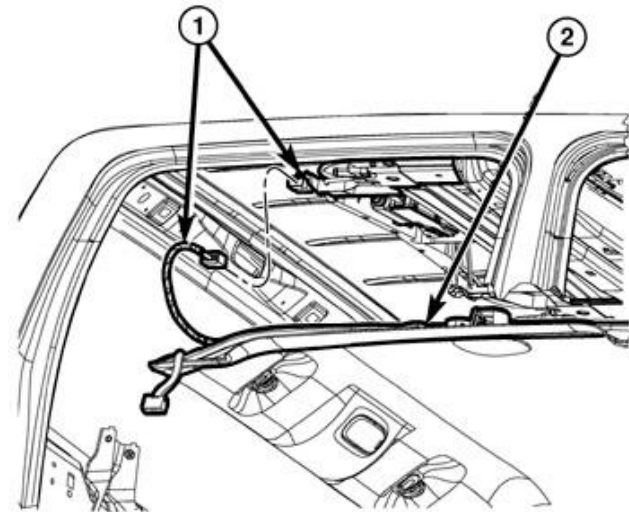
**Figure 31 – Headliner Harness**

22. Release the door seals from the door openings to allow for lowering of the headliner.
23. Tilt the rear view mirror up to allow clearance for lowering the headliner (Figure 30).
24. Carefully tilt the front of the headliner (2) down to clear the rear view mirror then slide the headliner forward to clear the C-pillar trim while disconnecting any wiring harness electrical connectors (1) as necessary to allow enough wiring harness slack to lower the headliner (Figure 31).

25. lower the headliner (2) allowing it to rest on the seat backs and instrument panel (Figure 31).

38. Raise the headliner into proper vehicle position and connect any electrical connectors previously disconnected from the headliner (Figure 31).

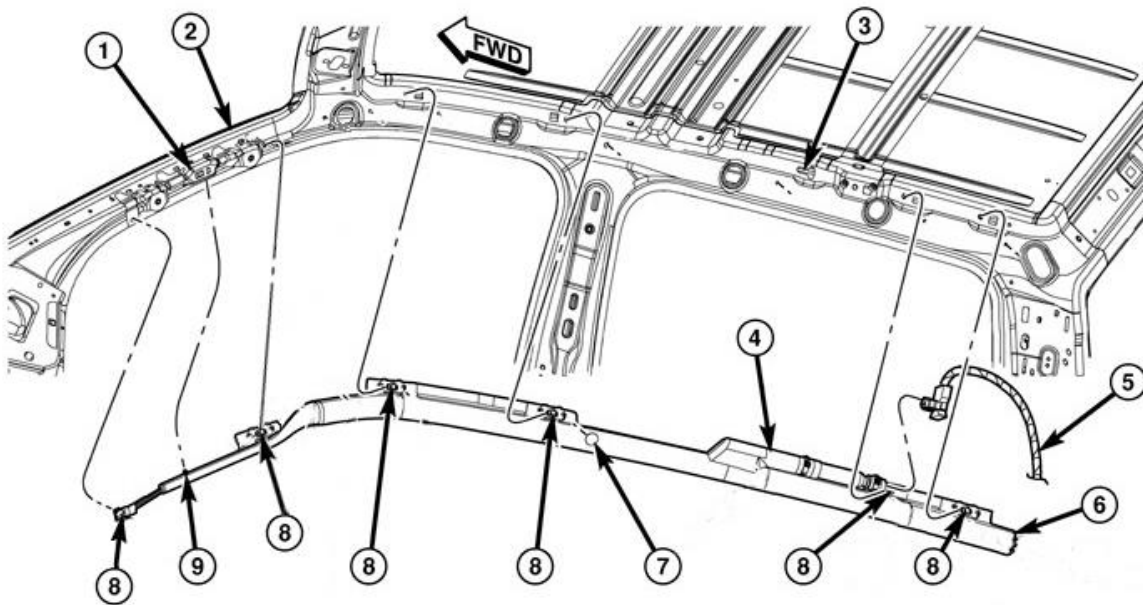
**Figure 32 – SABIC**

31. Remove the SABIC (6) from the vehicle as a unit and **DISCARD** following local ordinances and recommended procedures for handling and disposal of Non-Deployed Supplemental Restraints (Figure 32). Provided packaging is not authorized for the transport of the recalled SABIC Module. Parts will need to be either deployed on-site or transported in alternative approved containers.

32. Check to be certain that the spring nuts are properly installed in the inner roof rail and that they are in good condition.
33. Position the **NEW SABIC** (6) into the vehicle as a unit (Figure 32).

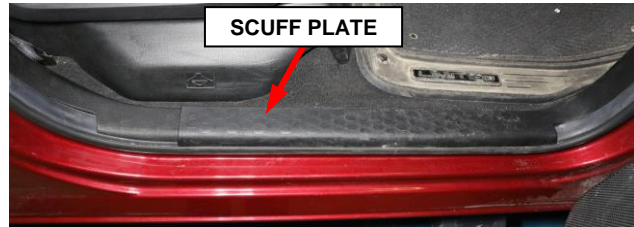
Figure 38 – Door Sill Scuff Plates

6. Release the front and rear door sill scuff plates on either side of the B-pillar lower trim panel to allow for removal of the B-pillar lower trim panel (Figure 38).

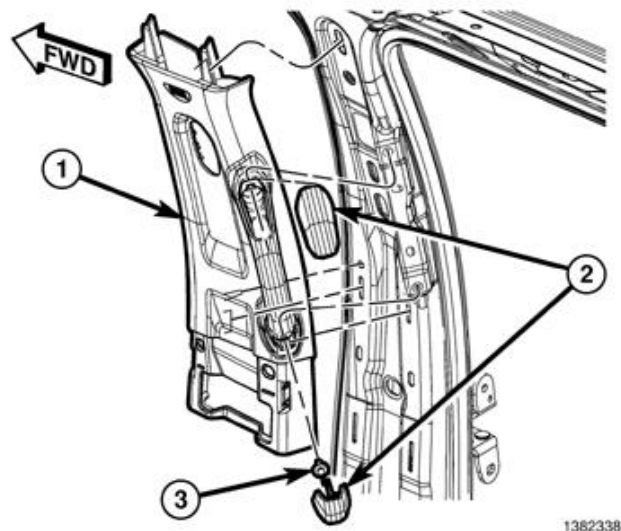
Figure 41 – B-Pillar Upper Trim Panel

10. Remove the two bolts (3) that secure the grab handle to the B-pillar (Figure 41).

47. Install the B-pillar upper trim panel (1) and engage the retaining clips fully (Figure 41).
48. Install the grab handle bolts (3) and tighten to 5 N·m (44 in. lbs.). Close the fastener covers (2) (Figure 41).
49. Remove and **DISCARD** the bolt retainer and the bolt from the seat belt turning loop, save the spacer washer for reuse (Figure 54).
50. Using a **NEW** bolt and reusing the spacer washer, install the turning loop then tighten the bolt to 40 N·m (30 ft. lbs.) (Figure 40).
51. Install the seat belt turning loop cover (Figure 40).
52. Position the B-pillar lower trim panel and engage the retaining clips fully (Figure 39).
53. Position the front and rear door sill scuff plates and engage the retainers

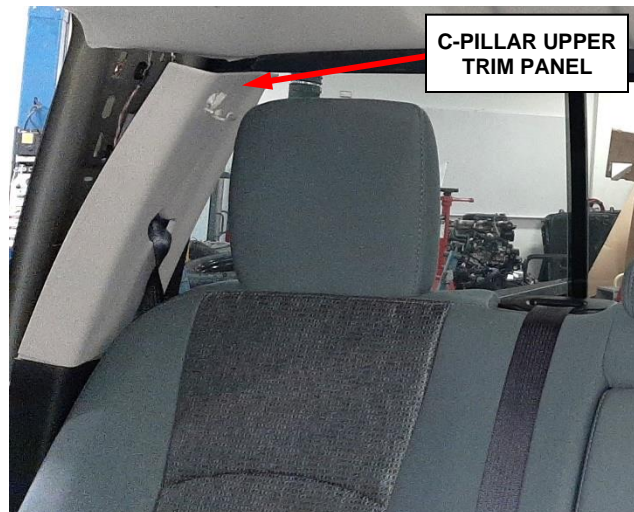
Figure 44 – C-Pillar Trim Panels

14. Release the retaining clips and tilt the top of the C-pillar upper trim panel inward (Figure 44).

44. Position the upper trim panel to the C-pillar then engage the retaining clips (Figure 44).
45. Install and tighten the screw that secures the C-pillar upper trim panel. Then install the airbag applique (Figure 43).

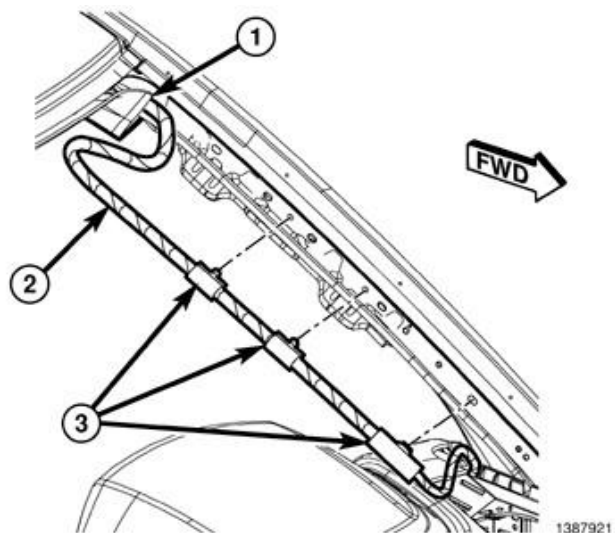
Figure 49 – Headliner Harness

NOTE: In some cases, the wire harness for the visor vanity mirror may be glued to the top side of the headliner and may be a little difficult to release.

20. As necessary, release the headliner wiring harness clips (3) from the A-pillar to allow enough wiring harness slack for lowering the headliner (Figure 49).

38. Tilt the rear view mirror down to allow it to support the headliner (Figure 50).
39. Reattach any headliner wiring harness clips (3) removed from the A-pillar to allow slack while lowering headliner (Figure 49).

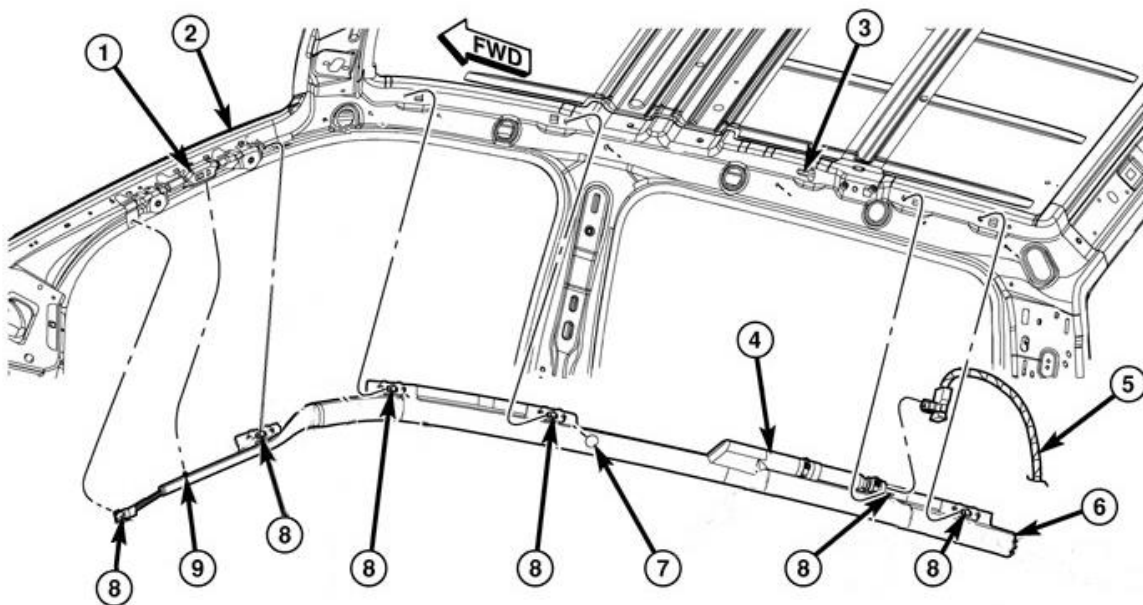
**Figure 52 – SABIC**

30. Remove the SABIC (6) from the vehicle as a unit and **DISCARD** following local ordinances and recommended procedures for handling and disposal of Non-Deployed Supplemental Restraints (Figure 52). Provided packaging is not authorized for the transport of the recalled SABIC Module. Parts will need to be either deployed on-site or transported in alternative approved containers.

31. Check to be certain that the spring nuts are properly installed in the inner roof rail and that they are in good condition.
32. Position the **NEW SABIC** (6) into the vehicle as a unit (Figure 52).
