Safety Recall Y99 / NHTSA 21V-925 Side Air Bag Inflatable Curtain Inflator

2021 (DS) Ram 1500 Pickup
2021 - 2022 (DJ) Ram 2500 Pickup
2021 - 2022 (D2) Ram 3500 Pickup

The Side Air Bag Inflatable Curtain (SABIC) on about 168 of the above vehicles may have been built with an inflator with out of specification propellant gas mass. SABIC assemblies with low gas mass may result in non-deployment or low/slow deployment and high gas mass may result in aggressive deployment of the air bag, which may increase the risk of occupant injury in certain crashes.

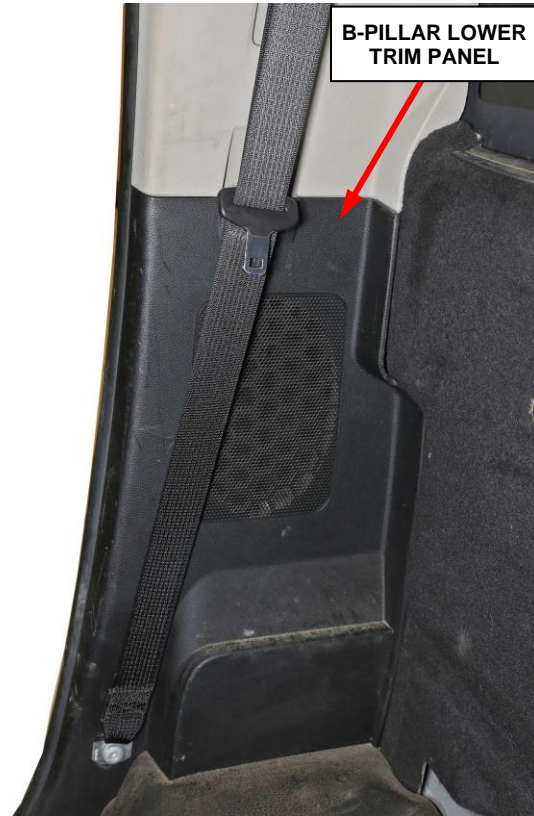
Figure 3 – B-Pillar Lower Trim Panel

5. Release the upper retaining clips of the B-pillar lower trim panel to allow for removal of the B-pillar upper trim panel (Figure 3).

47. Install and tighten the screw that secures the B-pillar upper trim panel then install the airbag applique cover (Figure 5).
48. Remove and **DISCARD** the bolt retainer and the bolt from the seat belt turning loop, save the spacer washer for reuse (Figure 14).
49. Using a **NEW** bolt and reusing the spacer washer, install the turning loop then tighten the bolt to 40 N·m (30 ft. lbs.) (Figure 4).
50. Install the turning loop cover (Figure 4).
51. Position the B-pillar lower trim panel and engage the retaining clips fully (Figure 3).
