(Revision 3) February 2026

Dealer Service Instructions for:

## **Safety Recall Z07 / NHTSA 21V-925 Side Air Bag Inflatable Curtain Inflator**

**2021 - 2022 (DS) Ram 1500 Pickup**  
**2021 - 2022 (DJ) Ram 2500 Pickup**  
**2021 - 2022 (D2) Ram 3500 Pickup**

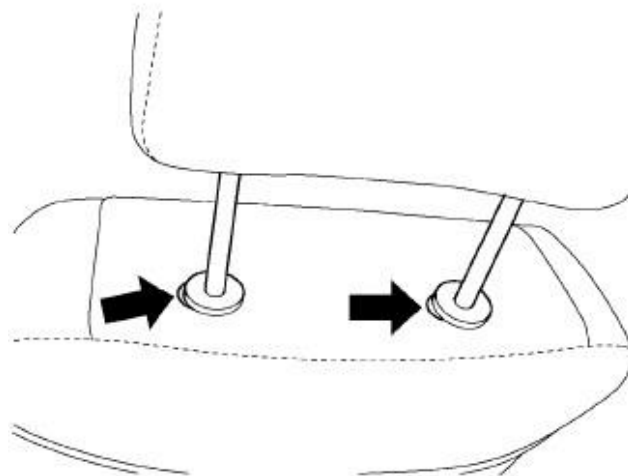
**Figure 16 – Head Rest**

3. Push in the buttons on front seat headrest sleeves then pull the headrest up and remove (Figure 16).
4. Position the front seats to the full forward position with the seat backs fully forward.

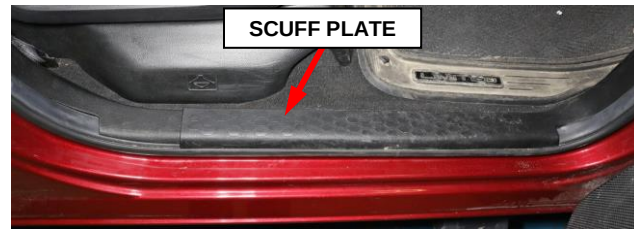
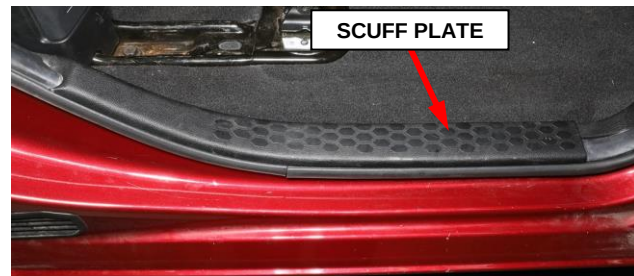
**Rear Door Sill****Figure 17 – Door Sill Scuff Plates**

6. Release the front and rear door sill scuff plates on either side of the B-pillar lower trim panel to allow for removal of the B-pillar lower trim panel (Figure 17).

51. Install the B-pillar upper trim panel (1) and engage the retaining clips fully (Figure 20).
52. Install the grab handle bolts (3) and tighten to 5 N·m (44 in. lbs.). Close the fastener covers (2) (Figure 20).
53. Remove and **DISCARD** the bolt retainer and bolt from the seat belt turning loop, save the spacer washer for reuse (Figure 35).
54. Using a **NEW** bolt and reusing the spacer washer, install the turning loop then tighten the bolt to 40 N·m (30 ft. lbs.) (Figure 19).
55. Install the seat belt turning loop cover (Figure 19).
56. Position the B-pillar lower trim panel and engage the retaining clips fully (Figure 18).
57. Position the front and rear door sill scuff plates and engage the retainers (Figure 17).

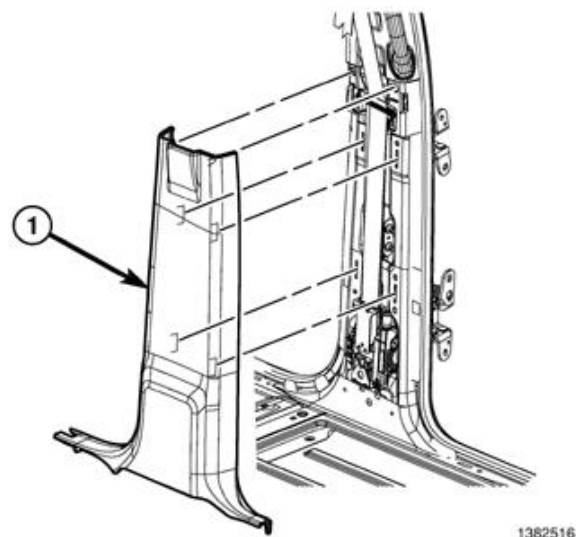
**Figure 18 – B-Pillar Lower Trim Panel**

7. Release the retaining clips and remove the B-pillar lower trim panel to allow for removal of the B-pillar upper trim panel (Figure 18).

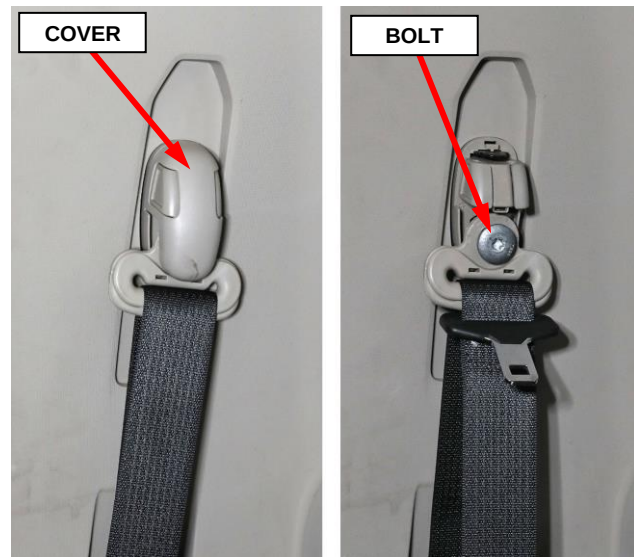
**Figure 19 – Seat Belt Turning Loop**

8. On the B-pillar, separate the seatbelt turning loop cover then remove the turning loop bolt (Figure 19).

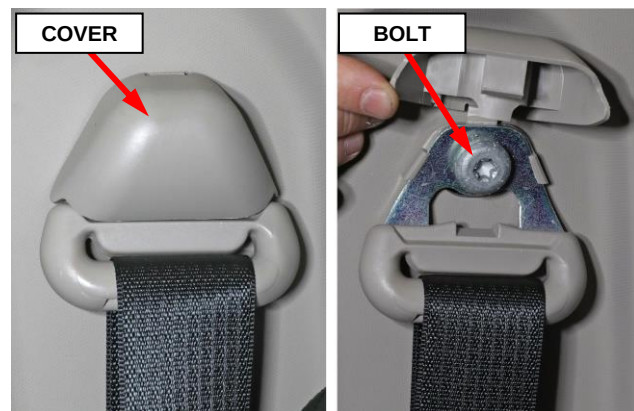
**Figure 22 – Seat Belt Turning Loop**

13. On the C-pillar, lift the seat belt turning loop cover then remove the turning loop bolt (Figure 22).

45. Position the upper trim to the C-pillar then engage the retaining clips (Figure 24).
46. Install and tighten the screw that secures the C-pillar upper trim panel. Then install the airbag applique (Figure 23).
47. Remove and **DISCARD** the bolt retainer and bolt from the seat belt turning loop, save the spacer washer for reuse (Figure 34).
48. Using a **NEW** bolt and reusing the spacer, install the turning loop then tighten the bolt to 40 N·m (30 ft. lbs.) (Figure 22).

49. Install the seat belt turning loop cover (Figure 22).
50. Position the coat hooks (5) onto the headliner and install the screws tightening securely into the mounting clips then close the screw cap fully (Figure 21).

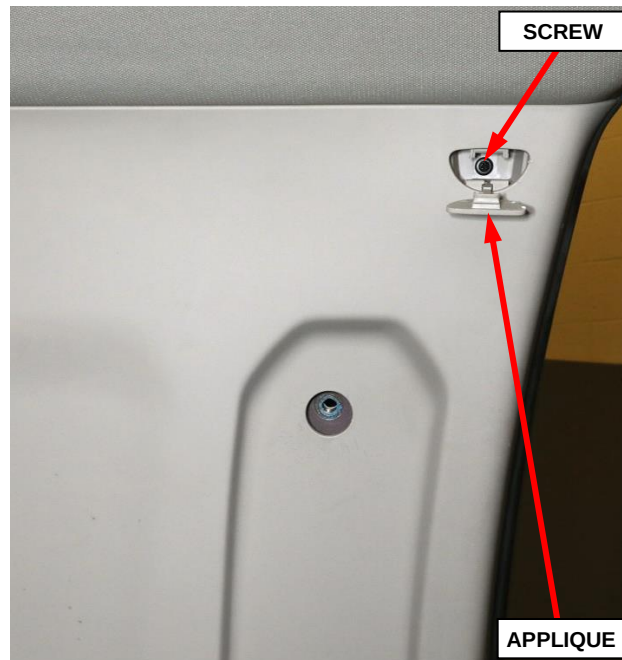
**Figure 23 – C-Pillar Upper Trim Panel**

14. Using a trim stick or equivalent, release the C-pillar airbag applique then remove the screw that secures the upper trim panel (Figure 23).

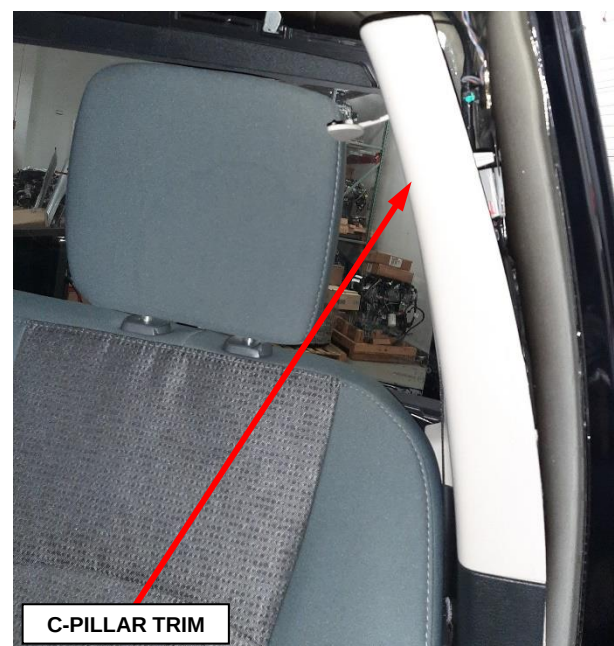
**Figure 24 – C-Pillar Upper Trim Panel**

15. Release the retaining clips and tilt the top of the C-pillar upper trim panel inward (Figure 24).

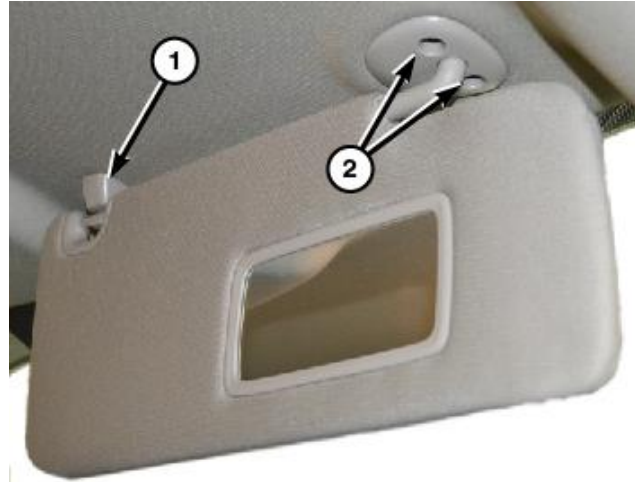
**Figure 27 – Visors**

18. Separate the visor from the support (1) then remove the screw and remove the visor support (Figure 27).
19. Remove the visor screws (2) then remove the visor (Figure 27).

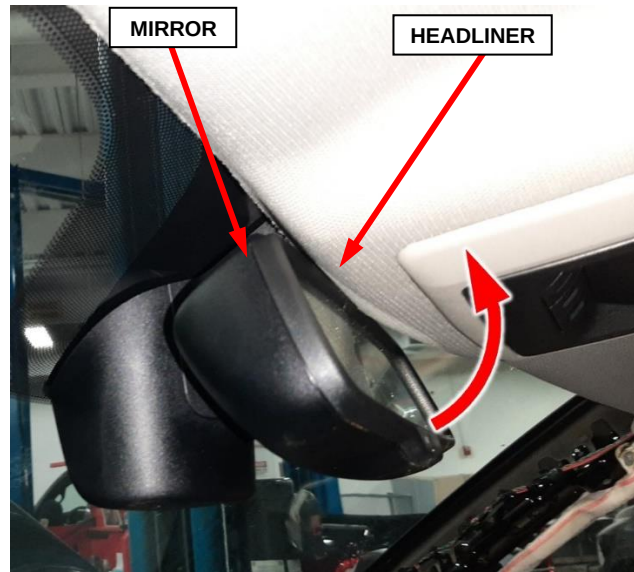
**Figure 30 – Headliner Harness**

22. Release the door seals from the door openings to allow for lowering of the headliner.
23. Tilt the rear view mirror up to allow clearance for lowering the headliner (Figure 30).
24. Carefully tilt the front of the headliner (2) down to clear the rear view mirror then slide the headliner forward to clear the C-pillar trim while disconnecting any wiring harness electrical connectors (1) as necessary to allow enough wiring harness slack to lower the headliner (Figure 31).

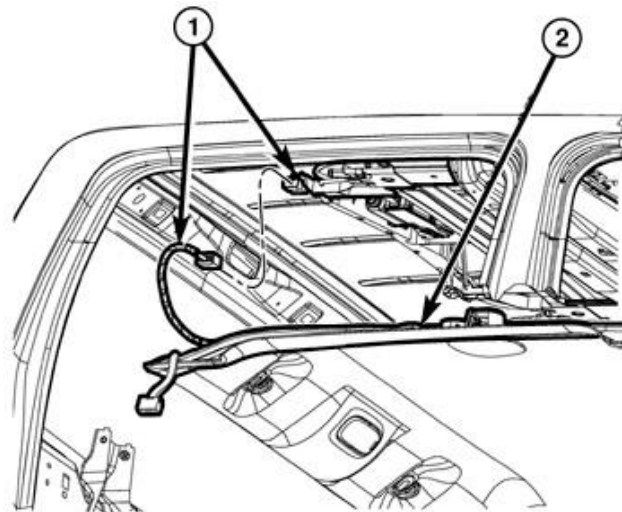
**Figure 31 – Headliner Harness**

25. lower the headliner (2) allowing it to rest on the seat backs and instrument panel (Figure 31).

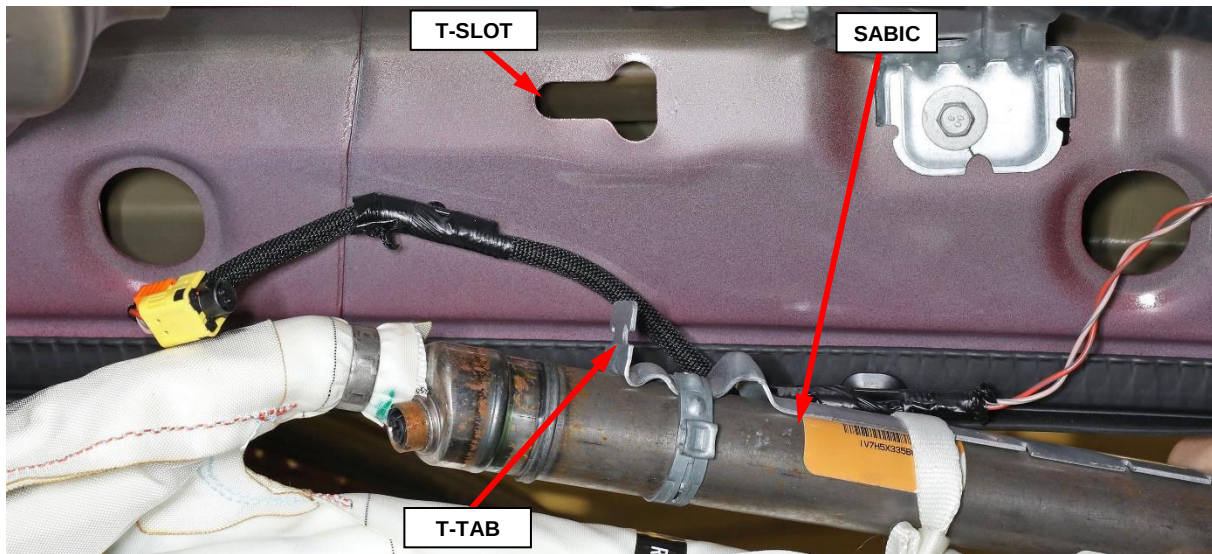
**Figure 33 – SABIC Inflator T-Tab and Inner Roof Rail T-Slot**

30. Slide the inflator rearward far enough to disengage the T-tab at the front of the inflator bracket from the keyed T-slot in the inner roof rail over the rear door opening (Figure 33).

34. Insert the T-tab at the front of the inflator bracket into the keyed T-slot in the inner roof rail over the rear door opening and slide the inflator forward to engage it (Figure 33).

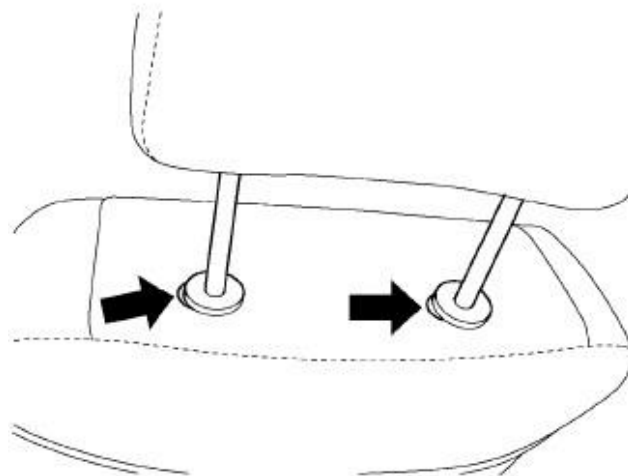
**Figure 37 – Head Rest**

3. Push in the buttons on front seat headrest sleeves then pull the headrest up and remove (Figure 37).
4. Position the front seats to the full forward position with the seat backs fully forward.

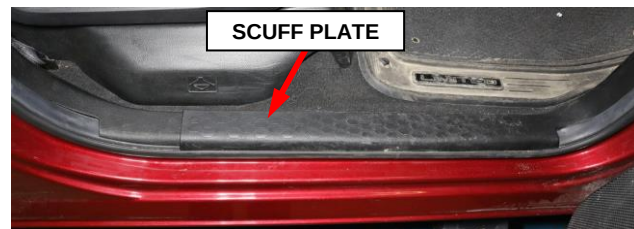
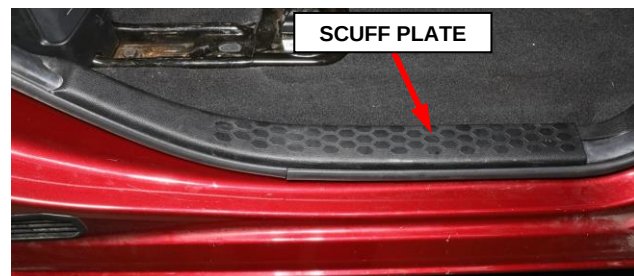
**Rear Door Sill****Figure 38 – Door Sill Scuff Plates**

6. Release the front and rear door sill scuff plates on either side of the B-pillar lower trim panel to allow for removal of the B-pillar lower trim panel (Figure 38).

47. Install the B-pillar upper trim panel (1) and engage the retaining clips fully (Figure 41).
48. Install the grab handle bolts (3) and tighten to 5 N·m (44 in. lbs.). Close the fastener covers (2) (Figure 41).
49. Remove and **DISCARD** the bolt retainer and the bolt from the seat belt turning loop, save the spacer washer for reuse (Figure 54).
50. Using a **NEW** bolt and reusing the spacer washer, install the turning loop then tighten the bolt to 40 N·m (30 ft. lbs.) (Figure 40).
51. Install the seat belt turning loop cover (Figure 40).
52. Position the B-pillar lower trim panel and engage the retaining clips fully (Figure 39).
53. Position the front and rear door sill scuff plates and engage the retainers (Figure 38).

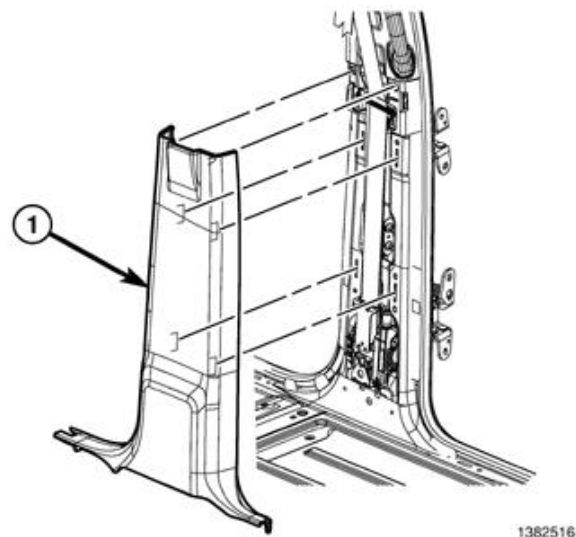
**Figure 39 – B-Pillar Lower Trim Panel**

7. Release the retaining clips and remove the B-pillar lower trim panel to allow for removal of the B-pillar upper trim panel (Figure 39).

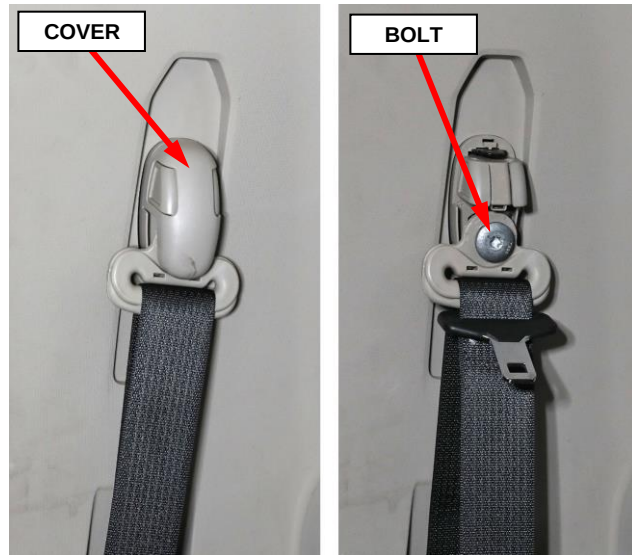
**Figure 40 – Seat Belt Turning Loop**

8. On the B-pillar, separate the seatbelt turning loop cover then remove the turning loop bolt (Figure 40).

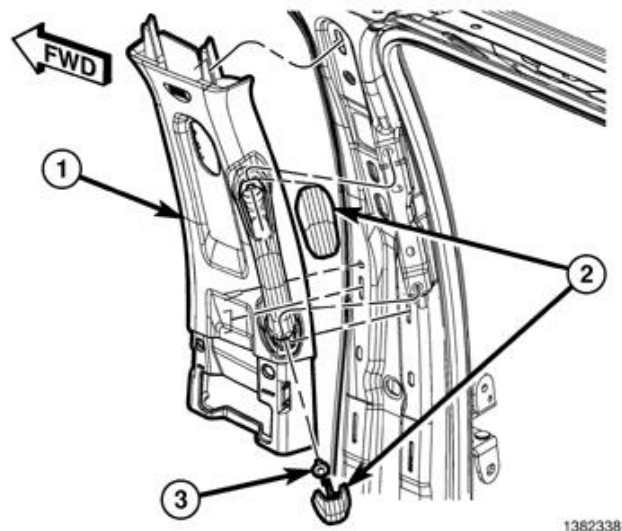
**Figure 41 – B-Pillar Upper Trim Panel**

9. On the B-pillar, use a small flat-bladed tool to carefully open the two fastener covers (2) located on the grab handle (Figure 41).
10. Remove the two bolts (3) that secure the grab handle to the B-pillar (Figure 41).
11. Using a trim stick C-4755 or equivalent, release the retaining clips that secure the B-pillar upper trim panel (1) then position the trim panel out of the way. It is not necessary to remove the seat belt from the trim panel (Figure 41).

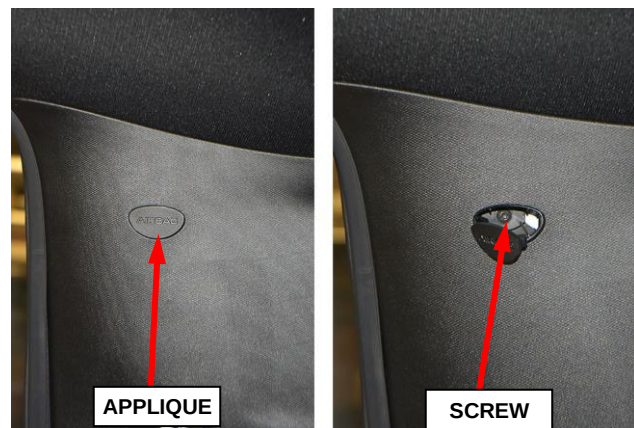
**Figure 43 – C-Pillar Upper Trim Panel**

13. Using a trim stick or equivalent, release the C-pillar airbag applique then remove the screw that secures the upper trim panel (Figure 43).

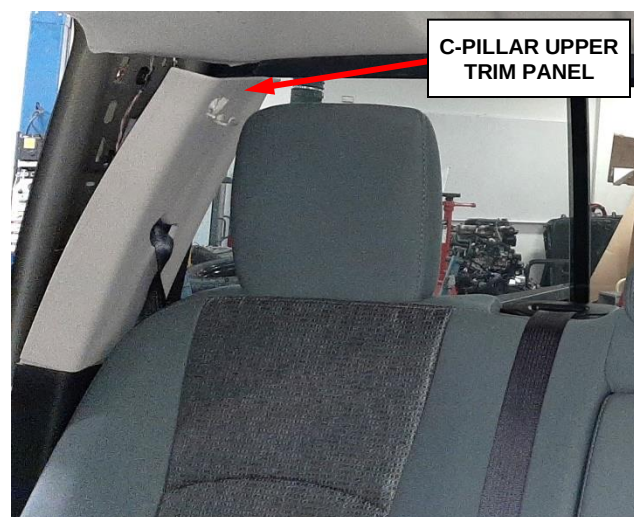
**Figure 44 – C-Pillar Trim Panels**

14. Release the retaining clips and tilt the top of the C-pillar upper trim panel inward (Figure 44).

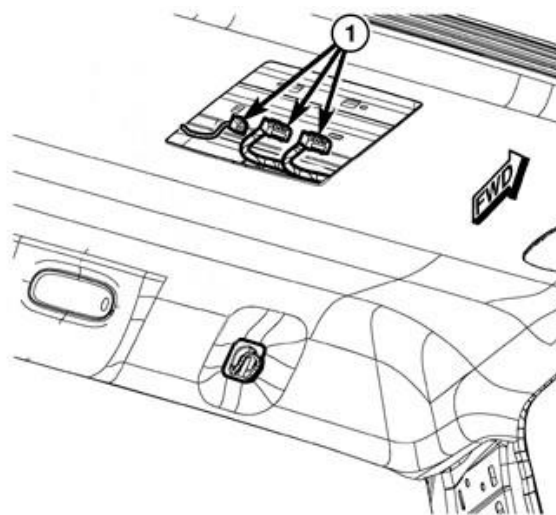
**Figure 46 – DVD Monitor Electrical Connectors**

16. If equipped with DVD monitor, disconnect the electrical connectors (1) (Figure 46).

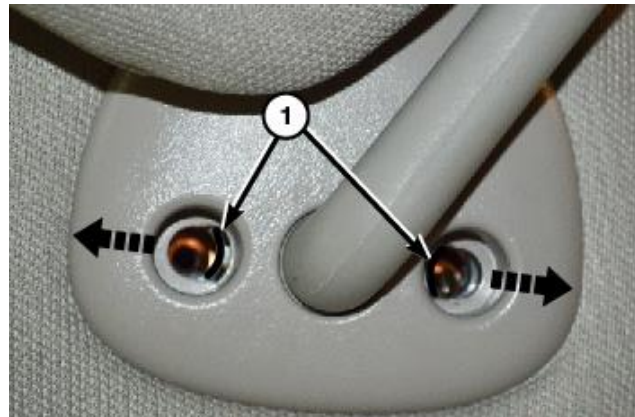
**Figure 48 – Visors**

Using a small flat bladed tool or equivalent, release the retaining tabs (1) and separate the visor from the headliner (Figure 48).

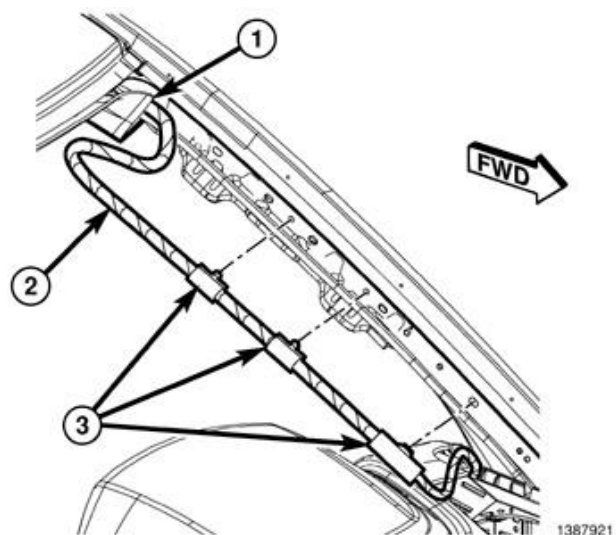
**Figure 49 – Headliner Harness**

20. As necessary, release the headliner wiring harness clips (3) from the A-pillar to allow enough wiring harness slack for lowering the headliner (Figure 49).

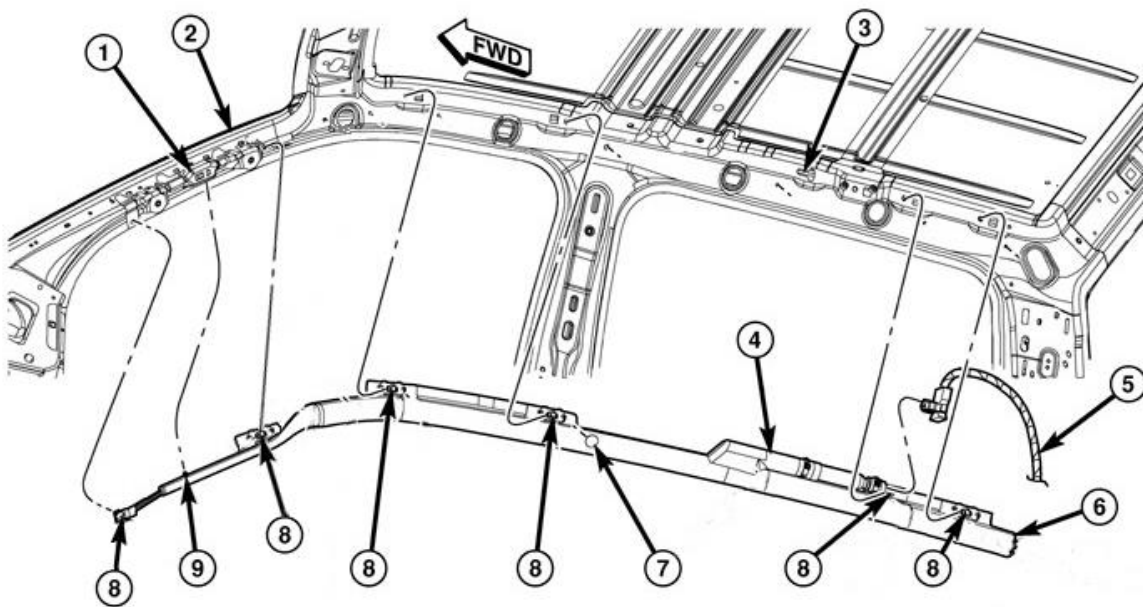
**Figure 52 – SABIC**

30. Remove the SABIC (6) from the vehicle as a unit and **DISCARD** following local ordinances and recommended procedures for handling and disposal of Non-Deployed Supplemental Restraints (Figure 52). Provided packaging is not authorized for the transport of the recalled SABIC Module. Parts will need to be either deployed on-site or transported in alternative approved containers.

31. Check to be certain that the spring nuts are properly installed in the inner roof rail and that they are in good condition.
32. Position the **NEW** SABIC (6) into the vehicle as a unit (Figure 52).

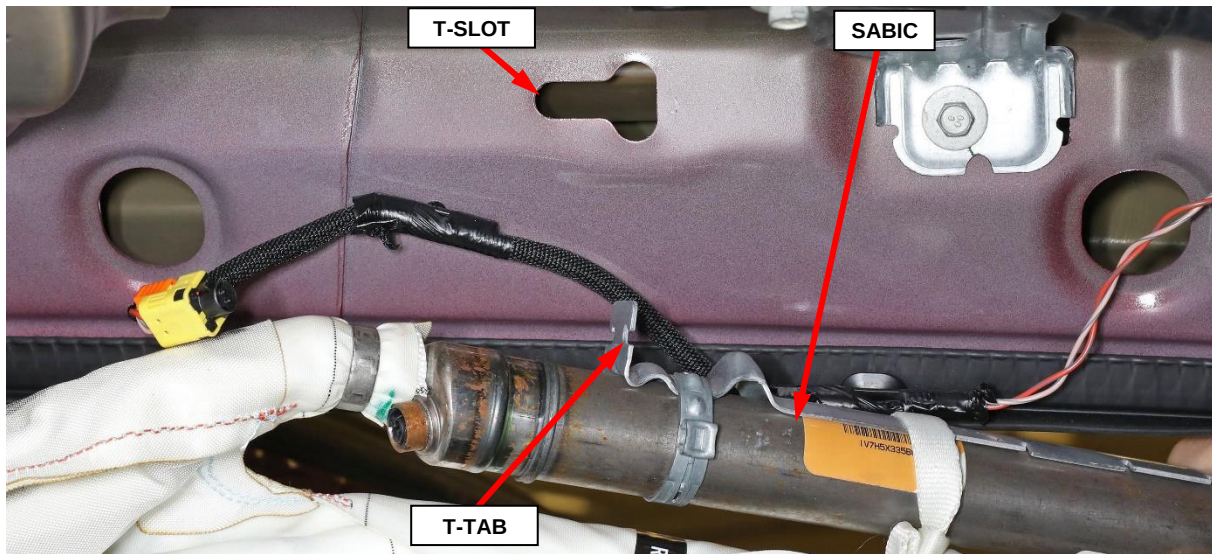
**Figure 53 – SABIC Inflator T-Tab and Inner Roof Rail T-Slot**

29. Slide the inflator rearward far enough to disengage the T-tab at the front of the inflator bracket from the keyed T-slot in the inner roof rail over the rear door opening (Figure 53).
