**RECREATIONAL VEHICLE
SAFETY RECALL NOTICE**

Safety Recall: 21V-250
Safety Advisory: 21-407
December 9, 2022

IMPORTANT SAFETY RECALL – 2nd Notice

Bullet Egress Window Crank Instructions

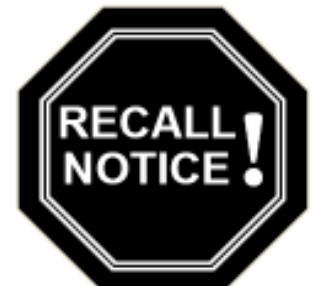
The remedy is to replace the black round knob on the bedroom egress window with the narrow crank handle.

Keystone representatives have been in contact with the staff at your selling dealership regarding this situation. The remedy is to remove the existing black round knob and replace it with a narrow crank handle, see page 2 for instructions. We have enclosed the correct narrow crank handle. The service and parts required for this corrective action will be provided at no charge to you.

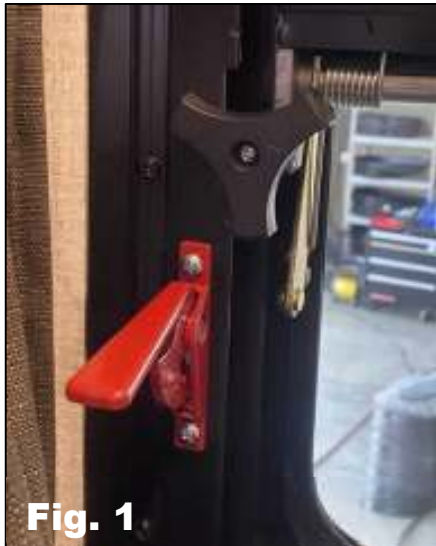
Locate the bedroom egress window. Figure 1

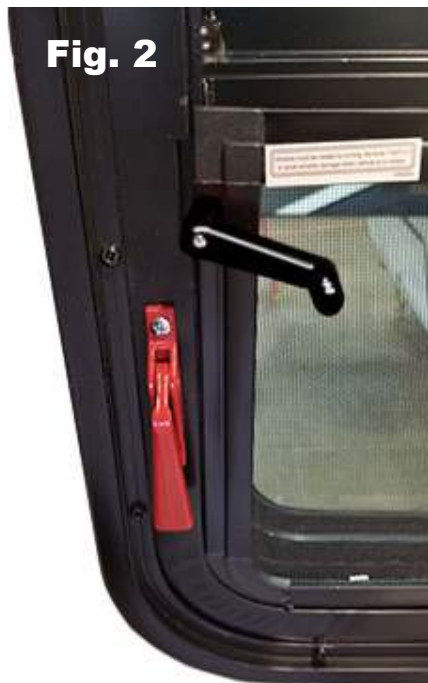
Remove the black round knob and install the narrow crank handle using KRV # 630481- Window - Crank - 3' - Black and an #8-32 x 2" screw. See Figure 2.
