KEYSTONE
RV COMPANY

RECREATIONAL VEHICLE
SAFETY RECALL NOTICE

Safety Recall: 21V-250
Safety Advisory: 21-407
January 19, 2024

Bullet Egress Window Crank Instructions

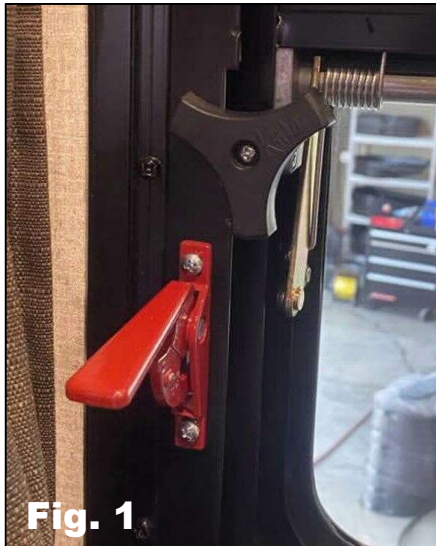
Locate the bedroom egress window. Figure 1

It has been decided that the vehicles in the recall population have an egress window installed in the bedroom and did not have the correct crank handle installed. If an emergency situation arises the emergency exit may be difficult to open as the current black round knob may impede the ability to open the window, which could result in an increased risk of personal injury.

The remedy is to replace the black round knob on the bedroom egress window with the narrow crank handle.
