Product Safety Recall

N212328760 Front Passenger Airbag Takata Inflator

– Priority Group 6

Revision: 04

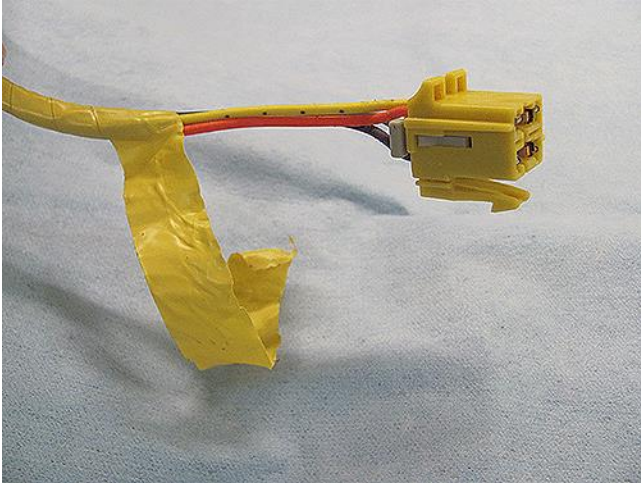
5680363

1. Peel the yellow tape off of the wire harness near the connector. **DO NOT** use a knife or sharp tool to remove the yellow tape.

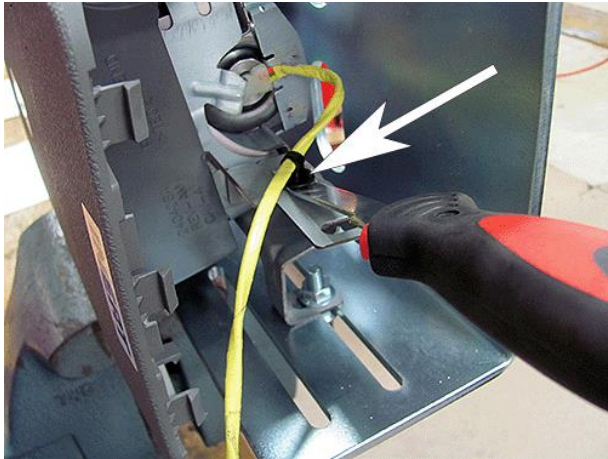
4664053

10. Disengage the wire harness locator from the housing.

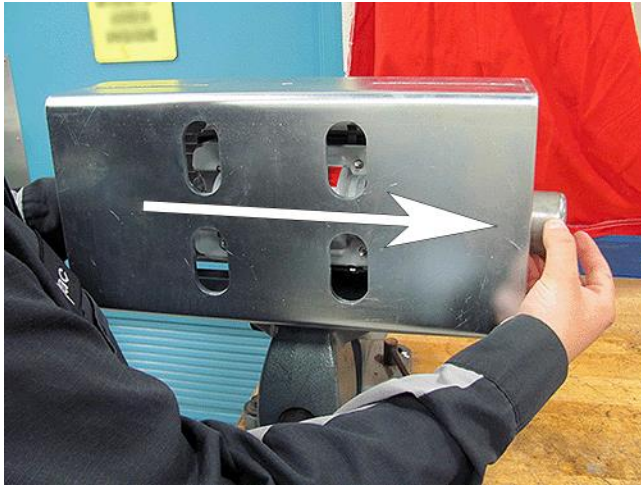
4664060

13. Remove the inflator from the housing, slide the inflator to the right.

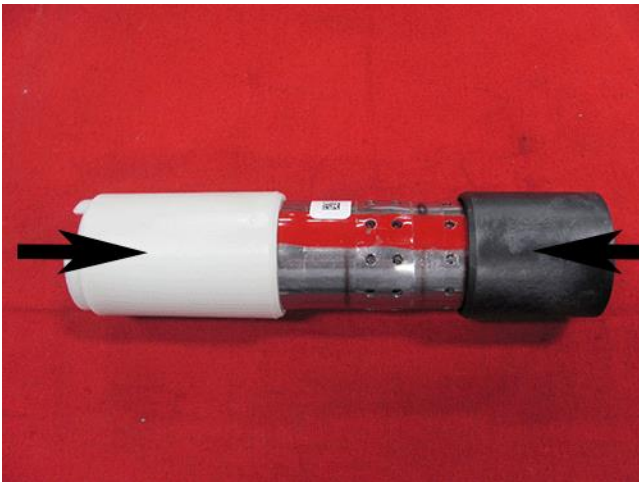
5680403

- Ensure both end caps are fully seated onto the inflator.

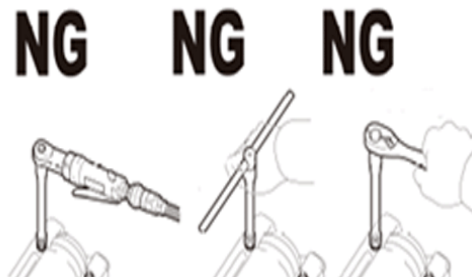
3610416

23. Tighten four (4) *NEW* plate nuts evenly in several increments in the order shown in the illustration using a 10-mm socket driver while pushing on the inflator against the alignment tab.

Note: The inflator should be netted out against the alignment tab prior to tightening the nuts. You will encounter some resistance during tightening because these nuts are self-locking nuts. **Torque Specification: 6.5 Nm 57 in-lb).**

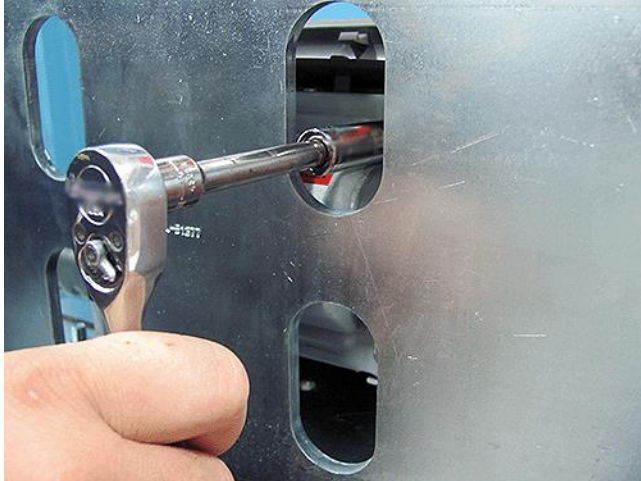
4664052

1. Use the access holes in the bracket to loosen and remove the four self-locking nuts, **do not use power tools to remove the nuts**. Discard the nuts, they will not be reused.

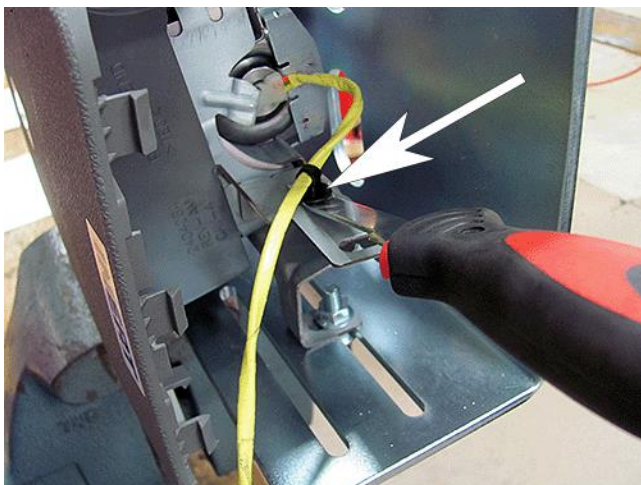
4664053

3. Disengage the wire harness locator from the housing.

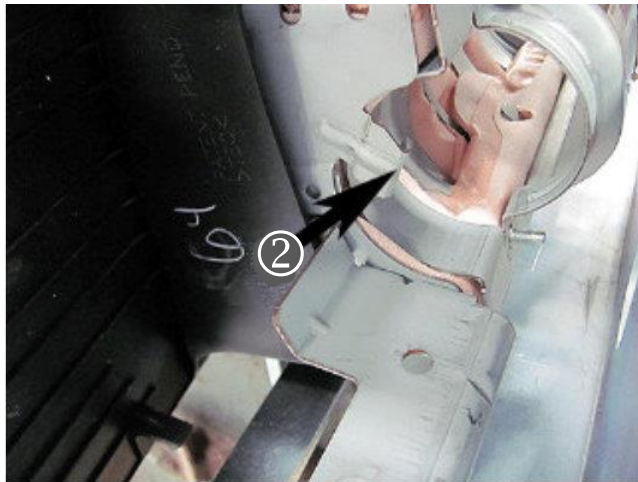
5845806

10. Using a small pair of slip joint pliers, bend the alignment tab on the airbag inward from a 90 Deg. angle (1) to a 45 Deg. angle (2).
