# Product Safety Recall

## N212328760 Front Passenger Airbag Takata Inflator

### – Priority Group 6

**Release Date:** February 2021

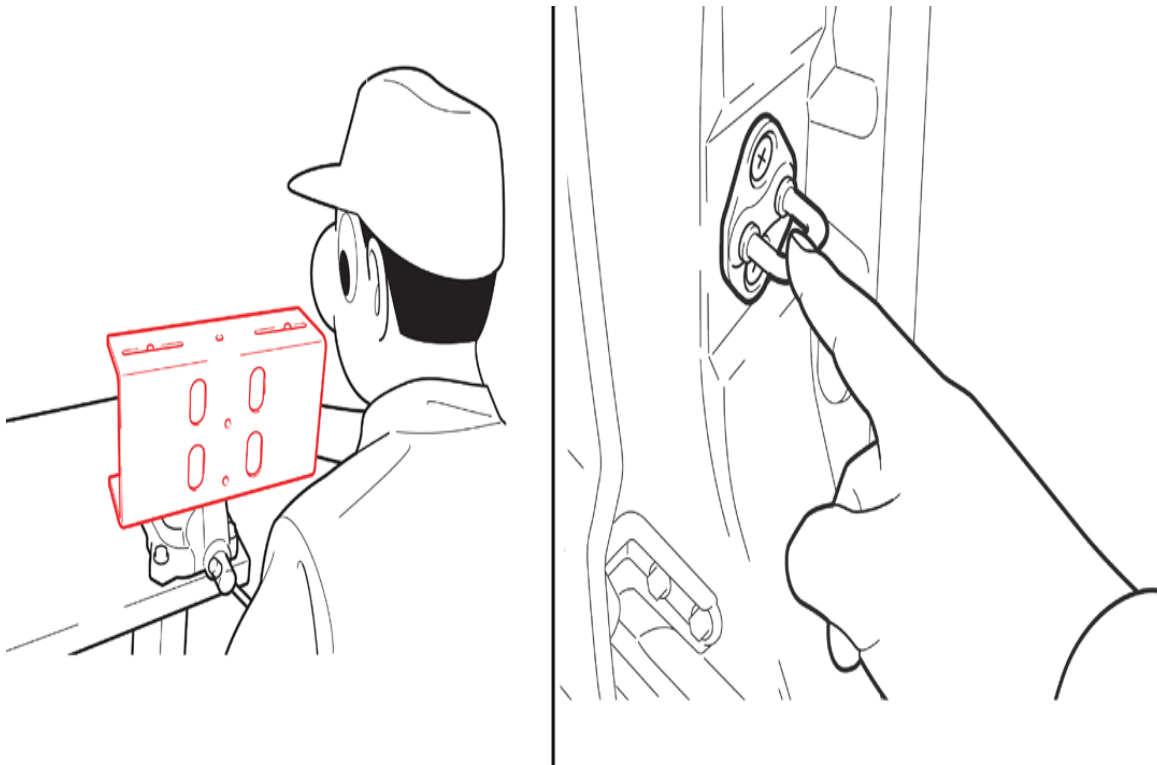
3607909

**Danger:** To avoid personal injury, *ALWAYS* keep as much of your body as possible in front of the bracket when working on the airbag assembly. Remember to periodically touch a metallic part of the vehicle or work bench to discharge static electricity in the body. **DO NOT** use power tools when performing the inflator removal/reinstallation steps.

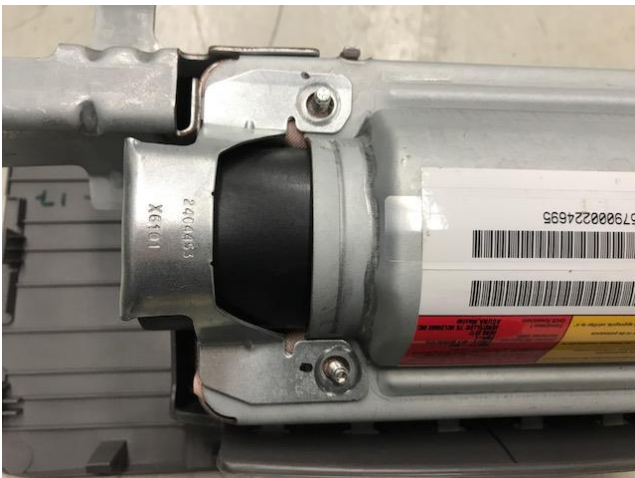
5680668

20. Place the stopper plate onto the studs as shown.

21. Place 4 new nuts on the studs.

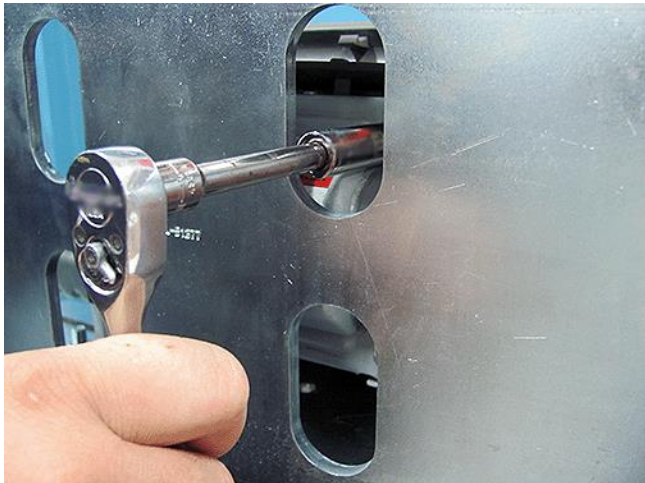
4664052

2. Use the access holes in the bracket to loosen and remove the four self-locking nuts, **do not use power tools to remove the nuts**. Discard the nuts, they will not be reused.
3. Remove the two stopper plates.
