Product Safety Recall

N212328770 Front Passenger Airbag Takata Inflator

- Priority Group 7

Release Date: February 2021

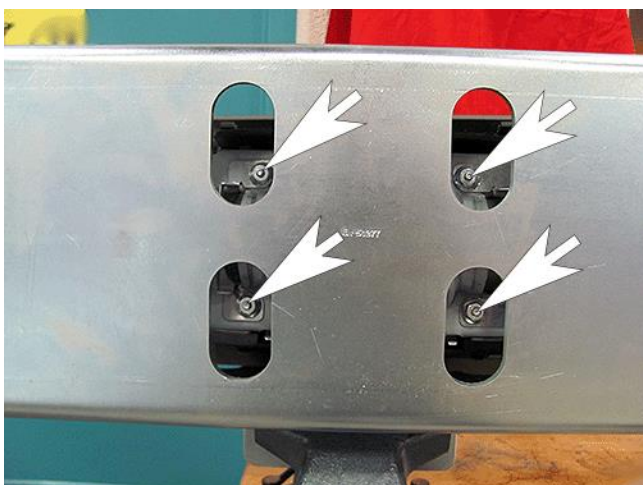
4664049

3. Position the airbag assembly so that all four stopper plate nuts can be removed through the access holes.
