Product Safety Recall

N212328770 Front Passenger Airbag Takata Inflator

- Priority Group 7

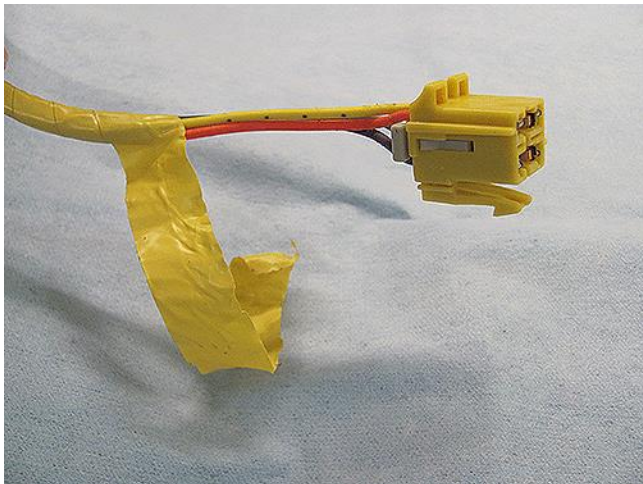
5680363

1. Peel the yellow tape off of the wire harness near the connector. **DO NOT** use a knife or sharp tool to remove the yellow tape.

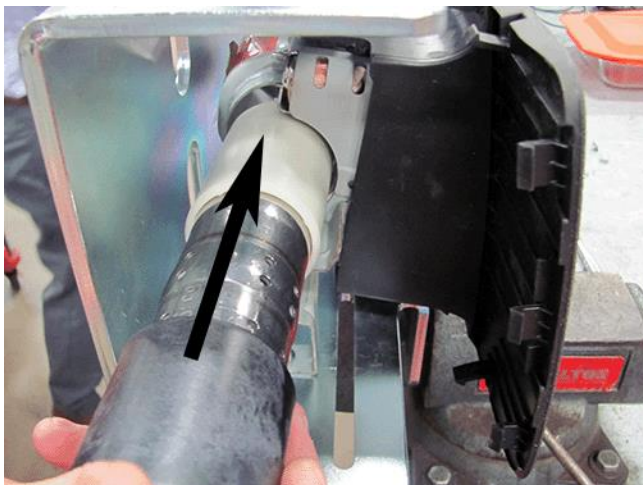
5680409

19. Slide the new inflator into the housing with the white end cap first.

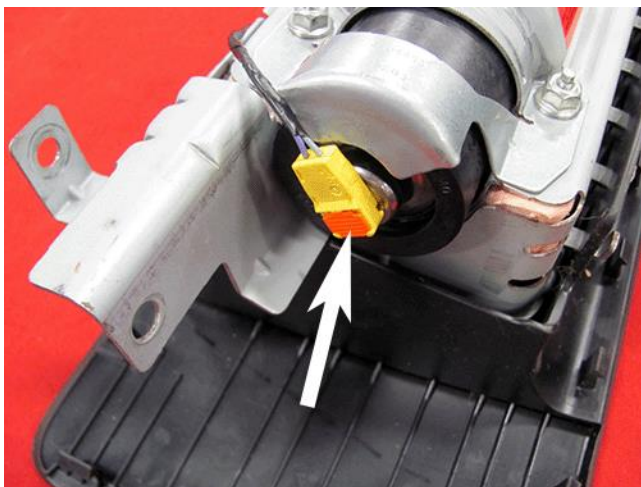
5680522

27. Install the black taped wire into the inflator (black cap end). Ensure the CPA is engaged.
