Product Safety Recall

N212328790 Front Passenger Airbag Takata Inflator

– Priority Group 9

Revision: 02

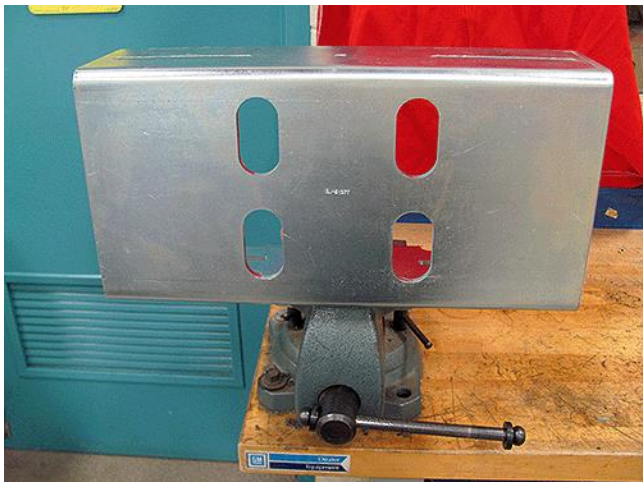
4664047

1. Mount the airbag module bracket securely in a vise.

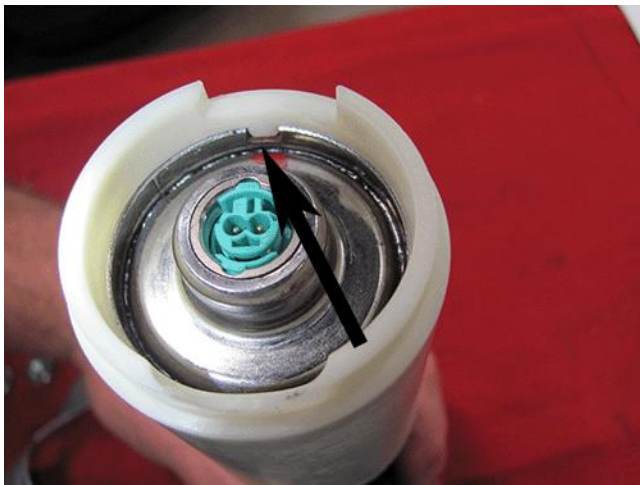
5680402

- Ensure the tab on the white end cap is aligned with the notch in the inflator.

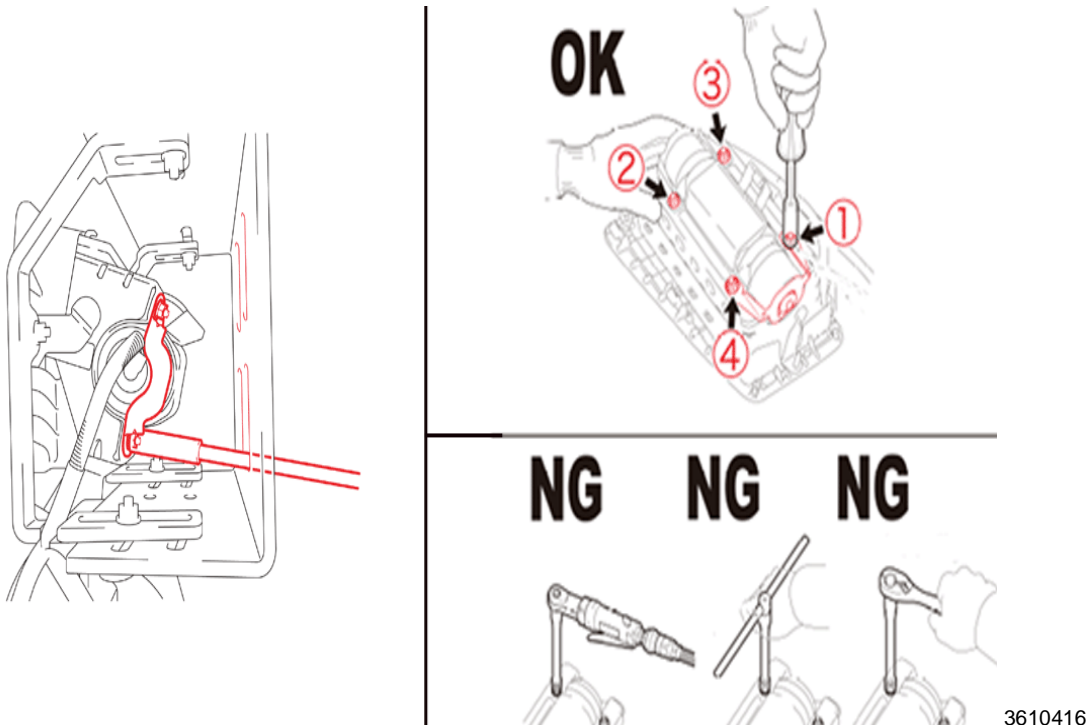
23. Tighten four (4) *NEW* plate nuts evenly in several increments in the order shown in the illustration using a 10-mm socket driver while pushing on the inflator against the alignment tab.

Note: The inflator should be netted out against the alignment tab prior to tightening the nuts. You will encounter some resistance during tightening because these nuts are self-locking nuts. **Torque Specification: 6.5 Nm (57 in-lb).**
