# Product Safety Recall

## N212328800 Front Passenger Airbag Takata Inflator

### - Priority Group 10

Release Date: February 2021

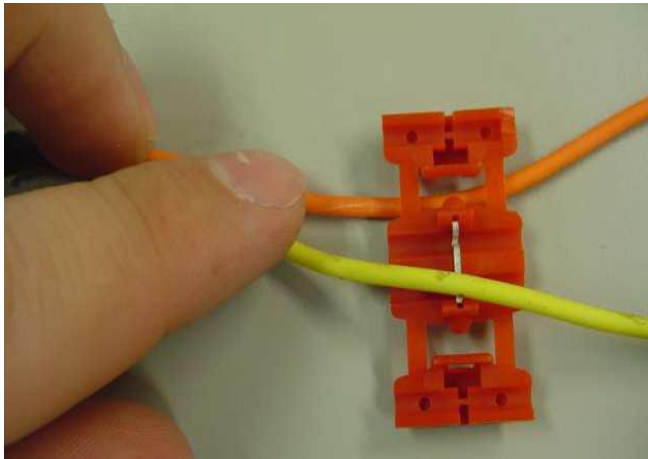
5680660

3. Locate the yellow wire and place it in the electro tap.

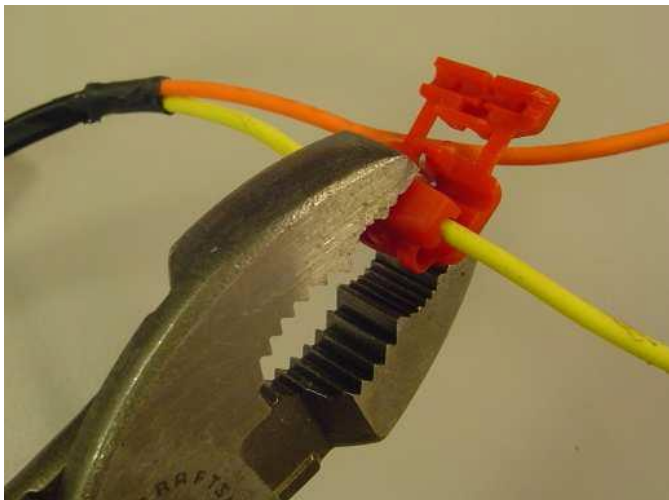
5680663

4. Use pliers to firmly close the electro-tap on the **yellow wire** until an audible “click” is heard confirming the installation.

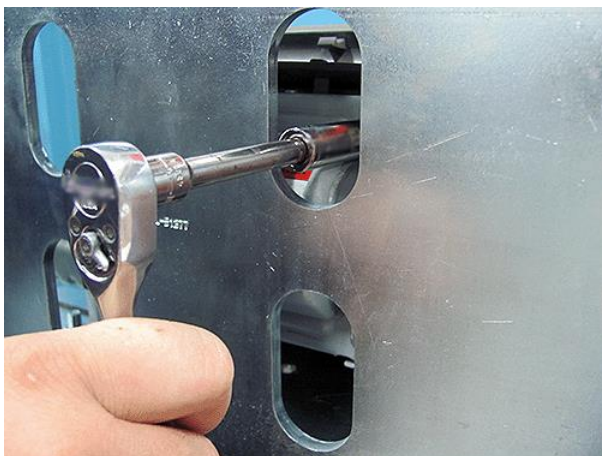
4664052

8. Use the access holes in the bracket to loosen and remove the four self-locking nuts, **do not use power tools to remove the nuts**. Discard the nuts, they will not be reused.

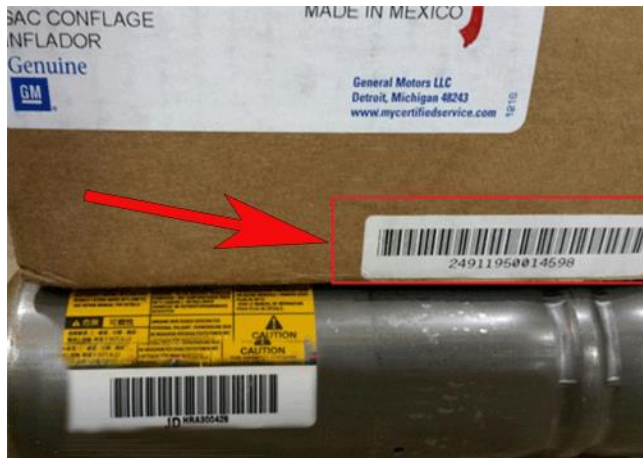
4664074

15. Record the serial number of the new inflator from the service kit on the job card. Also record the serial number of the used inflator that is being returned on the job card.
16. Inspect the new inflator for the following two conditions:

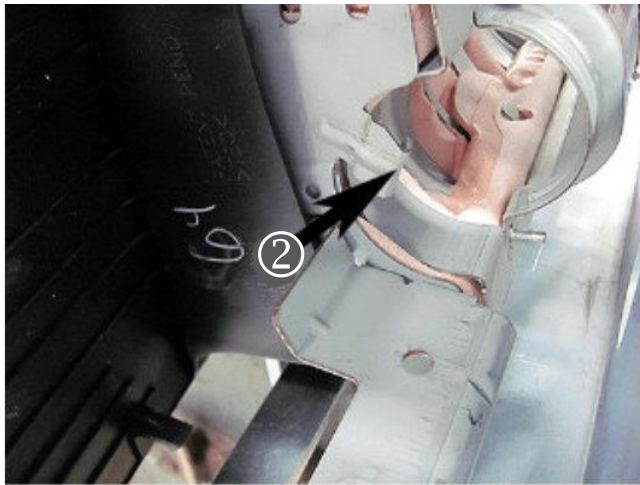
5735686

17. Using a small pair of slip joint pliers, bend the alignment tab on the airbag from a 90 Deg. angle (1) to a 45 Deg. angle (2).

**Note:** Only the small return tab should be bent. Take care to not bend any other portion of the orientation tab.

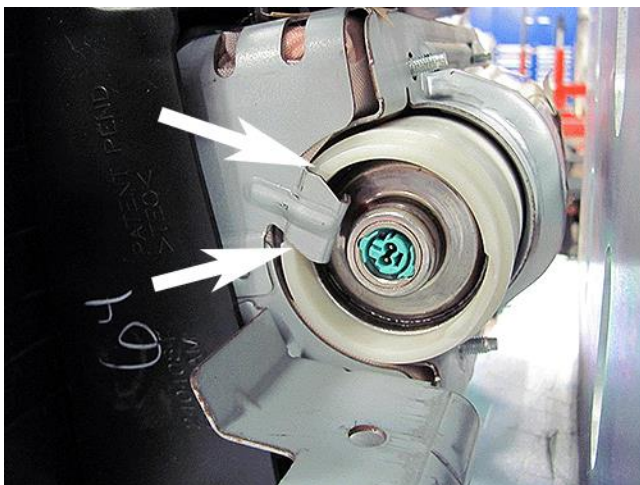
5680411

19. Rotate the inflator until the notch in the white end cap aligns with the alignment tab.

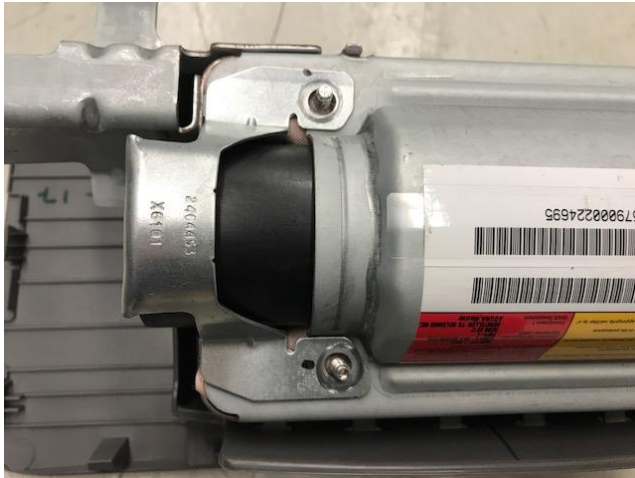
5680668

20. Place the stopper plate onto the studs as shown.

21. Place 4 new nuts on the studs.

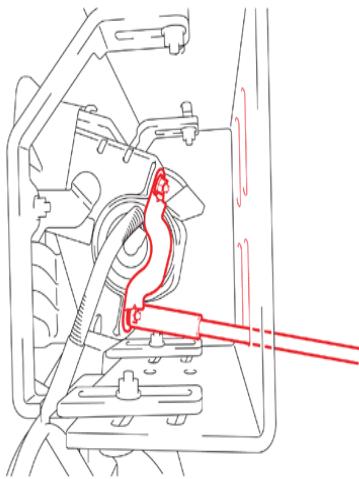
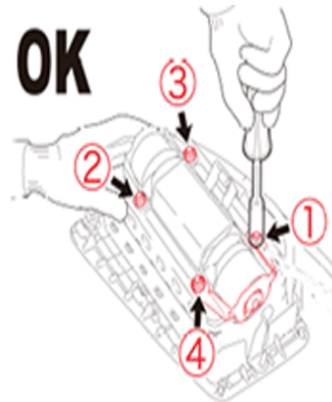
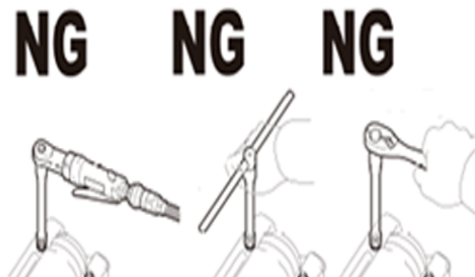
3610416

22. Tighten four (4) **NEW** plate nuts evenly in several increments in the order shown in the illustration using a 10-mm socket driver while pushing on the inflator against the alignment tab.

**Note:** The inflator should be netted out against the alignment tab prior to tightening the nuts. You will encounter some resistance during tightening because these nuts are self-locking nuts. **Torque Specification: 6.5 Nm (56 in-lb).**

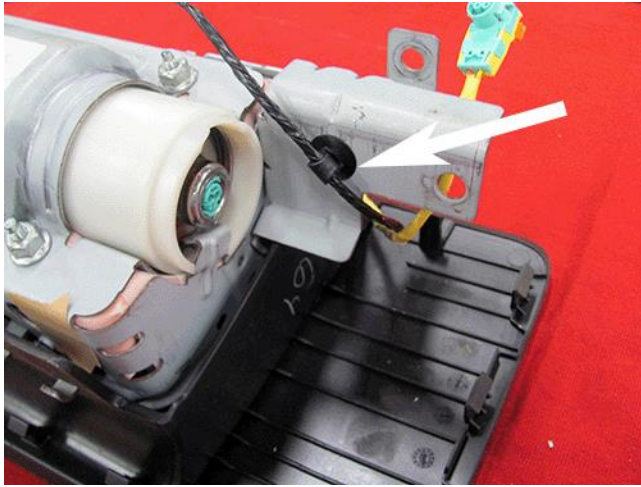
5680514

23. Install the wire harness locator to the housing.

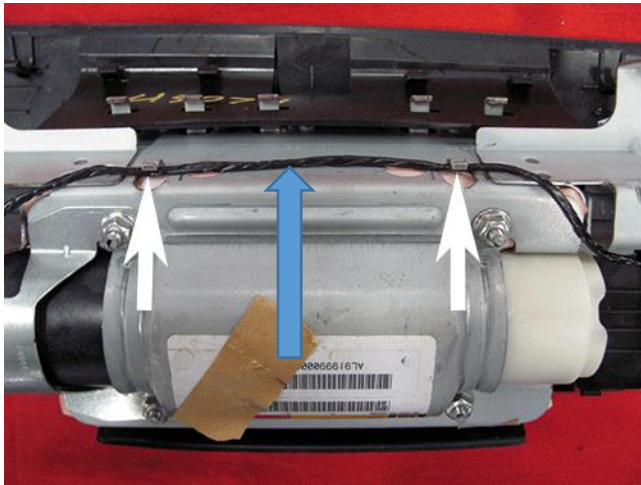
5680516

24. Press the black taped wire into the housing tabs as shown. Tape the wire harness to the metal housing in between the tabs (in the area of the blue arrow).

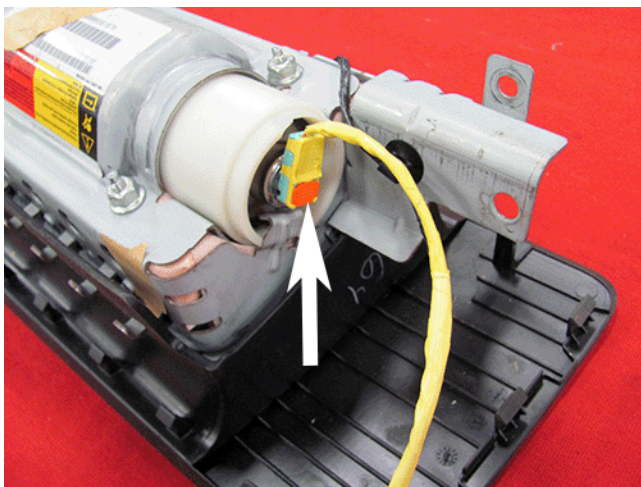
5680520

25. Install the yellow taped wire into the inflator (white cap end). Ensure the CPA is engaged.

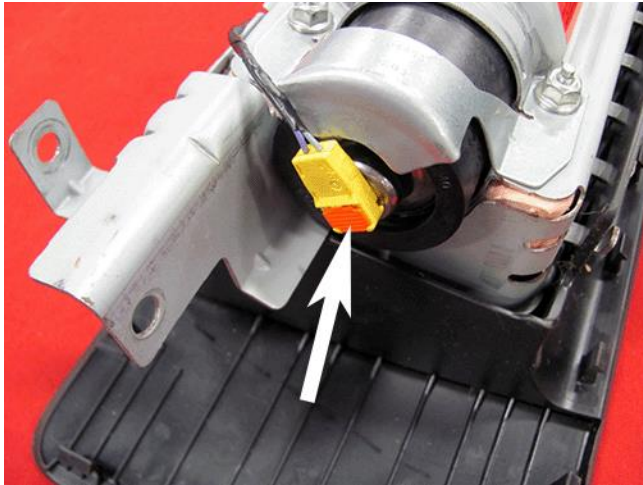
5680522

26. Install the black taped wire into the inflator (black cap end). Ensure the CPA is engaged.

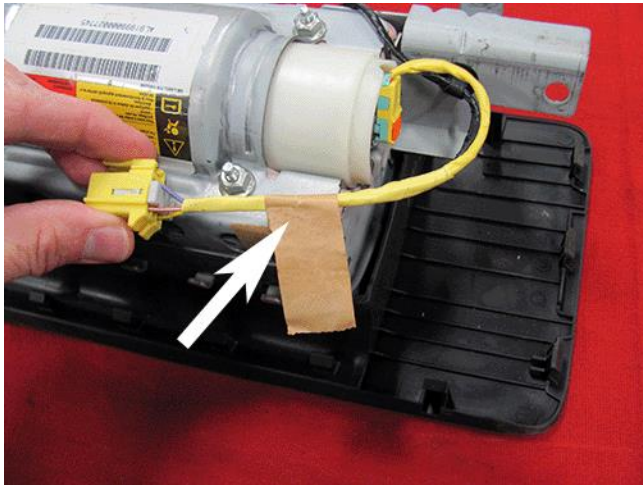
5680523

27. Apply a masking tape strip to the wire harness in the location shown below.

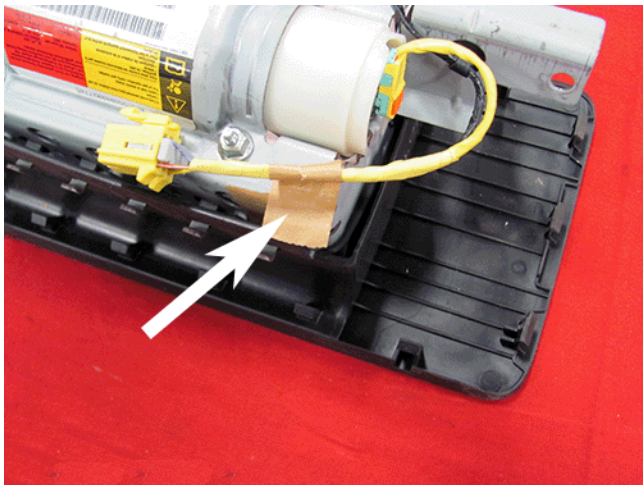
5680525

28. Adhere the tape strip and wire harness to the metal housing as shown.

29. Confirm the wire harness is in the correct orientation after taping.

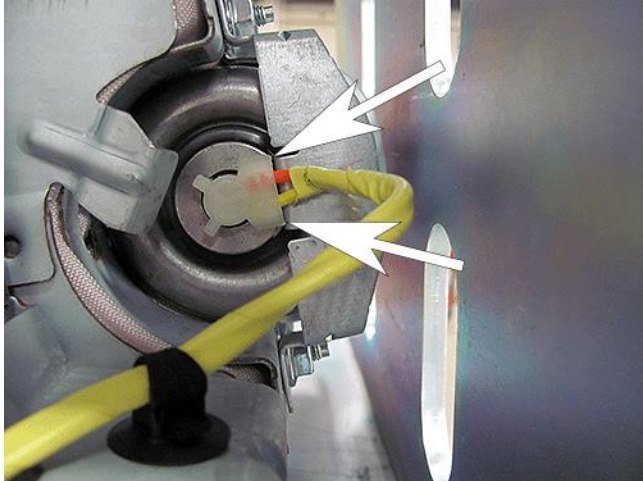
4664051

1. Note the orientation between the inflator and the stopper plate.

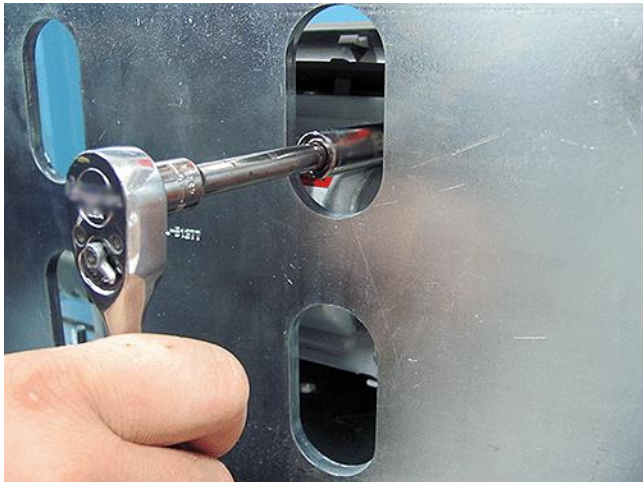
4664052

2. Use the access holes in the bracket to loosen and remove the four self-locking nuts. **Do not use power tools to remove the nuts.** Discard the nuts, they will not be reused.

3. Remove the two stopper plates.

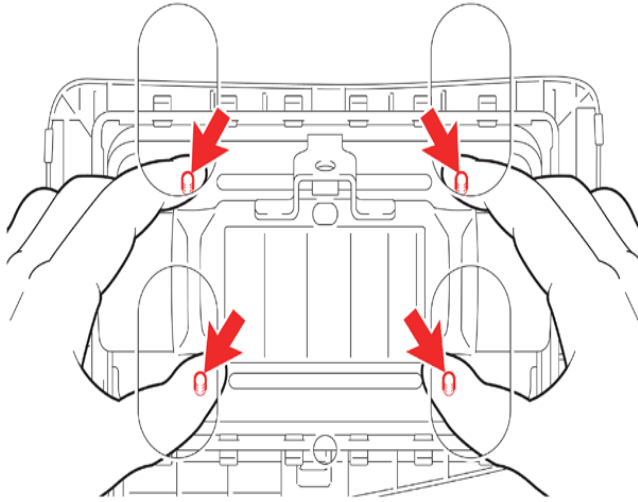
3607857

5. Gently push in the 4 studs to loosen the inflator for removal.

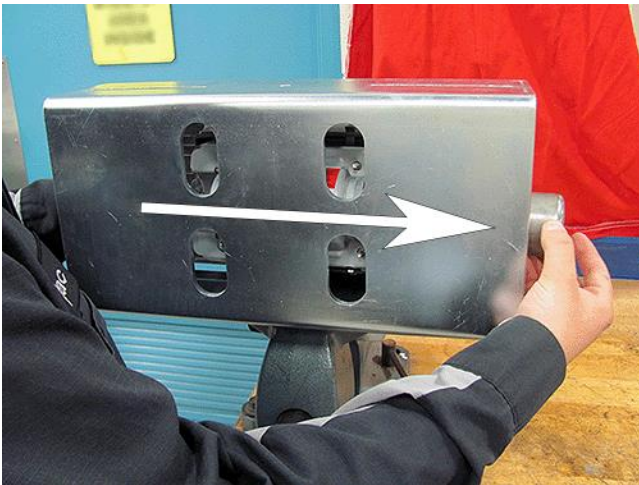
4664060

6. Remove the inflator from the housing, slide the inflator away from the harness side.

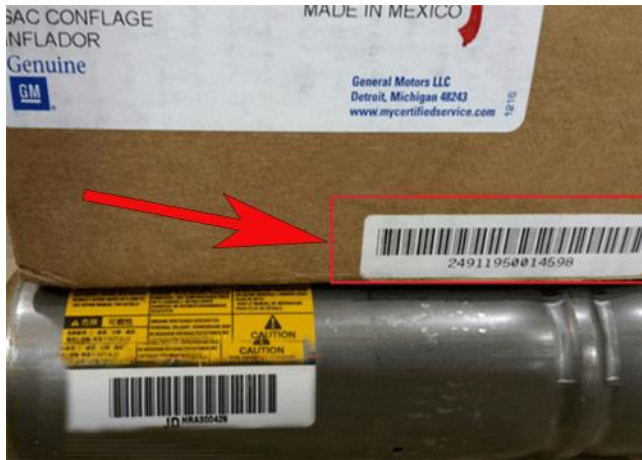
4664074

- 8. Record the serial number of the new inflator from the service kit on the job card. Also record the serial number of the used inflator that is being returned on the job card.

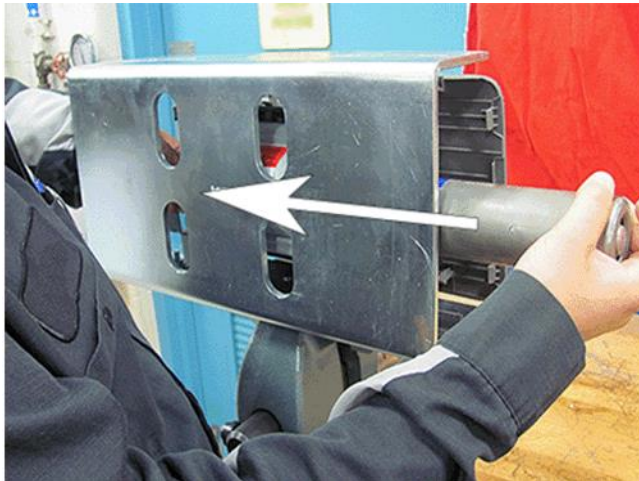
4664064

- 9. Carefully slide the new inflator into the airbag assembly. Ensure the inflator is installed with the harness end first.

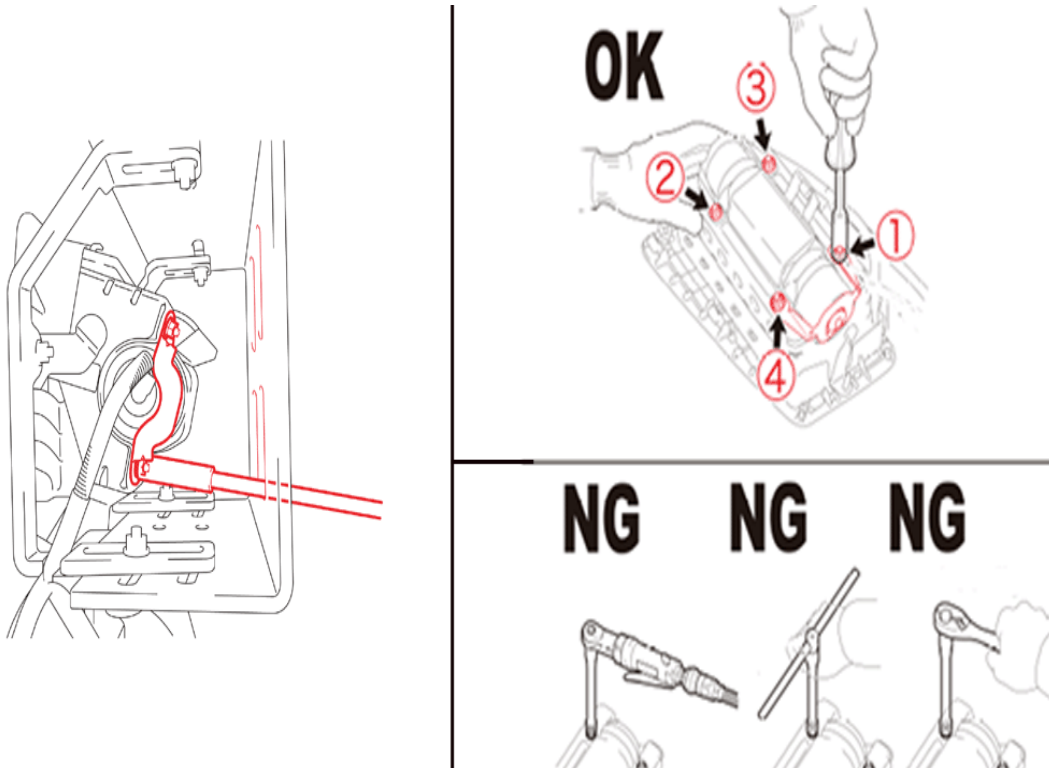
3610416

14. Tighten four (4) **NEW** plate nuts evenly in several increments in the order shown in the illustration using a 10-mm socket driver while pushing the inflator. You will encounter some resistance during tightening because these nuts are self-locking nuts. **Torque Specification: 6.5 Nm (57.53 in-lb).**

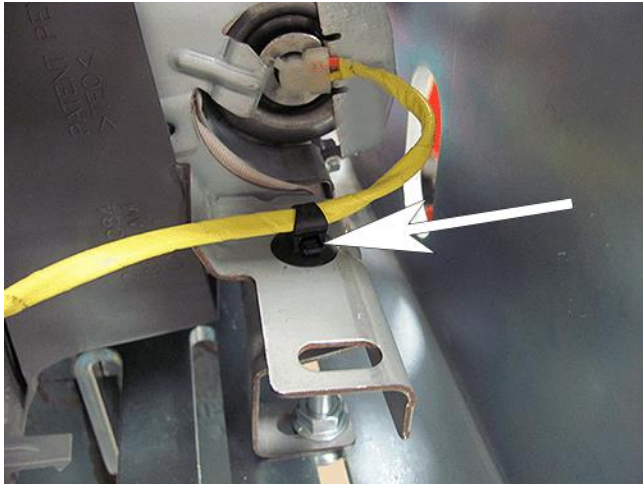
4664069

15. Install the wire harness locator to the housing.
16. Remove the airbag assembly from the bracket by removing the two bolts and the airbag assembly.
17. Reinstall the instrument panel passenger airbag assembly. Refer to *Airbag Instrument Panel Module Replacement* in SI.
