Product Safety Recall

N212328800 Front Passenger Airbag Takata Inflator

- Priority Group 10

Revision: 01

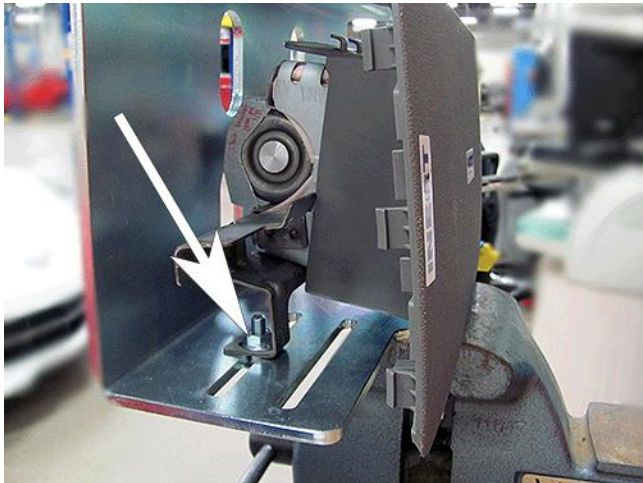
4664048

2. Using the hardware kit supplied with the module bracket, loosely mount the airbag assembly to the bracket using two nuts and bolts.

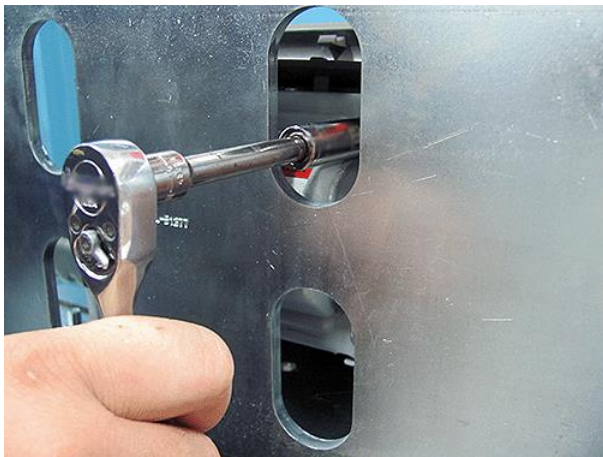
4664052

8. Use the access holes in the bracket to loosen and remove the four self-locking nuts, **do not use power tools to remove the nuts**. Discard the nuts, they will not be reused.

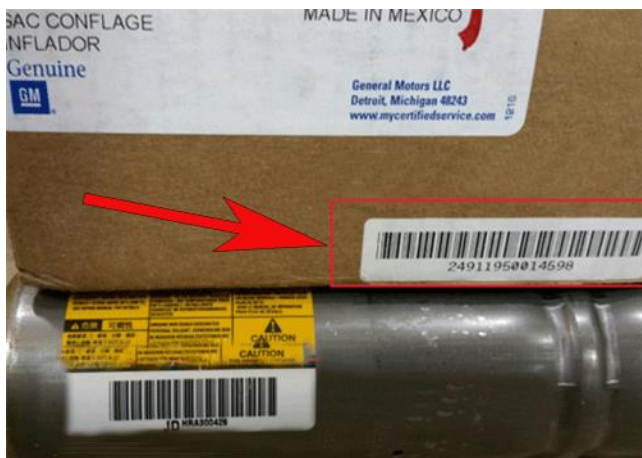
4664074

15. Record the serial number of the new inflator from the service kit on the job card. Also record the serial number of the used inflator that is being returned on the job card.
16. Inspect the new inflator for the following two conditions:

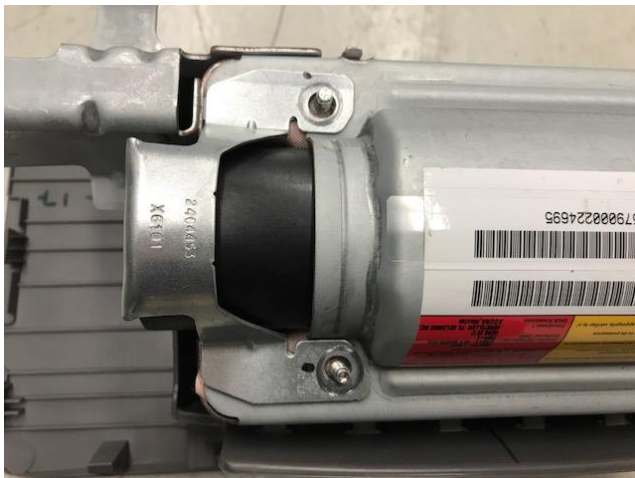
5680668

20. Place the stopper plate onto the studs as shown.
21. Place 4 new nuts on the studs.

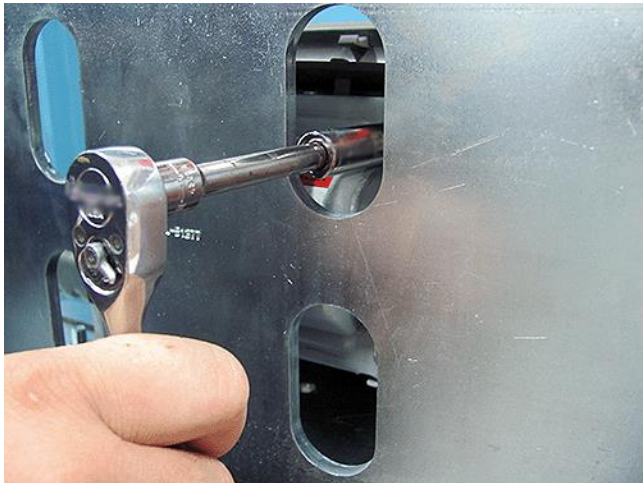
4664052

2. Use the access holes in the bracket to loosen and remove the four self-locking nuts, **do not use power tools to remove the nuts**. Discard the nuts, they will not be reused.
3. Remove the two stopper plates.

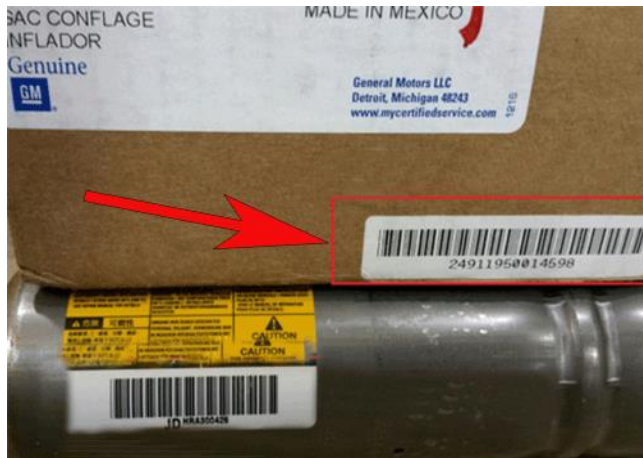
4664074

- Record the serial number of the new inflator from the service kit on the job card. Also record the serial number of the used inflator that is being returned on the job card.

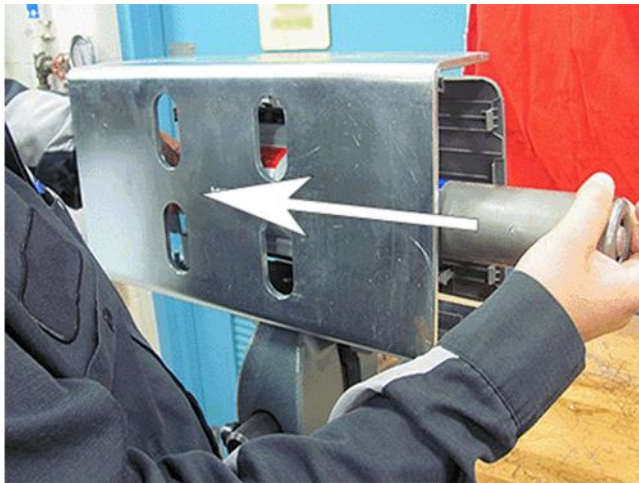
4664064

- Carefully slide the new inflator into the airbag assembly. Ensure the inflator is installed with the harness end first.
