Product Safety Recall

N212328800 Front Passenger Airbag Takata Inflator

- Priority Group 10

Revision: 02

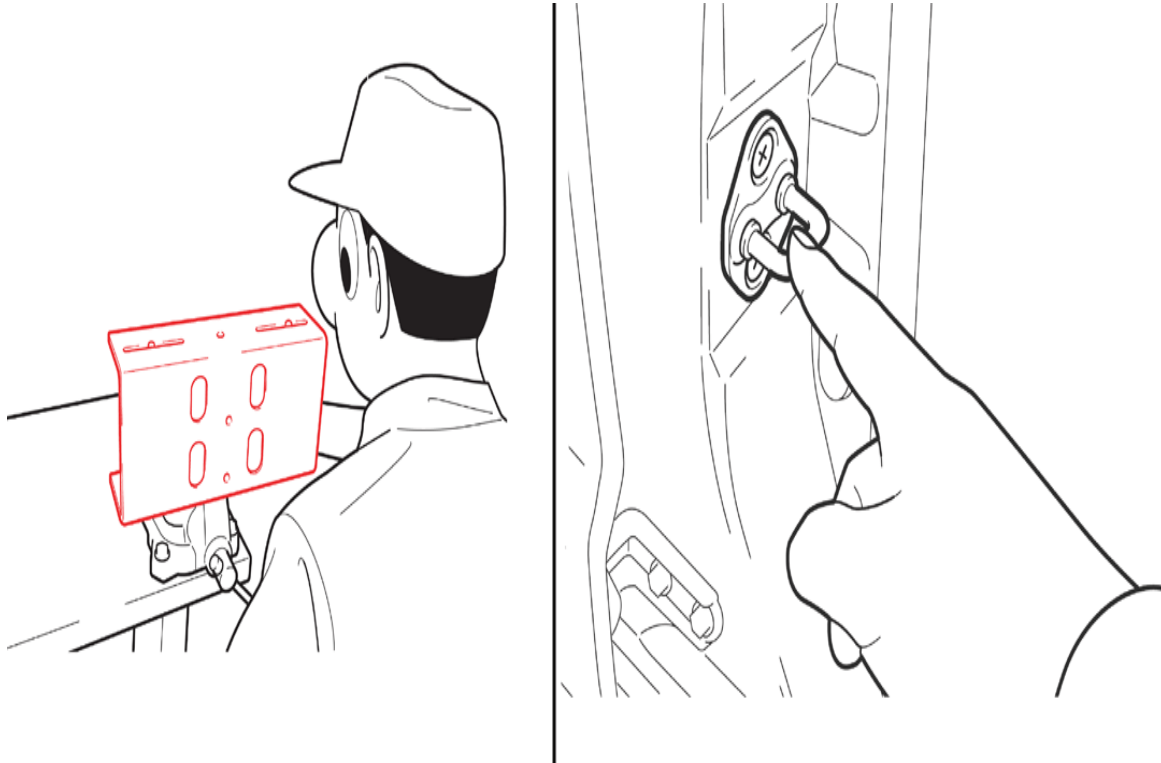
3607909

Danger: To avoid personal injury, *ALWAYS* keep as much of your body as possible in front of the bracket when working on the airbag assembly. Remember to periodically touch a metallic part of the vehicle or work bench to discharge static electricity in the body. **DO NOT** use power tools when performing the inflator removal/reinstallation steps.

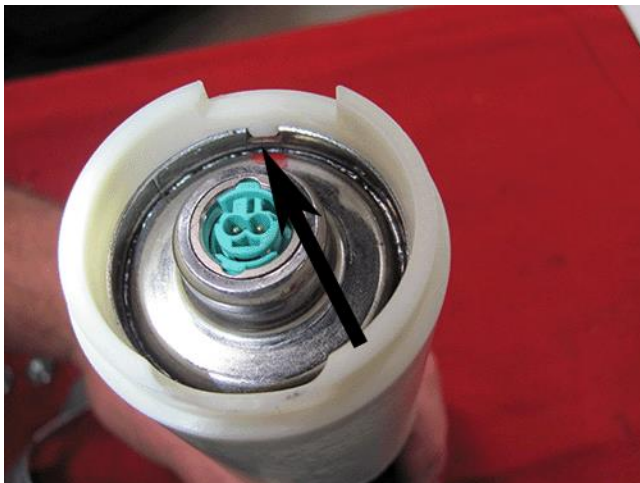
5680402

- Ensure the tab on the white end cap is aligned with the notch in the inflator.

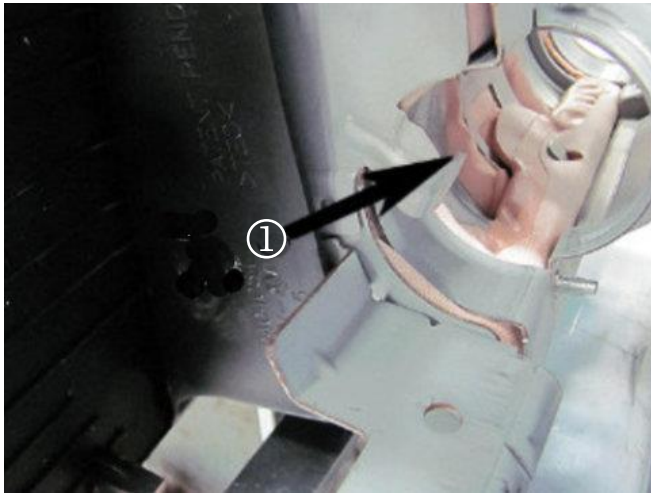
18. Using a small pair of slip joint pliers, bend the alignment tab on the airbag inward from a 90 Deg. angle (1) to a 45 Deg. angle (2).

Note: Only the small return tab should be bent. Take care to not bend any other portion of the orientation tab.

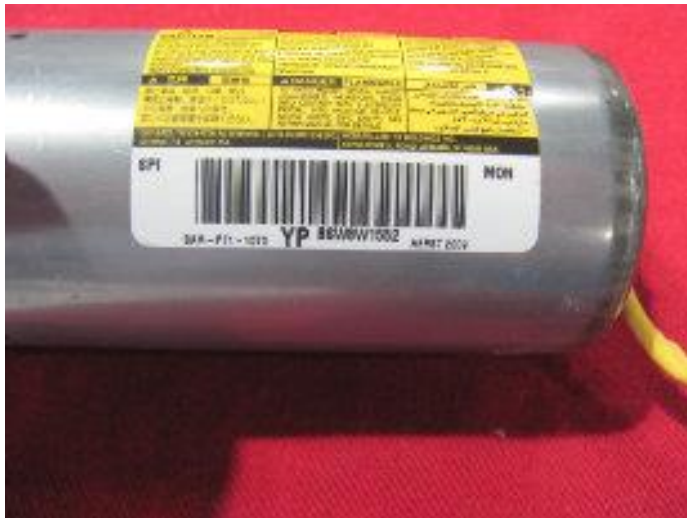
5844318

8. Record the serial number of the used inflator that is being returned on the job card.
9. Inspect the new inflator for the following two conditions:
