F/CMVSS Noncompliance Recall

N212329320 Second Row Center Seat Belt Latch Inaccessible

Release Date: March 2021

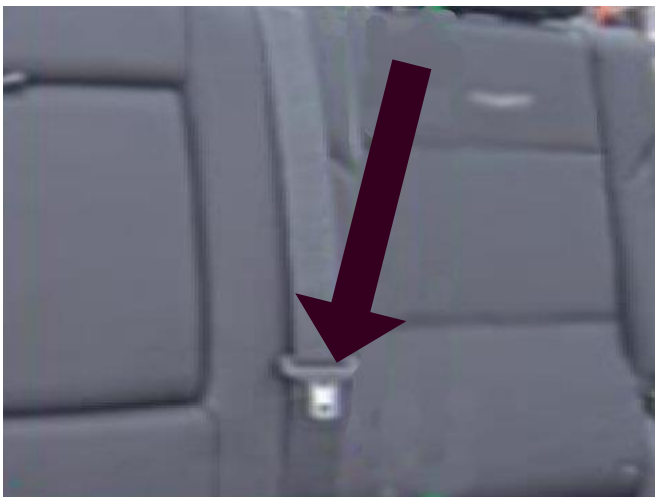
5782984

1. Locate the second-row center seatbelt.

- Verify the seatbelt latch assembly is showing and moves freely up and down the belt webbing. If the latch assembly is correctly installed and functioning properly, no further action is required.
- If the latch is not showing, it may be trapped under the seat belt retractor bezel. Proceed to step #2.

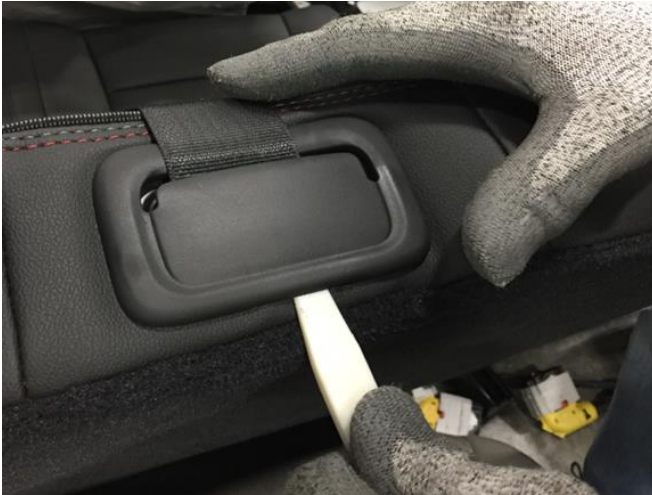
5782985

2. Using a plastic trim tool, release the center seatbelt retractor bezel. Use care to not damage the seat or bezel.

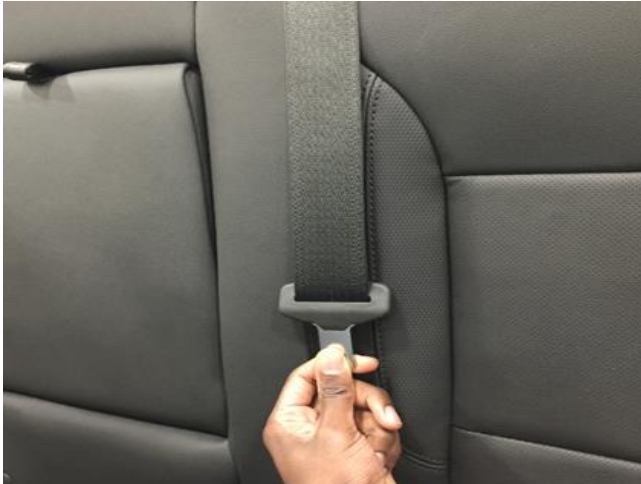
5782993

4. Pull the latch out of the seatbelt retractor area of the seat and slide it down the belt webbing.

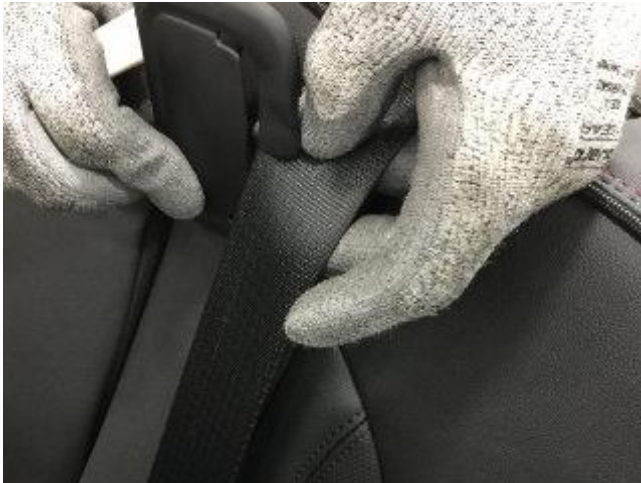
5782995

5. Using the slit opening in the seat belt retractor bezel, reinstall the bezel onto the belt. Use care to orient the bezel in the correct direction to prevent the belt from twisting.

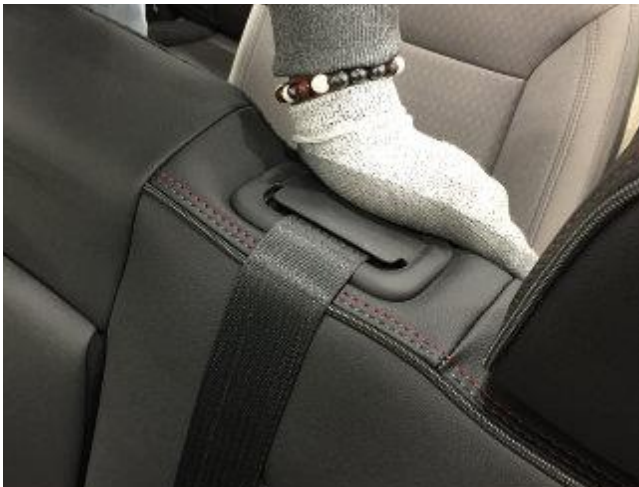
5782999

7. Using the palm of your hand, firmly press down on the bezel to engage the mounting tabs.
