F/CMVSS Noncompliance Recall

N212329320 Second Row Center Seat Belt Latch Inaccessible

Release Date: April 2021

Condition	General Motors has decided that certain 2021 model year Chevrolet Tahoe and Cadillac Escalade vehicles fail to conform, in part, to S7.1.1 of Federal Motor Vehicle Safety Standard (FMVSS) No. 208, "Occupant Crash Protection." The second-row center seat belt latch may be trapped beneath the trim bezel and therefore not accessible by the occupant for use. An occupant who rides unbelted in the second-row center seating position has an increased risk of injury in a crash.
Correction	Dealers will remove the trim bezel for the second-row center seat belt and correctly position the seat belt latch plate before reinstalling the trim bezel.

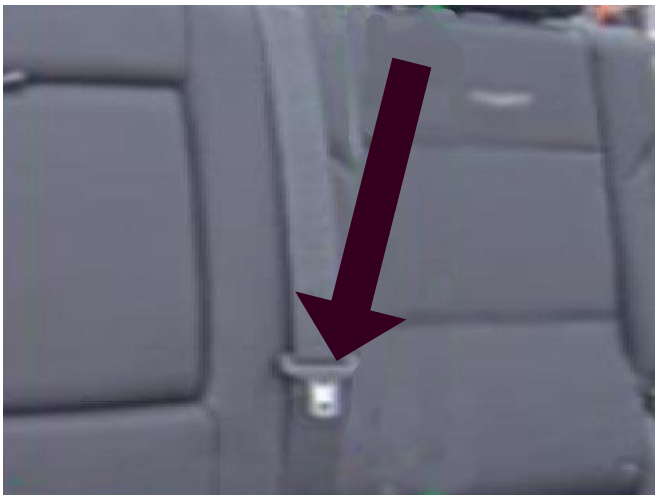
5782984

1. Locate the second-row center seatbelt.

- Verify the seatbelt latch assembly is showing and moves freely up and down the belt webbing. If the latch assembly is correctly installed and functioning properly, no further action is required.
- If the latch is not showing, it may be trapped under the seat belt retractor bezel. Proceed to step #2.

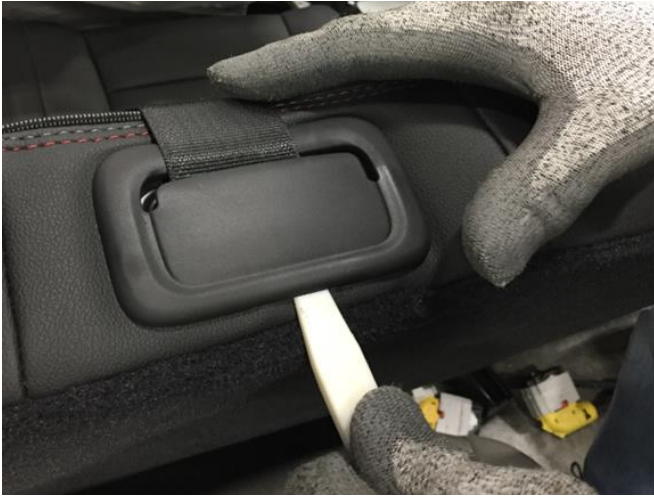
5782985

2. Using a plastic trim tool, release the center seatbelt retractor bezel. Use care to not damage the seat or bezel.

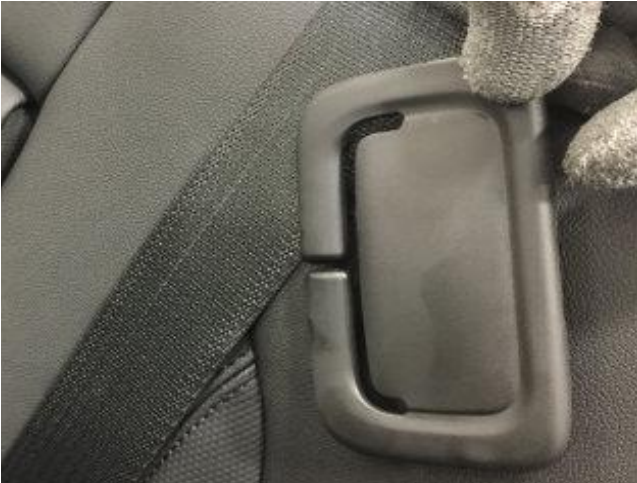
5782988

3. Using the slit opening in the seat belt retractor bezel, remove the bezel from the belt.

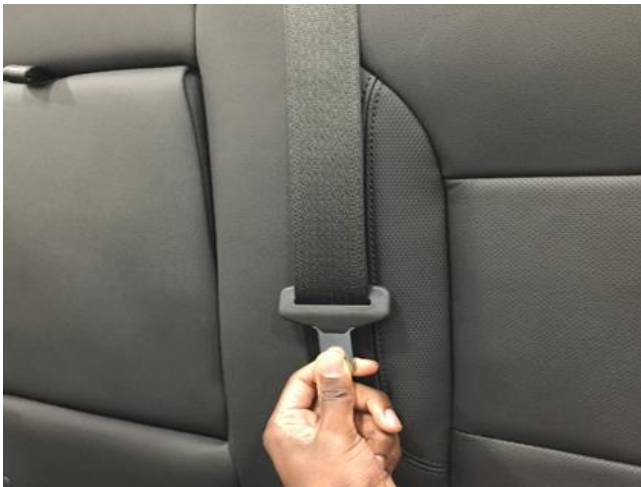
5782993

4. Pull the latch out of the seatbelt retractor area of the seat and slide it down the belt webbing.

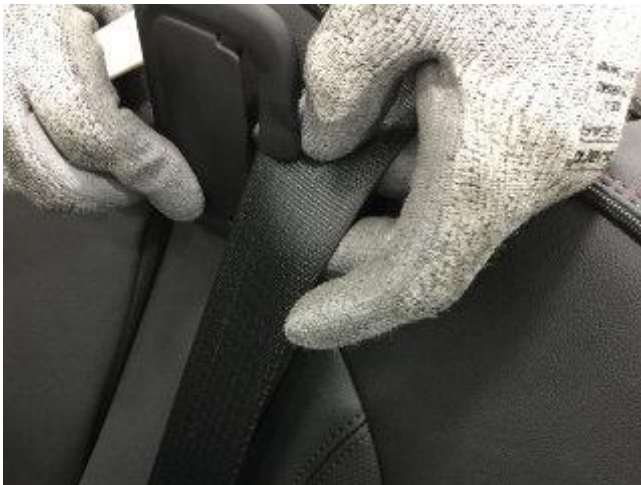
5782995

5. Using the slit opening in the seat belt retractor bezel, reinstall the bezel onto the belt. Use care to orient the bezel in the correct direction to prevent the belt from twisting.

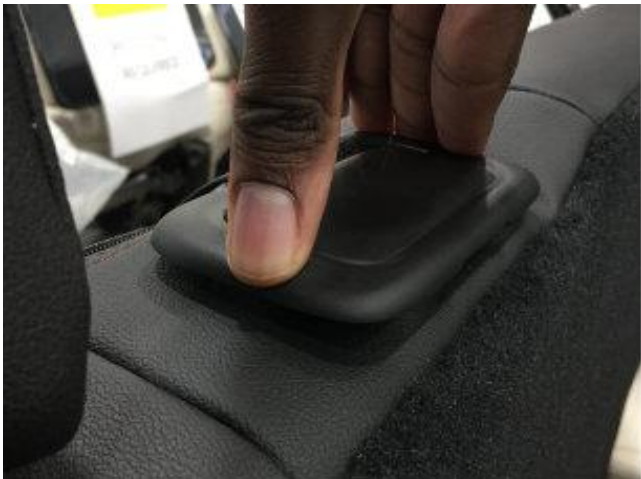
5782996

6. Carefully align the mounting tabs on the bezel with bezel opening on the seat.

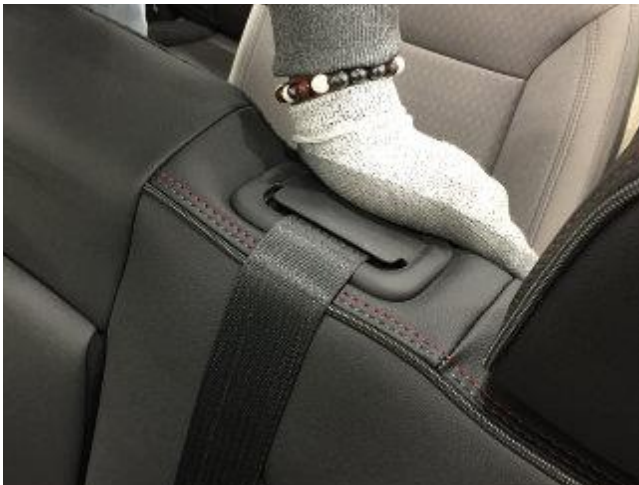
5782999

7. Using the palm of your hand, firmly press down on the bezel to engage the mounting tabs.

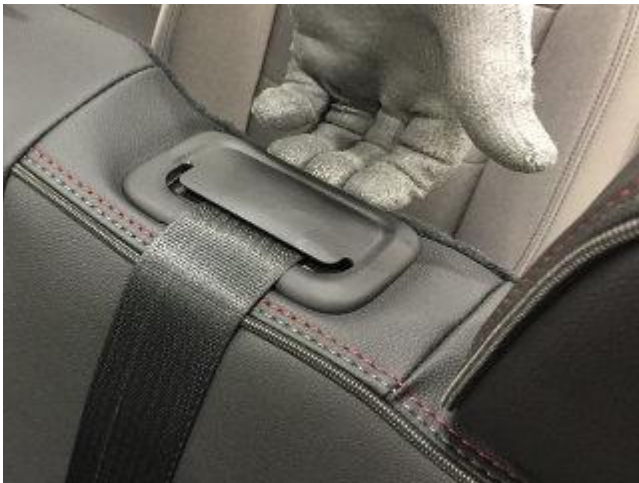
5783008

8. Pull up on the bezel to ensure it is fully engaged. Visually inspect the bezel for proper installation.
9. Latch the belt and verify the function of the belt and retractor.
