# Product Safety Recall

## N212329780 Mismatched Spare Tire – US Only

**Release Date:** October 2021

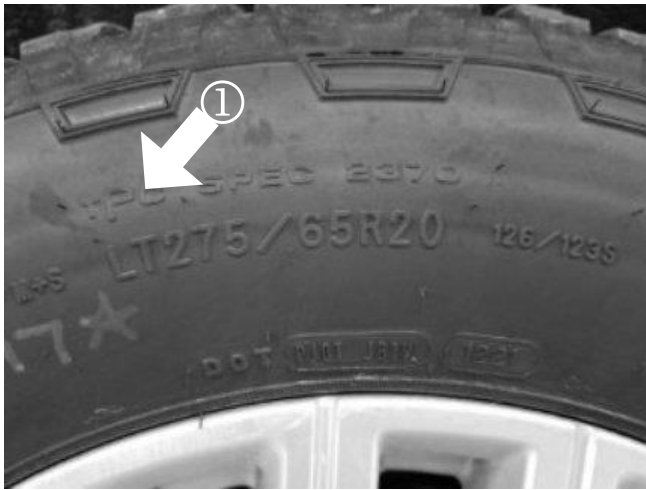
5908479

**TPC Location (1)**

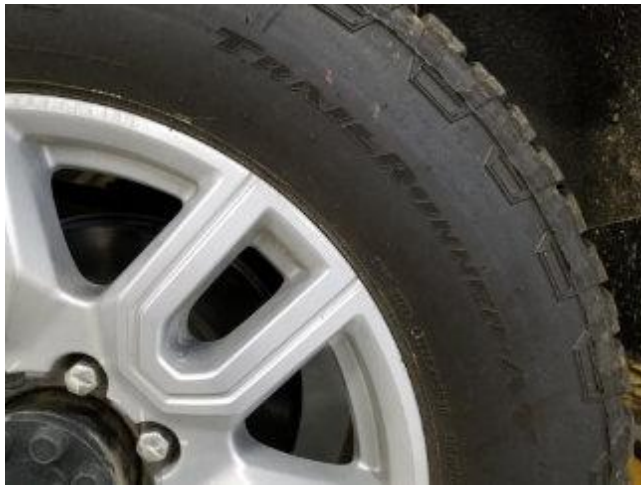
5908474

**20" Goodyear Wrangler Trailrunner LT275/65R20 Sidewall Information**

1. Is the vehicle equipped with OEM 20" or 18" accessory road tire? See the photograph images and table information above to identify these tires by locating and inspecting the TPC number on the sidewalls of the tires. TPC numbers are 2370 for the OEM 20" accessory road tires and 2373 for the OEM 18" accessory road tires.
2. If yes, replace the existing 17" spare tire and wheel assembly that is in the spare tire and wheel carrier under the truck with a new 18" spare tire and wheel assembly.
3. Place the original 17" spare tire and wheel assembly that the vehicle was built with in the cargo bed of the truck and restrain it with two straps. The customer needs to re-install this original 17" spare tire and wheel assembly in the vehicle the spare tire and wheel carrier under the truck whenever they transition back to the OEM 17" production road tires.

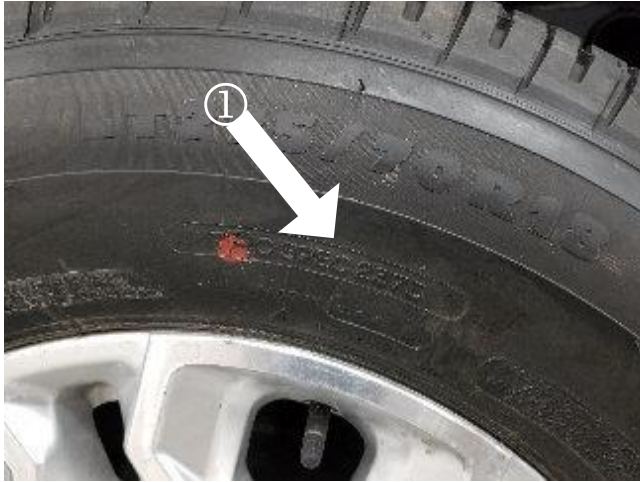
5908483

**TPC Location (1)**

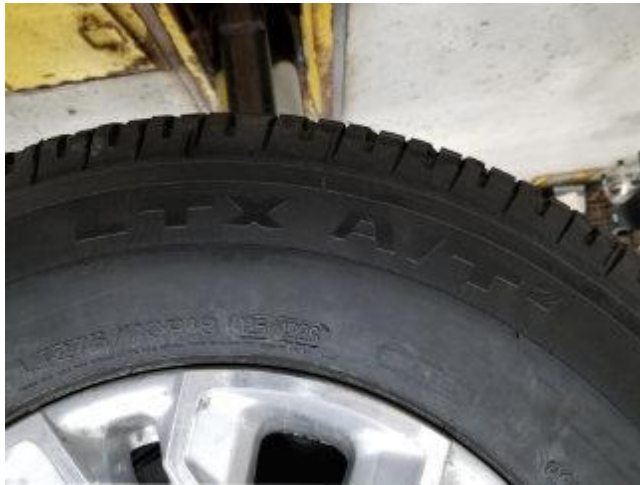
5908484

**18" Michelin LTX A/T2 LT275/70R18 Sidewall Information**

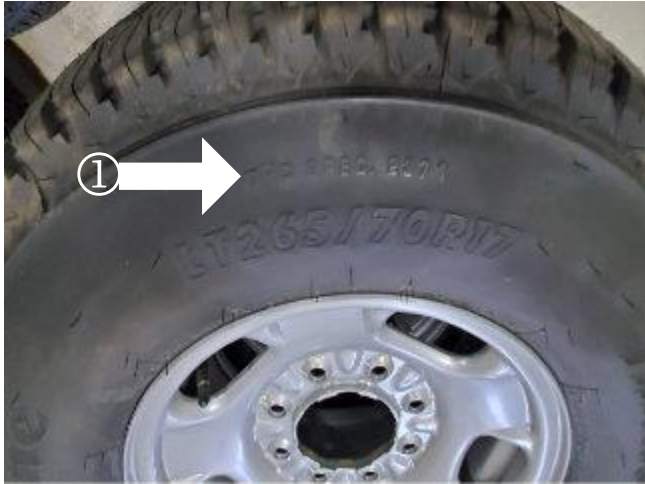
5908690

**TPC Location (1)**

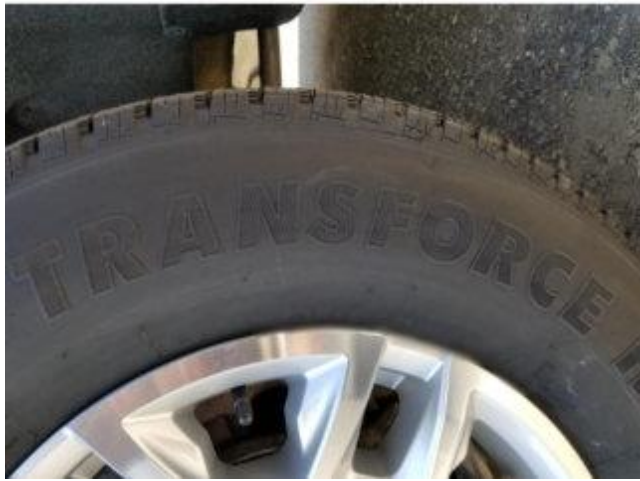
5908671

**17" Firestone Transforce HT LT265/70R17 Sidewall Information**

1. Is the vehicle equipped with OEM 17" production road tires? See the photograph images and table information above to identify these tires by locating and inspecting the TPC number on the sidewalls of the tires. TPC numbers are either 2029 MS or 2371 for the OEM 17" production road tires.

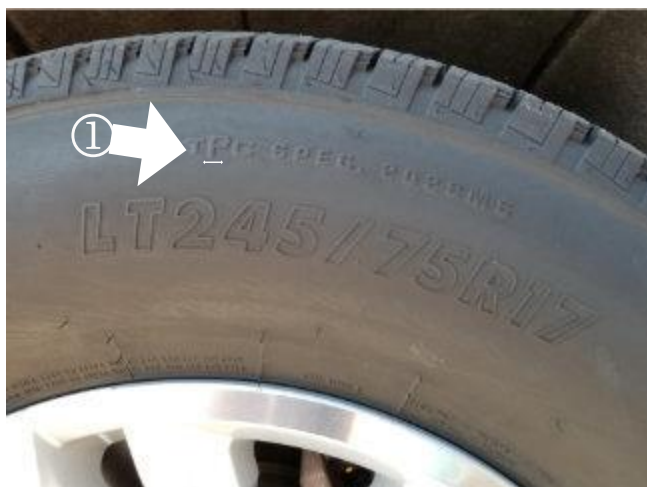
5908688

TPC Location (1)

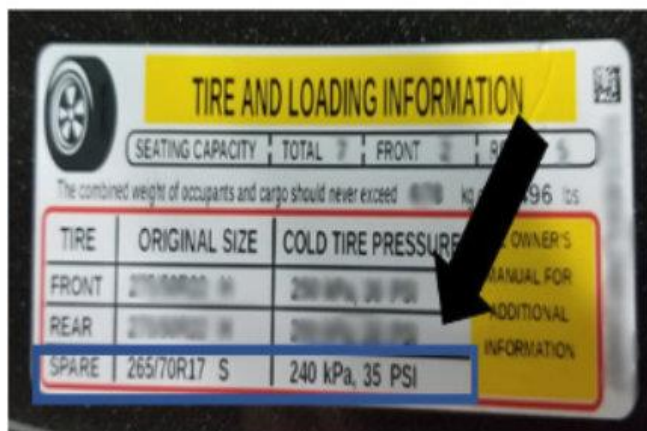
5908675

1. Locate the Tire and Loading Information label in the driver door opening.

2. Identify the spare tire information section.
3. Clean the information label using 50% isopropyl alcohol and dry with a clean, lint free cloth. Receiving surface MUST be clean, dry, and free of any contaminants. The surface temperature should not be less than 65° F (21° C).
4. Firmly hold the new label and peel protective liner from the back side, being careful not to touch or contaminate the adhesive with dirt or foreign matter.

5. Ensure the new label is properly positioned before allowing contact with the original label surface. The adhesive used is very aggressive and will not allow repositioning once the new label is applied. Install the new spare tire information label over the existing spare tire section of the Tire and Loading Information label using the black centerline for reference. Press firmly and smooth out entire label ensuring corners are fully adhered.

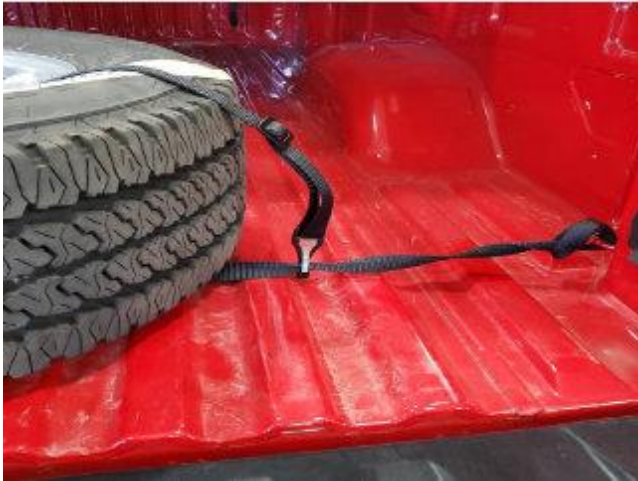
5908683

- Fit strap through the bottom right rear tie down ring.

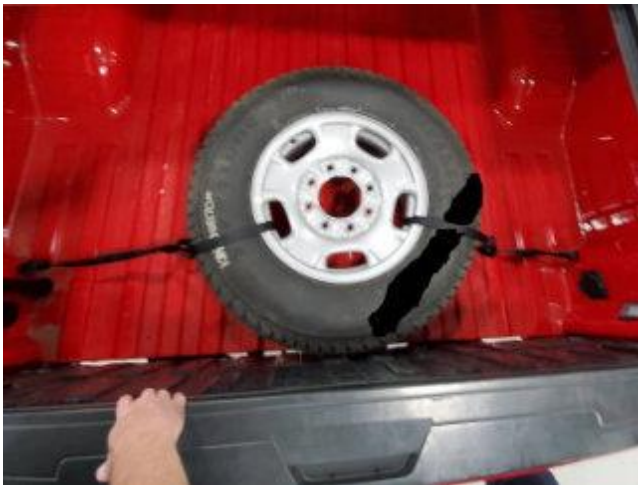
5908684

- Feed the strap under the bottom of the spare tire and wheel assembly, through the wheel and latch the strap as shown.

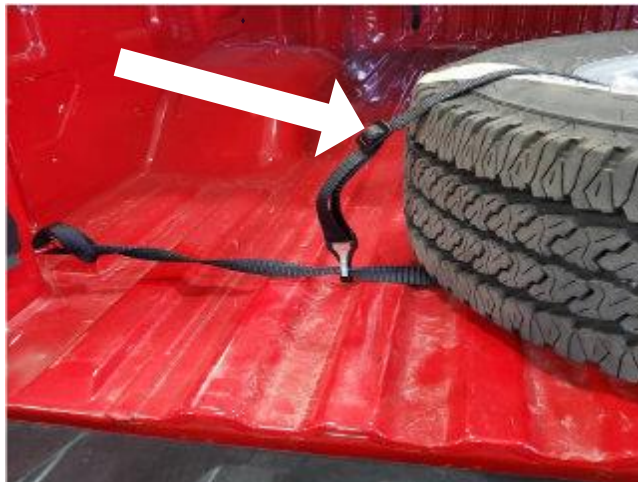
5908686

- Tighten both strap buckles to secure the spare tire and wheel assembly.
