Product Safety Recall

N212329780 Mismatched Spare Tire – US Only

Release Date: January 2022

Revision: 01

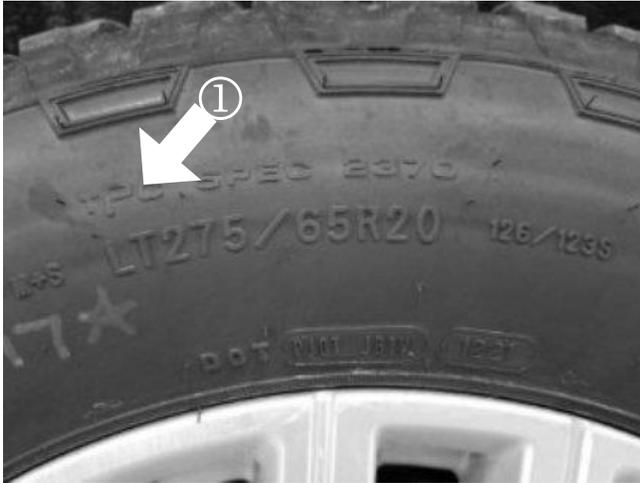
5908479

TPC Location (1)

1. Is the vehicle equipped with OEM 20" or 18" accessory road tire? See the photograph images and table information above to identify these tires by locating and inspecting the TPC number on the sidewalls of the tires. TPC numbers are 2370 for the OEM 20" accessory road tires and 2373 for the OEM 18" accessory road tires.
2. If yes, replace the existing 17" spare tire and wheel assembly that is in the spare tire and wheel carrier under the truck with a new 18" spare tire and wheel assembly.
3. Place the original 17" spare tire and wheel assembly that the vehicle was built with in the cargo bed of the truck and restrain it with two straps. The customer needs to re-install this original 17" spare tire and wheel assembly in the vehicle the spare tire and wheel carrier under the truck whenever they transition back to the OEM 17" production road tires.

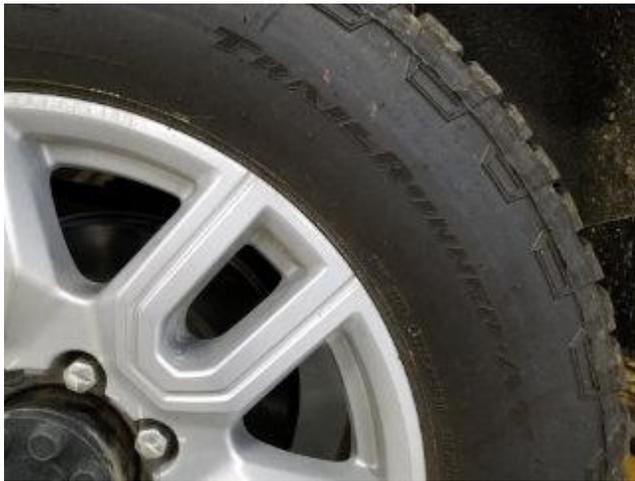
5908474

20" Goodyear Wrangler Trailrunner LT275/65R20 Sidewall Information

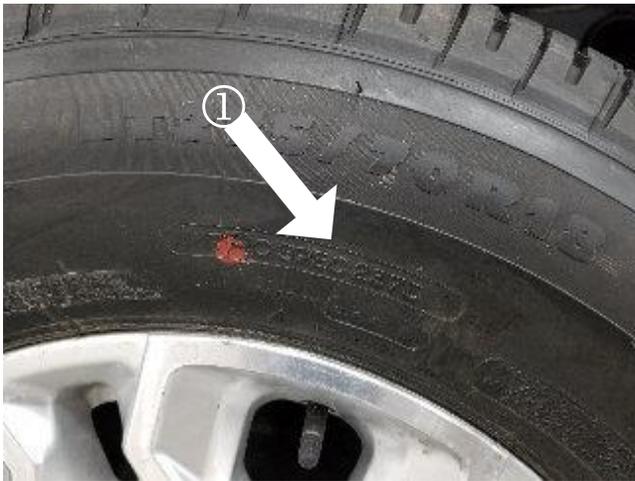
5908483

TPC Location (1)

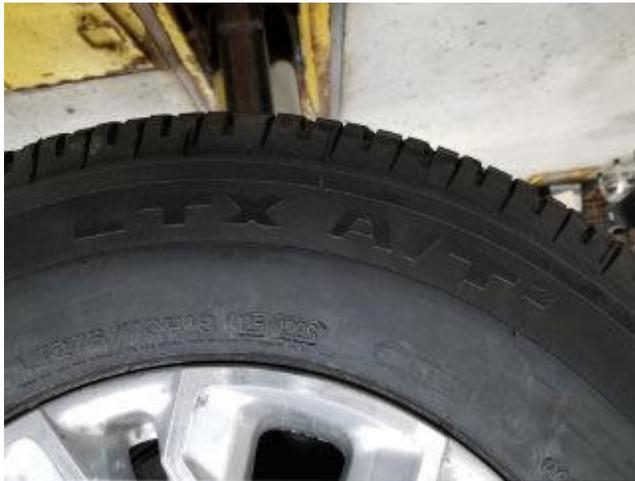
5908484

18" Michelin LTX A/T2 LT275/70R18 Sidewall Information

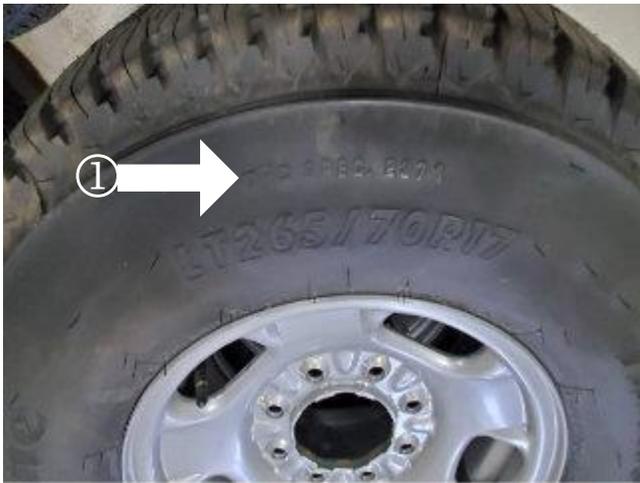
5908690

TPC Location (1)

1. Is the vehicle equipped with OEM 17" production road tires? See the photograph images and table information above to identify these tires by locating and inspecting the TPC number on the sidewalls of the tires. TPC numbers are either 2029 MS or 2371 for the OEM 17" production road tires.

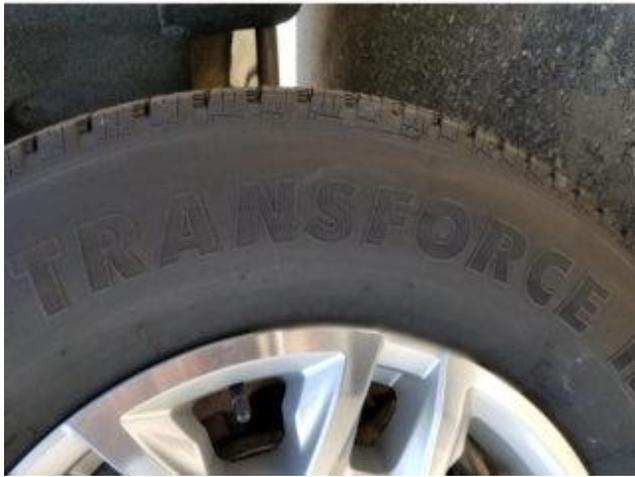
5908671

17" Firestone Transforce HT LT265/70R17 Sidewall Information

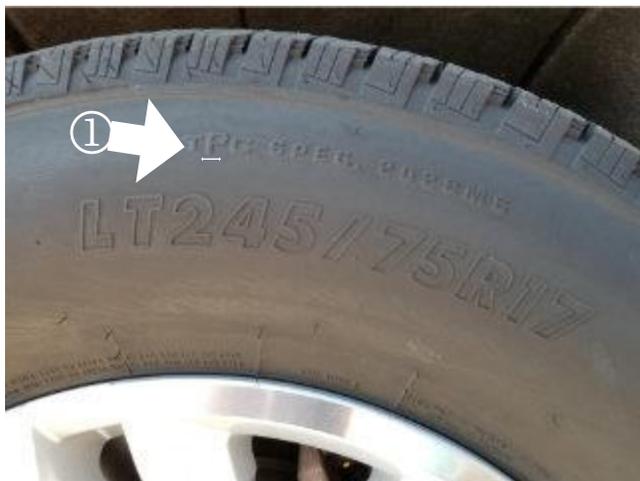
5908688

TPC Location (1)

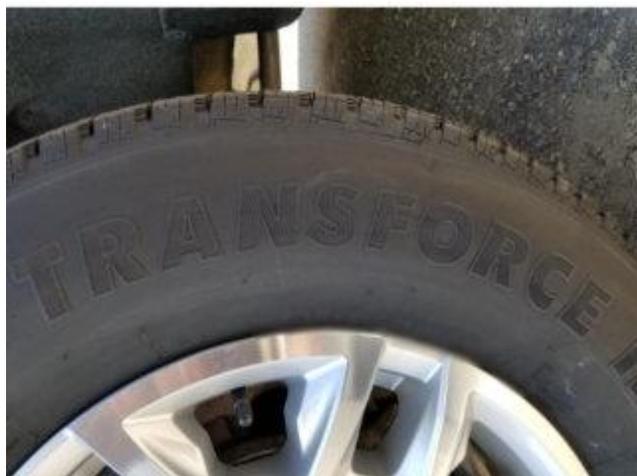
5908671

17" Firestone Transforce HT LT245/75R17 Sidewall Information

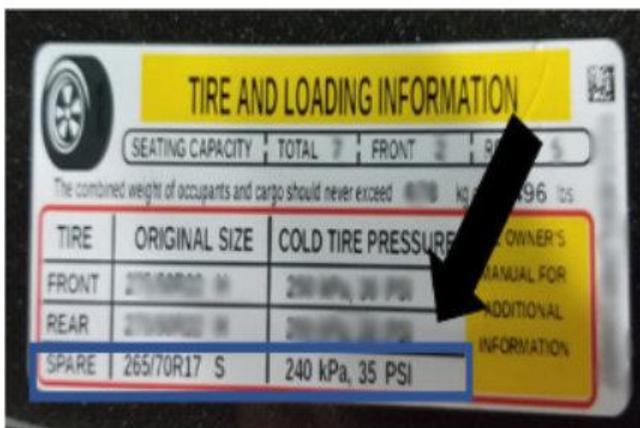
5908675

1. Locate the Tire and Loading Information label in the driver door opening.

2. Identify the spare tire information section.
3. Clean the information label using 50% isopropyl alcohol and dry with a clean, lint free cloth. Receiving surface MUST be clean, dry, and free of any contaminants. The surface temperature should not be less than 65° F (21° C).
4. Firmly hold the new label and peel protective liner from the back side, being careful not to touch or contaminate the adhesive with dirt or foreign matter.

5. Ensure the new label is properly positioned before allowing contact with the original label surface. The adhesive used is very aggressive and will not allow repositioning once the new label is applied. Install the new spare tire information label over the existing spare tire section of the Tire and Loading Information label using the black centerline for reference. Press firmly and smooth out entire label ensuring corners are fully adhered.

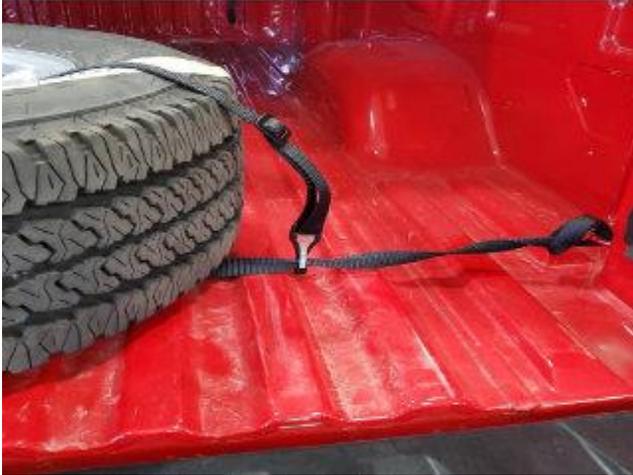
5908683

- Fit strap through the bottom right rear tie down ring.

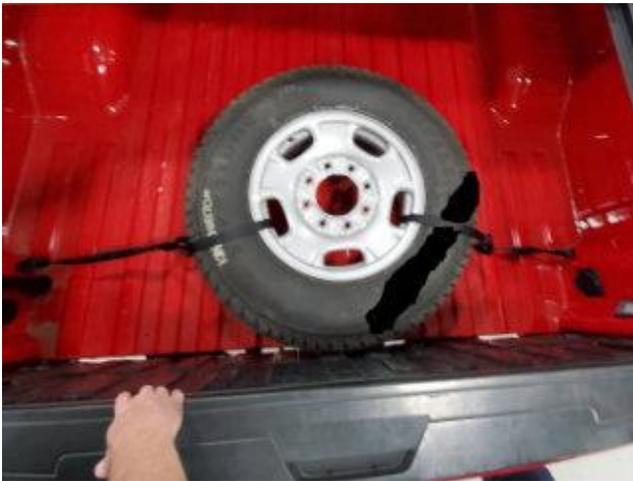
5908684

- Feed the strap under the bottom of the spare tire and wheel assembly, through the wheel and latch the strap as shown.

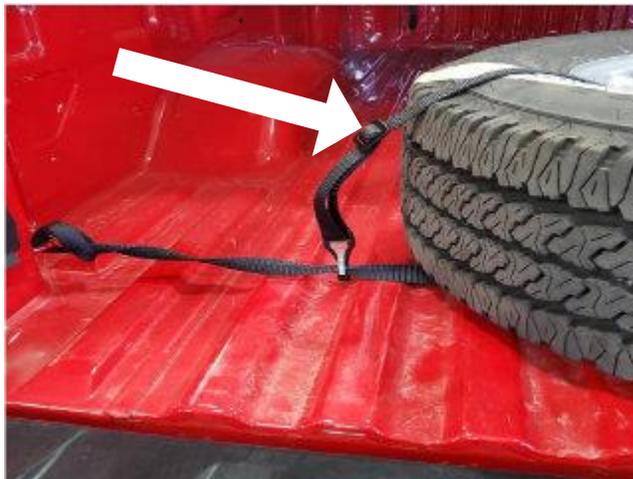
5908686

- Tighten both strap buckles to secure the spare tire and wheel assembly.
