# SAFETY RECALL

**SR21-85**

FRONT HEADLAMPS REPLACEMENT 9700 USCAN (B13R)

On the vehicles affected by this recall, replace both headlamp assemblies and then perform the software or parameters update.

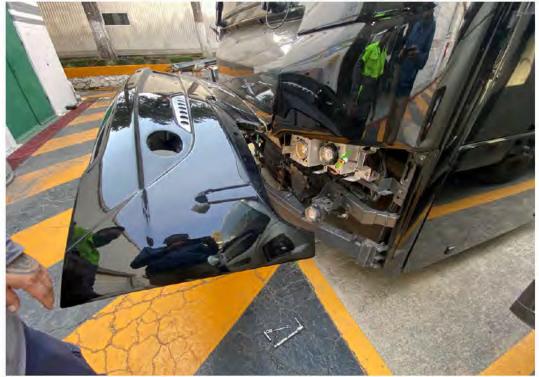
Figure 1

1) Open the front hatch.

Remove the original Bi-xenon front headlamp assemblies according to removal instructions of service operation: 35251-2 or 35252-2, both operations published in IMPACT for B13R model.

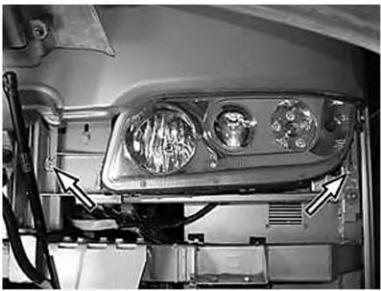
Figure 2

3) Before installing the new headlamps on the vehicle, check the pre-adjusted measurements on the headlamp unit at the lock nuts. The distance from the bracket base at each fixing screw should be 33 +/- 1 mm.

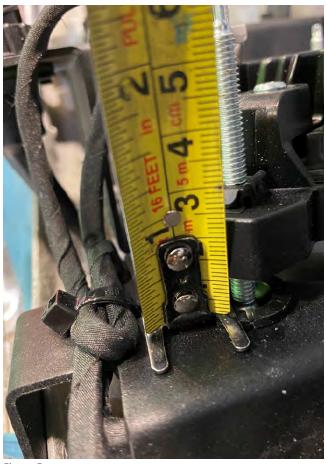
Figure 5

4) Check the pre-adjusted **low beam** module height in relation with the mounting plate. The measurement should be **10 mm**. If necessary, adjust using the corresponding adjustment screw.

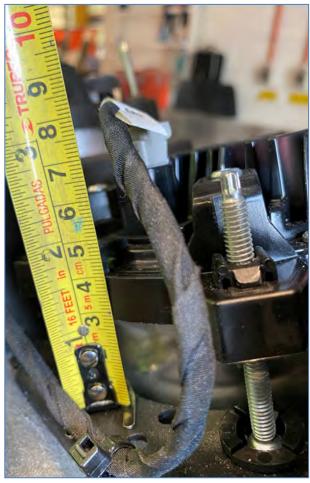
Figure 6

5) Check the pre-adjusted **high beam** module height in relation with the mounting plate. The distance should be **26 mm**. If necessary, adjust using the corresponding adjustment screw.

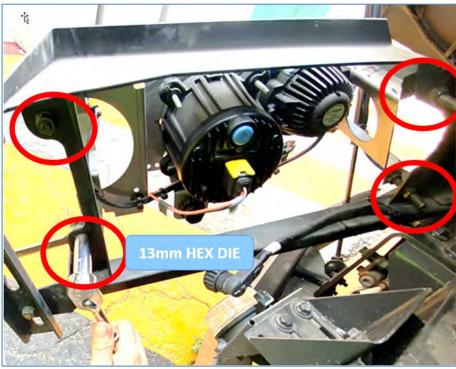
Figure 8

7) Install the new front headlamp assembly on the vehicle by screwing the four fixation screws to the body installation bracket. Tighten the headlamp fixation screws to a torque of **28 N-m**.

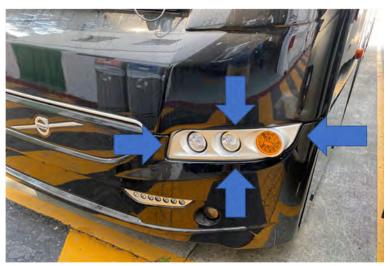
Figure 21

13) Close the front hatch and if necessary, adjust the headlamp bezel with the surrounding surfaces of the coach front panel and the bumper. To do so, screw or unscrew the bracket fixing screws locknut, modifying the pre-adjusted measurement of **33 +/- 1 mm** as required.

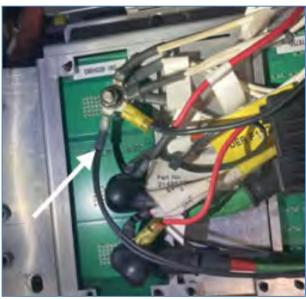
Figure 23

1) In the electrical compartment located on the L.H. side in the entrance, connect both black wires of the resistor harness 7775321 on the ground stud terminal.

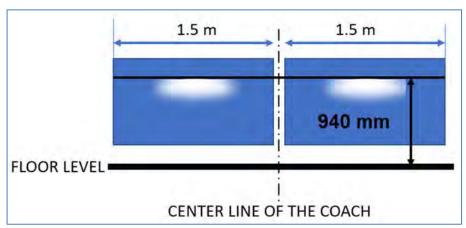
Figure 26

9) Draw a horizontal line at 940 mm above the floor level.

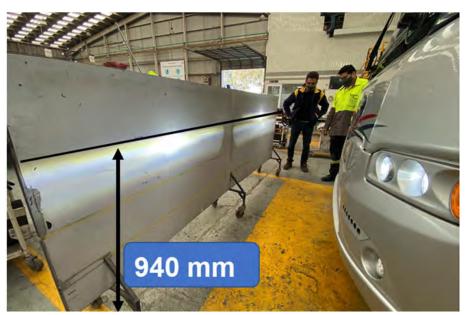
The <u>highest zone</u> of the light beam must be aligned (and touching) with the 940 mm line.

Figure 27: proper low beam height

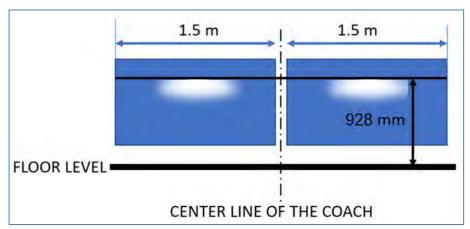
Figure 29

14) Draw a horizontal line at 928 mm (above the floor level).

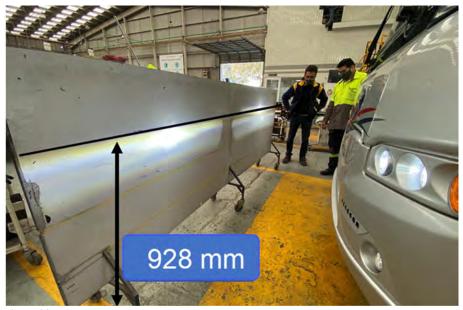
Figure 30

The <u>highest zone</u> of the light beam must be aligned (and touching) with the 928 mm line.
