Bridgestone Americas Tire Operations, LLC  
200 4<sup>th</sup> Avenue South  
Nashville, TN USA 37201

**IMPORTANT SAFETY RECALL**  
**NHTSA Recall No. 22T-021**

Bridgestone Americas Tire Operations, LLC (“**BATO**”) has determined that certain Firestone Destination LE2, Bridgestone Alenza Sport A/S, and Bridgestone Turanza EL440 tires may have sustained bead cuts from a warehouse de-palletizer during the shipping process, and that this condition could pose a safety risk. BATO has initiated a voluntary safety recall of these tires.

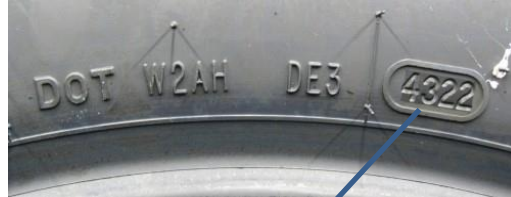
**FULL DOT**

NOTE: Potentially impacted tires would have "2522," "2622," "2722," or "2822" here.

The tire's DOT TIN can be found on the sidewall just above the rim (see images on pages 7 and 8).

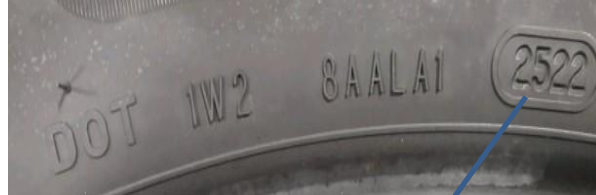
**FULL DOT**

NOTE: Potentially impacted tires would have "2522," as indicated here, or "2422," "2622," or "2722."
