SUBJECT: NEW VEHICLE DEMONSTRATION / DELIVERY HOLD -Safety Recall 22S13 Certain 2020-2022 Model Year F59 Commercial Stripped Chassis

Certain 2020-2022 Model Year F59 Commercial Stripped Chassis Steering Column Intermediate Shaft to Steering Gear Box Upper U-joint Bolt Inspection and Torque

NEW VEHICLE DEMONSTRATION / DELIVERY HOLD -Safety Recall 22S13

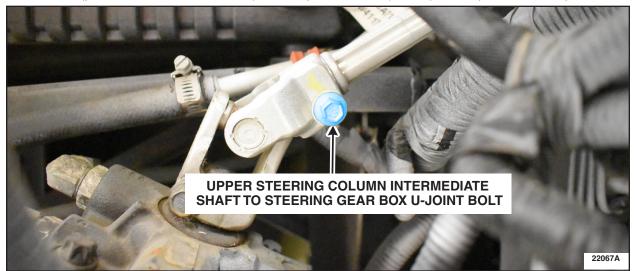
FIGURE 1

- 1. Position steering wheel to gain access to both steering column intermediate shaft to steering gear box U-joint bolts. See Figure 1.
- 2. Is the upper steering column intermediate shaft to steering gear box U-joint bolt installed on the vehicle? See Figure 1.
 - Yes: Torque the upper steering column intermediate shaft to steering gear box U-joint bolt to 18 lb.ft (25 Nm).Then, proceed to Step 3.
 - No: Install a *new* upper steering column intermediate shaft to steering gear box U-joint bolt (part number W712961-S439) and torque to 18 lb.ft (25 Nm). Then, proceed to Step 3.

The bolt that secures the intermediate steering shaft to the steering gear box may be improperly installed on some of the vehicles. An improperly installed bolt can result in separation of the intermediate steering shaft from the steering gear box.

Separation of the intermediate steering shaft from steering gear box can result in the loss of steering control, increasing the risk of a crash.

Before demonstrating or delivering any new in-stock vehicles involved in this recall, dealers are to inspect and verify the intermediate steering shaft bolt is present and if not, a new bolt will be installed, then torque both of the intermediate steering shaft U-Joint bolts. This service must be performed on all affected vehicles at no charge to the vehicle owner.

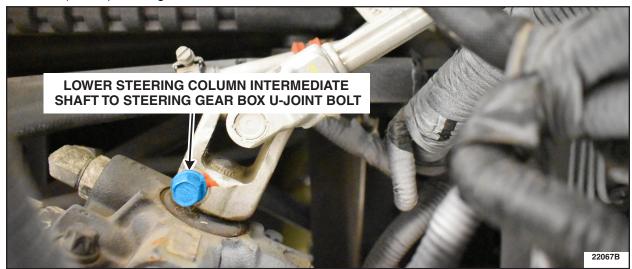
FIGURE 2

CPR © 2022 FORD MOTOR COMPANY DEARBORN, MICHIGAN 48121 03/2022 3. Verify that the lower steering column intermediate shaft to steering gear box U-joint bolt is torqued to 35 lb.ft (48 Nm). See Figure 2.
