IMPORTANT RECALL CAMPAIGN UPDATE

Recall Campaign Launch Notification			February 14, 2023
Campaign No. :	NHTSA ID	Campaign Desc. :	Inspect Brake Booster With Pedal Rework
2022050014	22V315	22P4290006	
<p>This is to notify you of an update to the Recall Campaign Launch to inspect the brake booster on 14,123 Model Year (“MY”) 2006-2012 GL-Class, ML-Class, and R-Class (X164, W164 and V251 platform) vehicles. The recall campaign will be visible on the www.safercar.gov website and may generate questions from customers. Affected VINs were flagged in VMI as “OPEN” on May 28, 2022.</p>			
Background			
Issue	<p>Mercedes-Benz AG (“MBAG”), the manufacturer of Mercedes-Benz vehicles, has determined that on certain Model Year (“MY”) 2006-2012 ML-Class, GL-Class (W164/X164 platform) and R-Class (V251 platform) vehicles, the function of the brake booster might be affected due to advanced corrosion in the joint area of its housing. After extended time in the field and in conjunction with prolonged water exposure, this corrosion might lead to a vacuum leak at the brake booster. If this were to occur, the brake force support might be reduced, leading to an increase in the brake pedal forces require

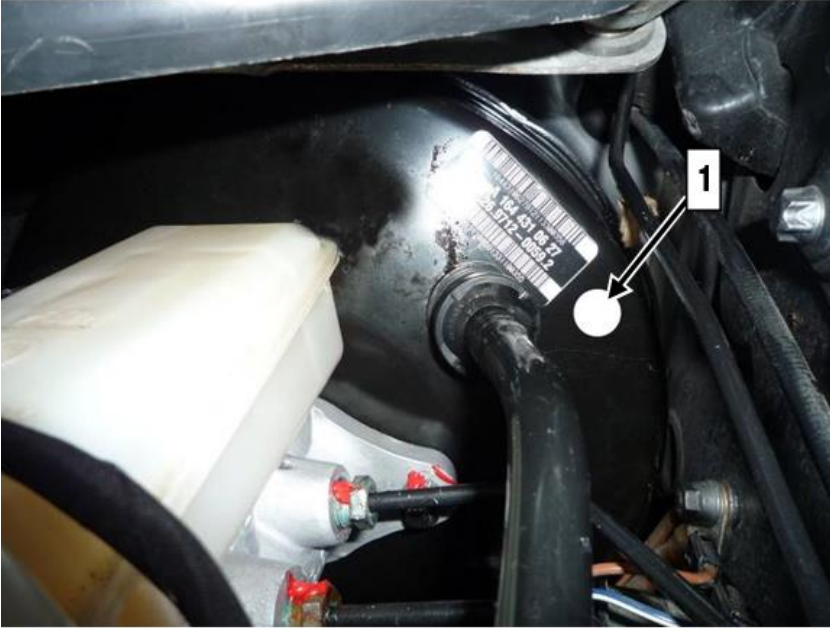
Figure 10

2. Apply marking with **white touch-up paint pen (1, figure 10)** to the inspected brake booster.
- i** Under no circumstances should you treat the brake booster with anti-corrosion agent/paint.
