**SUBJECT:** **NEW VEHICLE DEMONSTRATION / DELIVERY HOLD**  
**Safety Recall 22S43 - Supplement #3**  
Certain Model Years Multiple Vehicles  
Transmission Shifter Cable Bushing

## CERTAIN 2013-2019 ESCAPE, 2013-2016 FUSION, 2013-2018 C-MAX, 2013-2021 TRANSIT CONNECT AND 2015-2018 MODEL YEAR EDGE VEHICLES — SHIFTER CABLE BUSHING REPLACEMENT AND PROTECTIVE CAP

### SERVICE PROCEDURE

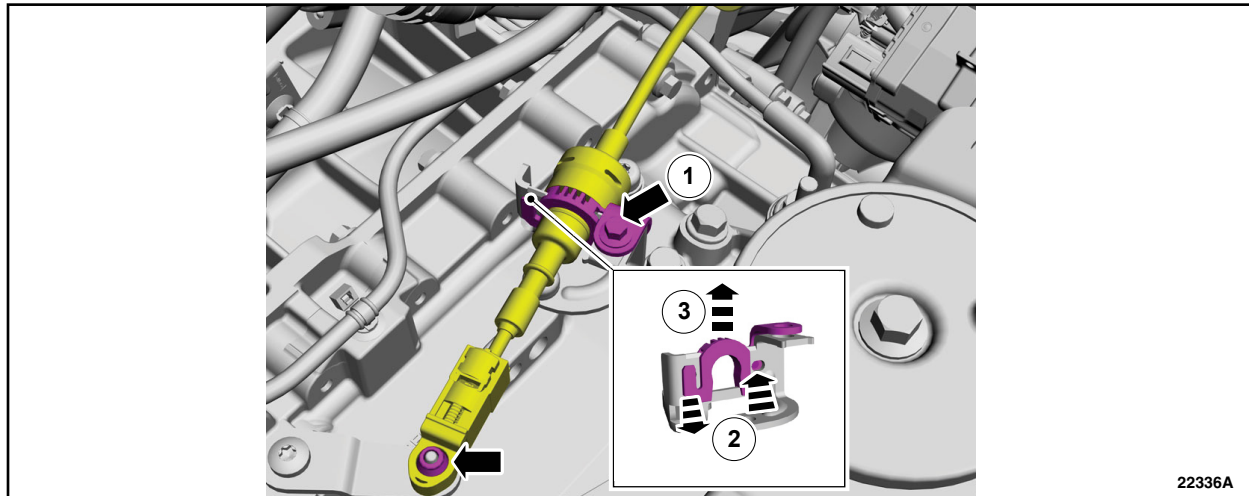
FIGURE 1

1. Apply the parking brake and chock wheels to make sure the vehicle does not roll.
2. Position the gear shift lever in Drive (D).
3. Remove the air cleaner assembly. Please follow the Workshop Manual (WSM) procedures in Section 303-12.
4. Remove the air cleaner outlet pipe. Please follow the WSM procedures in Section 303-12.
5. Disconnect the selector lever cable from the transmission manual lever and the bracket. See Figure 1.
  1. Remove the selector lever cable bracket bolt.
  2. Disengage the selector lever cable holding clip.
    - Use caution when removing the hold-down bracket to avoid damage. The hold-down bracket is available separate from the shift cable.
  3. Disconnect the selector lever cable.
    - Torque to 62 lb.in (7 Nm).

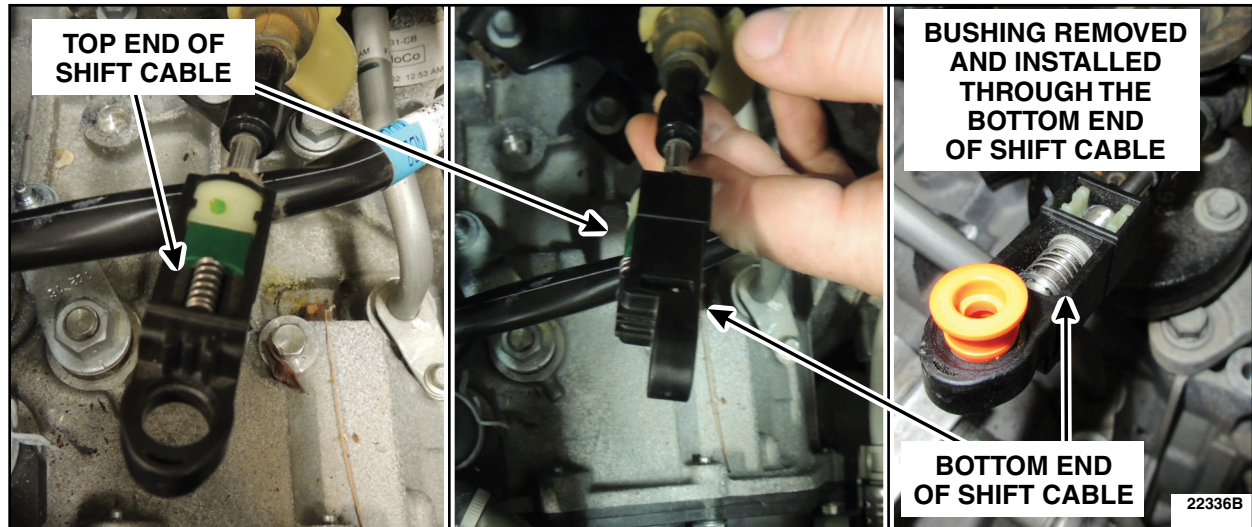
**FIGURE 2**

**NOTE:** Selector Lever Cable Bushing Replacement/Orientation. See Figure 2.

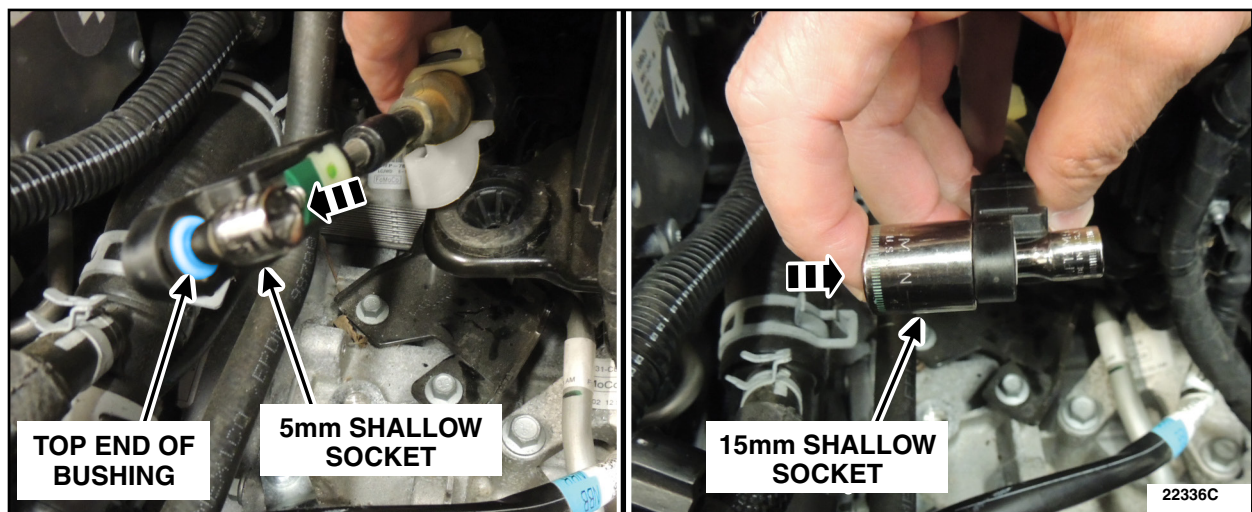
**FIGURE 3**

6. Press out the shifter cable bushing using one of the two methods below.

- Using a 5mm and a 15mm socket with Straight Jaw Adjustable pliers the bushing can be pressed out of the shifter cable end. The 5mm socket will fit into the small part of the bushing on top, the 15mm will go against the bottom of the shifter cable end, make sure to have the socket centered with the bushing to allow clearance of the bushing shoulder as it is being pressed out. See Figures 3 and 4.
- Use a tool such as a Lisle 38350 - Exhaust Hanger Removal plier to press the bearing out. Viewing Figure 5 the shoulder of the bushing is positioned upward, the small end of the plier is pressing the bushing out. Proceed to Step 7.

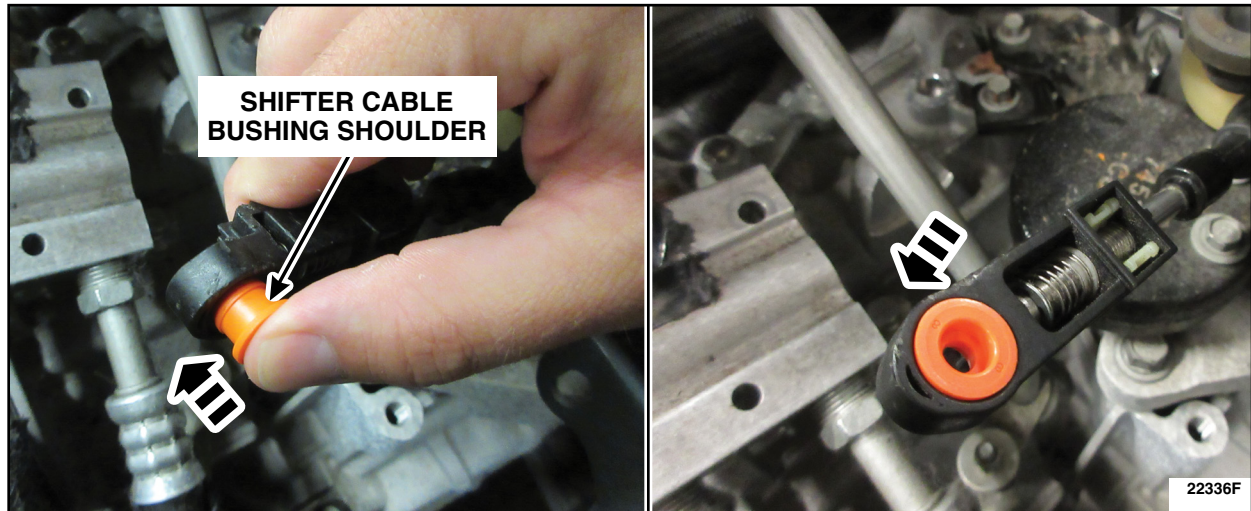
FIGURE 6

7. Using your hands only, install the *new* selector lever cable bushing. Do not use any grease to install, the bushing and cable end should be dry. See Figure 6.

- Visually check the shifter cable end for any signs of damage. If damage to the shifter cable end is found, please call the Special Service Support Center (SSSC).

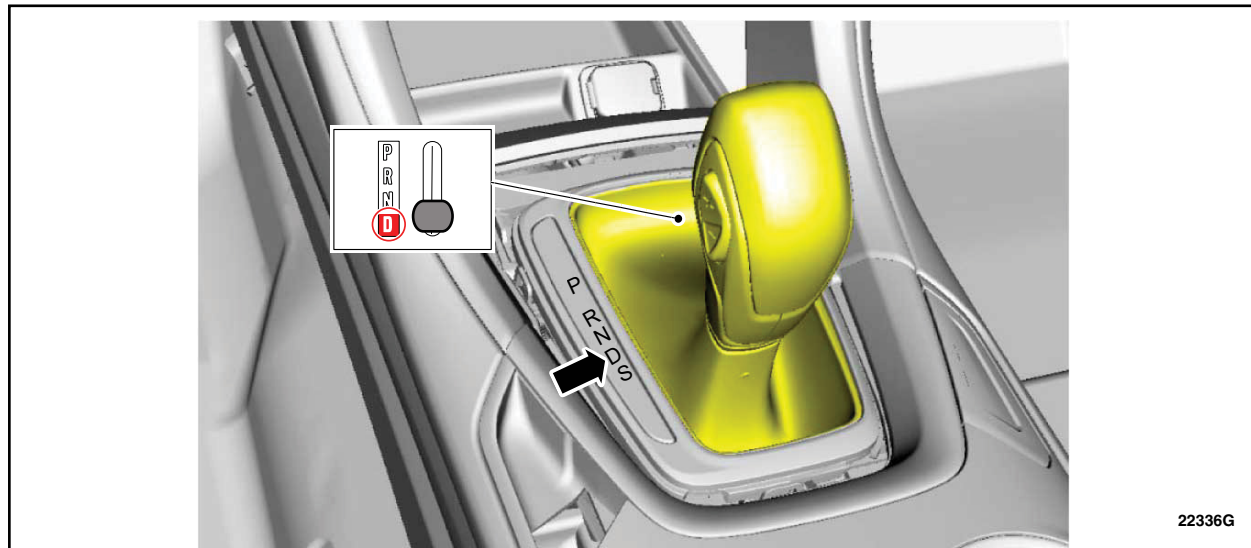
FIGURE 7

8. The vehicle's transmission gear selector lever should be in the Drive position from Step 2, if not, position the selector lever to Drive (D). See Figure 7.

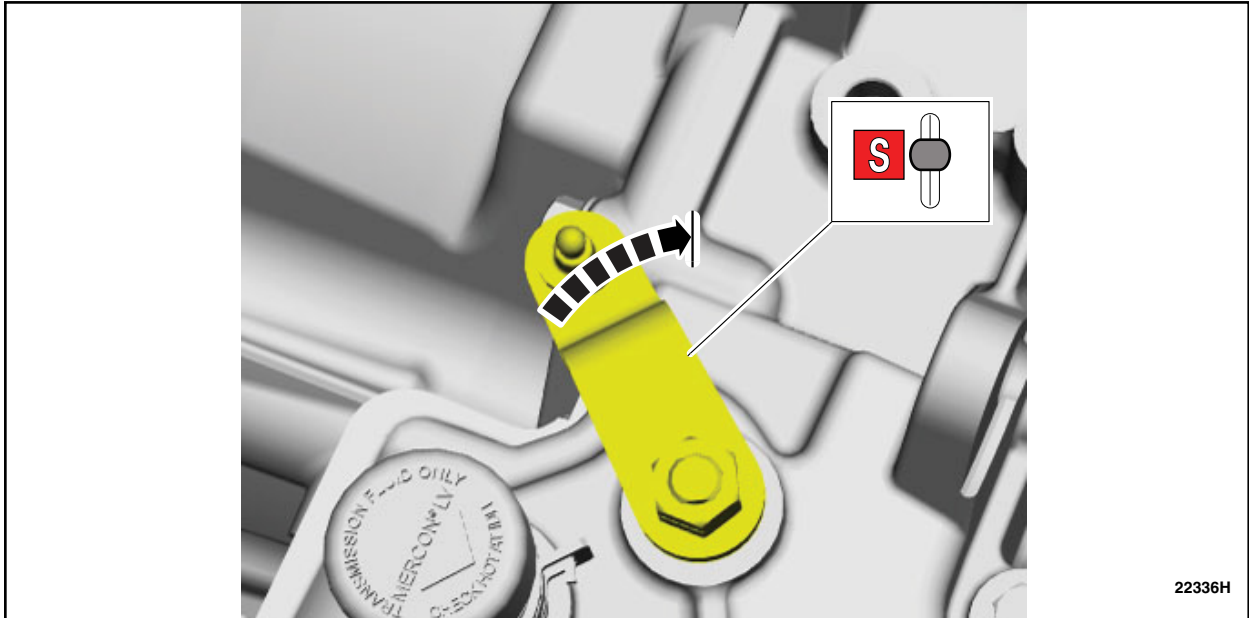
**FIGURE 8**

9. Rotate the manual control lever clockwise until it stops. See Figure 8.

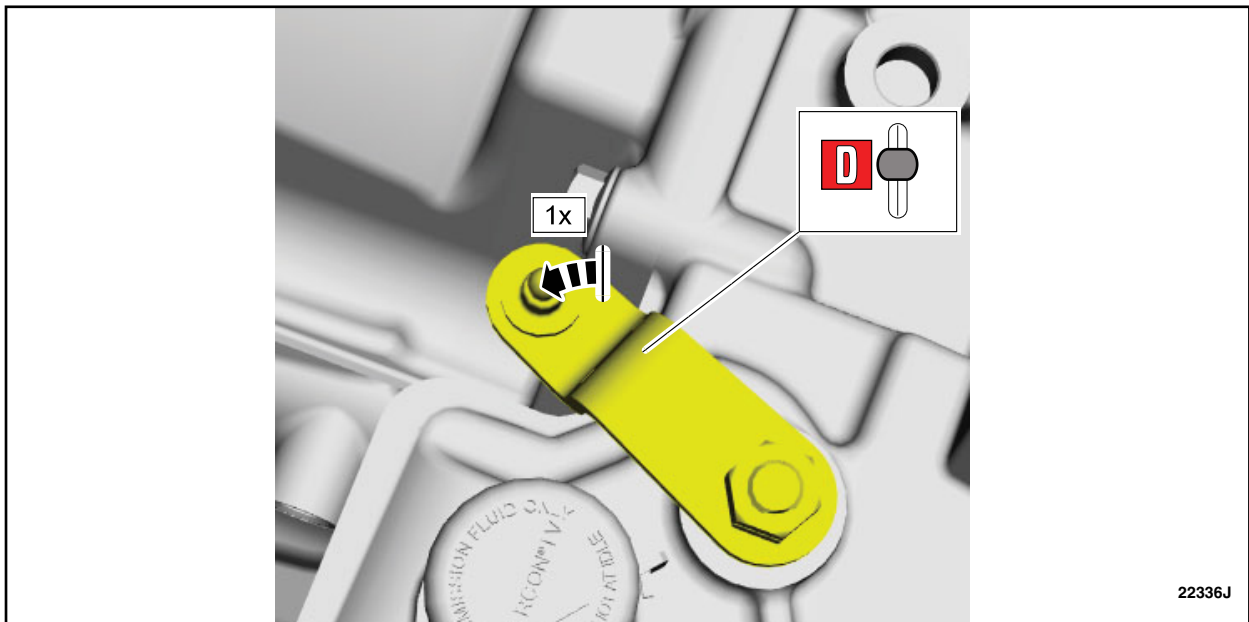
**FIGURE 9**

10. Rotate the manual control lever counterclockwise 1 detent into Drive (D). See Figure 9.

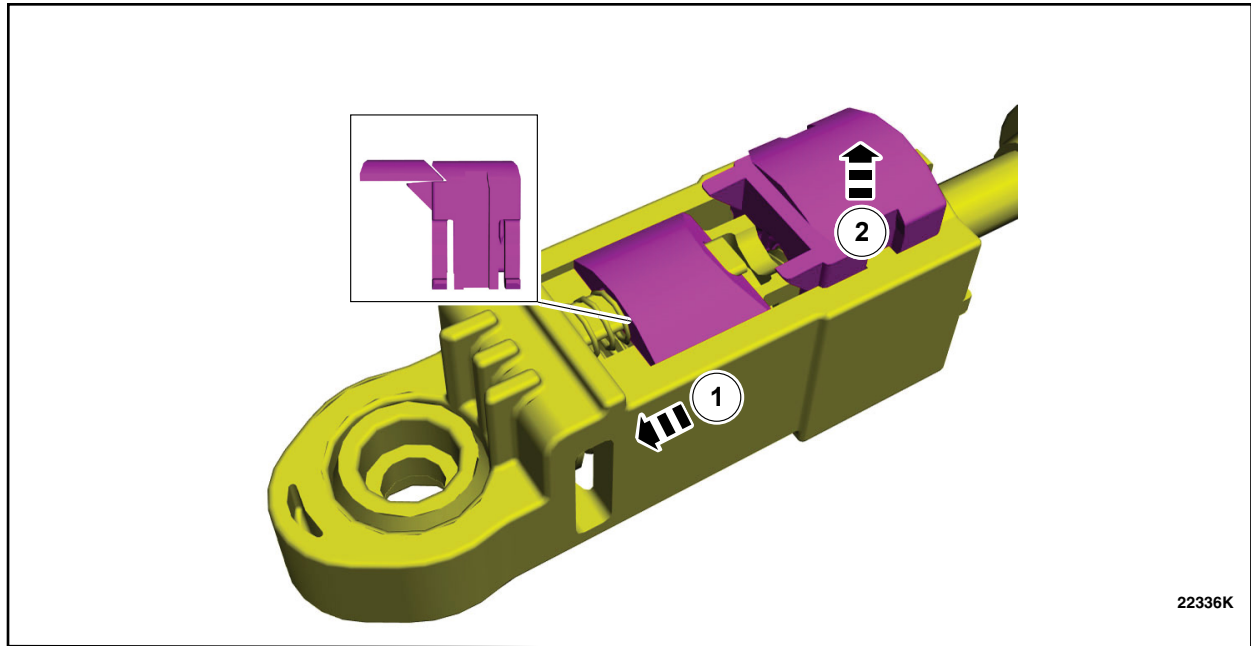
**FIGURE 10**

11. Release the selector lever cable adjuster lock. See Figure 10.

1. Carefully pry the adjuster lock tabs outward.
2. While holding the adjuster lock tabs outward, slide the lock out to unlock the selector lever cable.

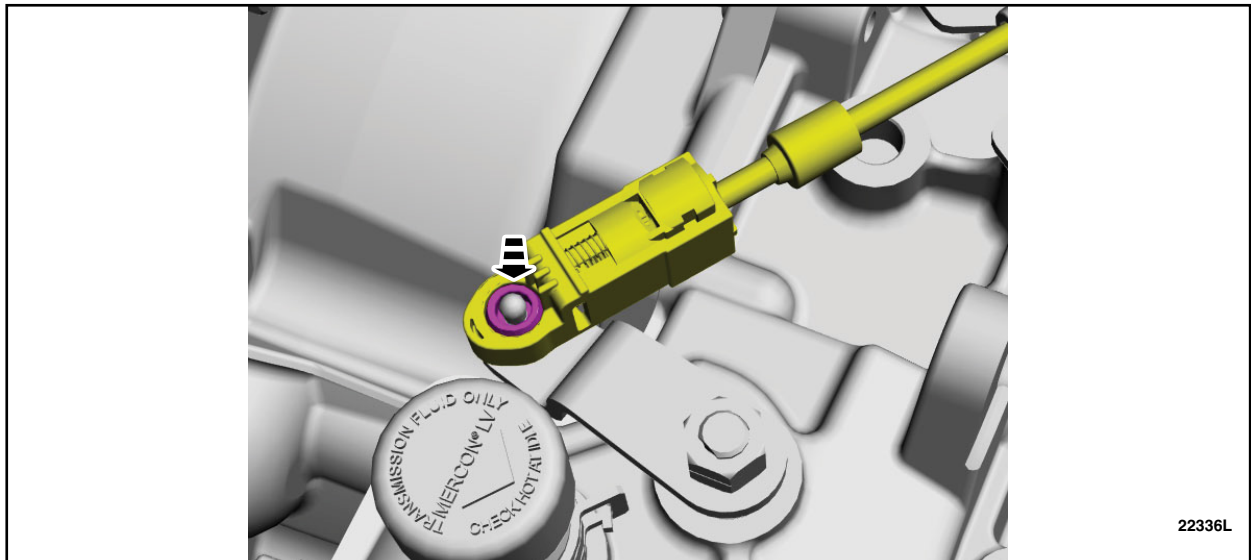
**FIGURE 11**

12. Connect the selector lever cable to the manual control lever. See Figure 11.

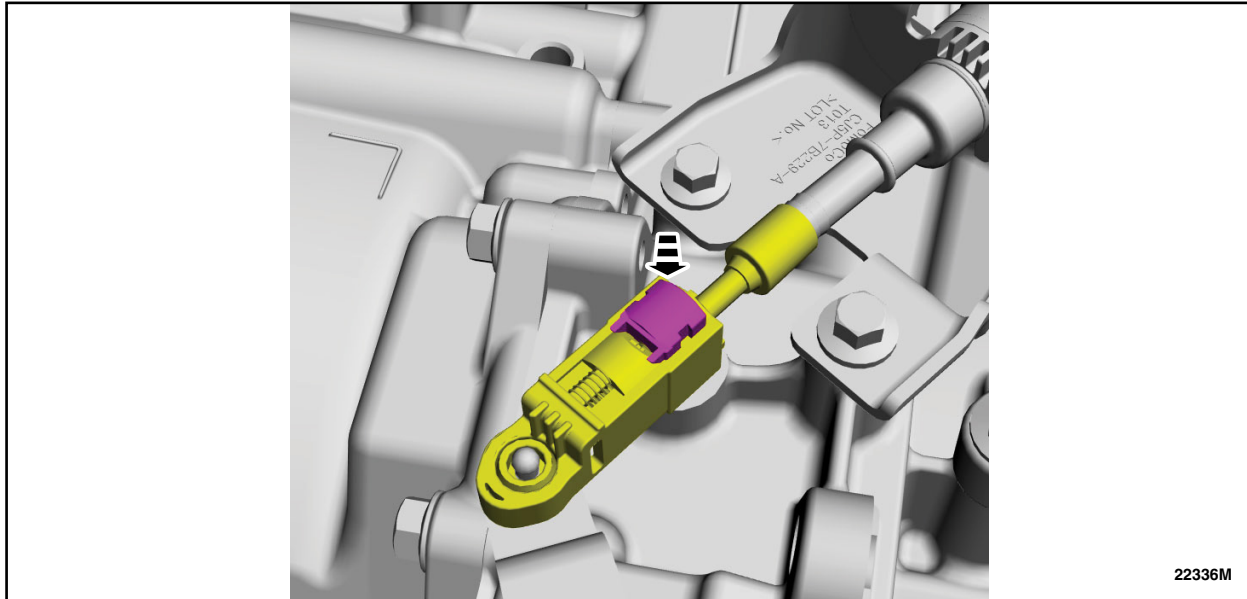
**FIGURE 12**

13. Slide the adjuster tab in place to lock the selector lever cable. See Figure 12.

**NOTE:** Visually inspect the cable end and give a slight pull up to verify the bushing is fully seated.

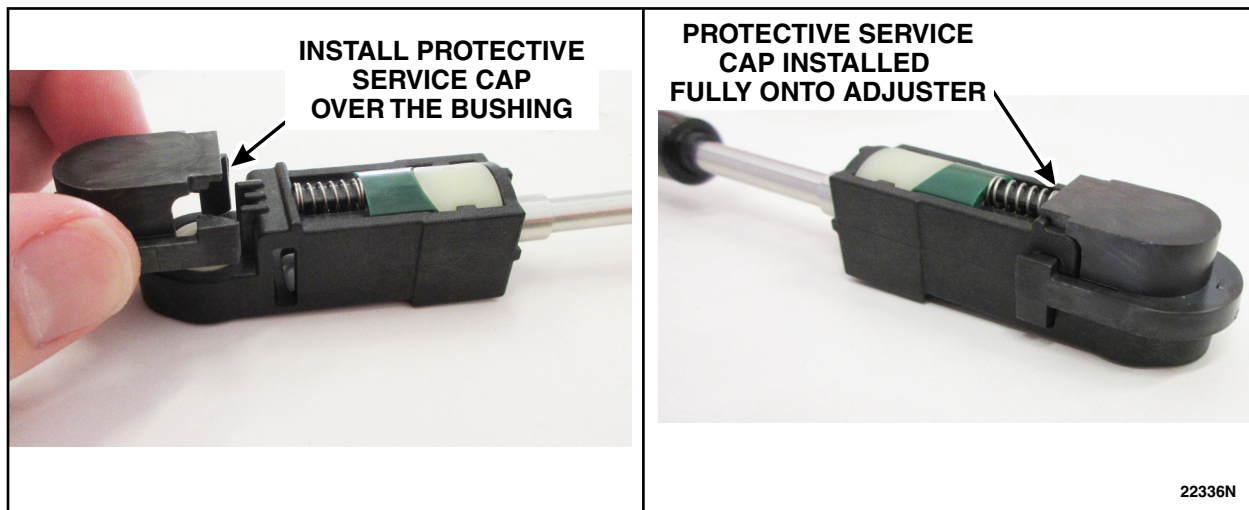
**FIGURE 13**

14. Install the *new* cap onto the selector lever cable adjuster. Clip one side into the adjuster body and then slide the other onto the housing until it snaps into place. The protective cap should cover the bushing and the terminal end of the adjuster. See Figure 13.

15. Verify installation by checking the cap is retained by the adjuster body.

**NOTE:** The selector lever cable was removed for clarity.
