August 2023  
 FL843AB  
 NHTSA #22V-634 (School Bus)  
 Transport Canada #2022-680 (School Bus)

**Subject: TBB Front Seat Barriers**

**Models Affected: Specific model years 2011-2021 Thomas Built Buses Saf-T-Liner HDX school buses, manufactured October 21, 2009, through December 16, 2019.**

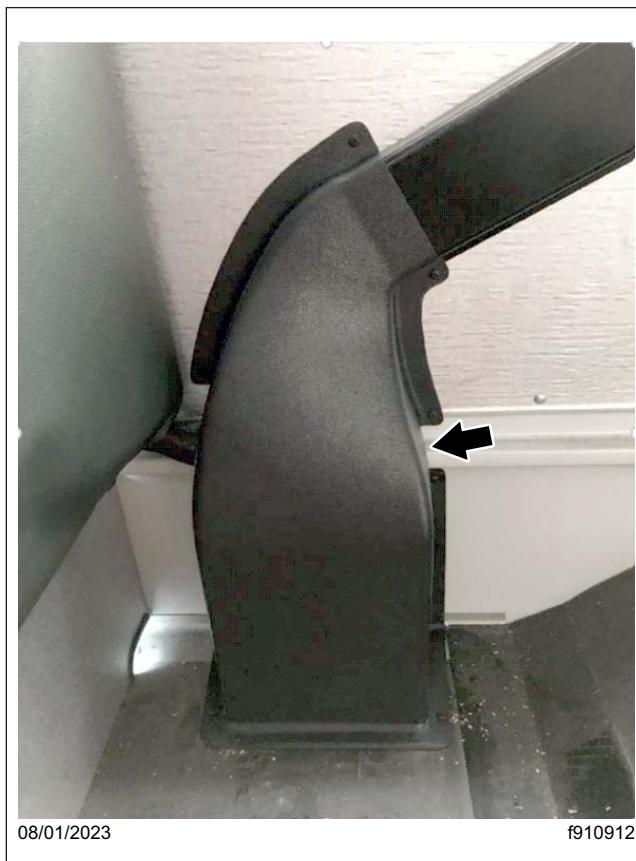
**Fig. 1, Location of the A/C Hose Cover**

1. Park the vehicle on a level surface, shut down the engine, and set the parking brake. Chock the tires.  
NOTE: The main power disconnect switch (MPDS) is located in the battery box compartment.
2. Turn the MPDS to the OFF position.
3. Disconnect the negative battery cables at the batteries.
4. If so equipped, remove the air conditioning (A/C) hose cover on the passenger side to gain access to the seat rail and the barrier mounting bolt. See [Fig. 1](#).
5. Remove the front barrier mounting bolt from the seat rail. Retain the mounting bolt for use in a later step. See [Fig. 2](#).

11. Install the new hose cover (TBB-242511) by hand, and ensure proper alignment and seating of the wall and floor flanges along with the rectangular snout. Adjust the diagonal wall cover, if required, to get proper alignment. See [Fig. 1](#).

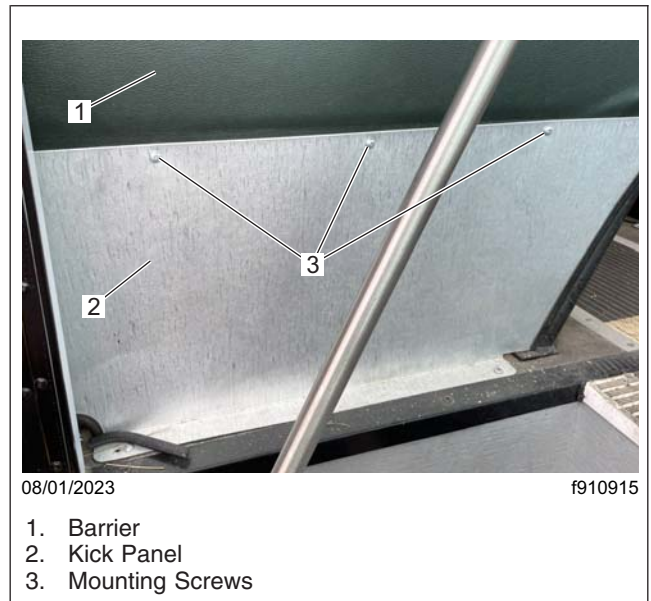
**Fig. 4, Top Kick Panel Mounting with the Barrier**

6. On the floor barrier mount, near the aisle way, shown in [Fig. 3](#), loosen the two rear 9/16-inch mounting bolts, but do not fully remove the bolts. Remove the 1/2-inch lag bolt.
7. If so equipped, remove the mounting screws that attach the top kick panel to the barrier. See [Fig. 4](#).

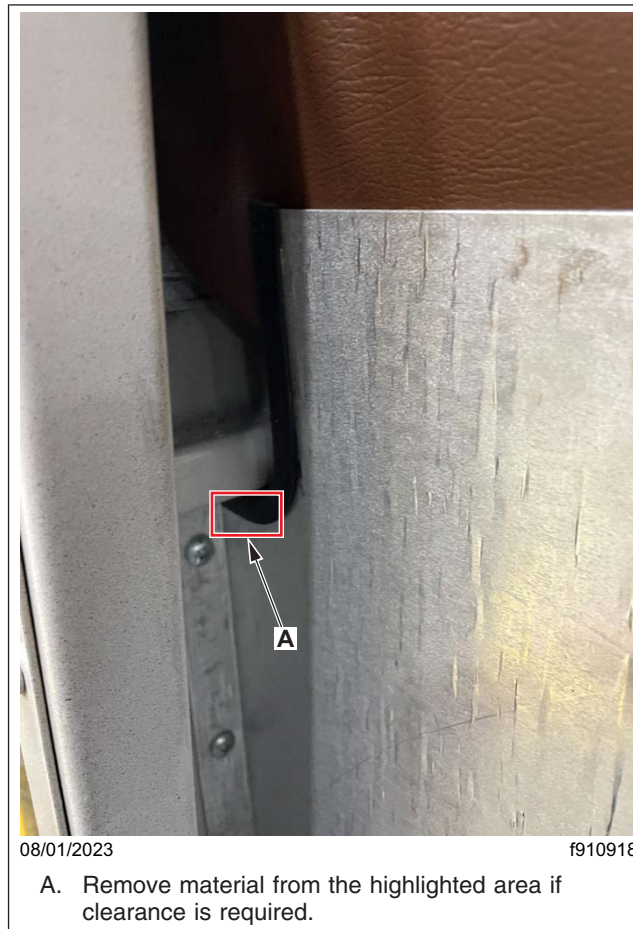
**Fig. 10, Trimming the Kick Panel to Clear the Seat Rail**

- 16.2 Install the fasteners that attach the top kick panel to the barrier, and ensure the previous perforations are used.
- 16.3 Trim the kick panel to clear the seat rail. See **Fig. 10**.
