May 2023
FL957A-D
NHTSA #22V-762 (School Bus)
Transport Canada #2022-577 (School Bus)

Subject: Thomas Built Bus Roof Sheet Joint

Models Affected: Specific model years 2011-2023 Thomas Built EFX and HDX school buses manufactured March 1, 2010, through August 1, 2022.

Roof Joint Repair

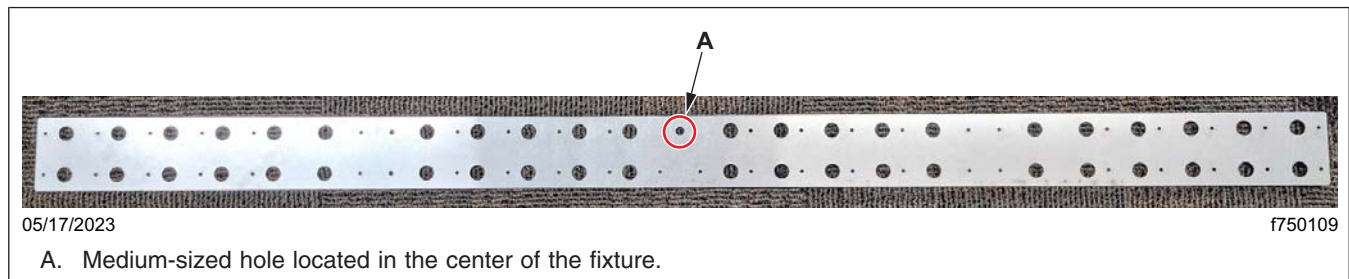
Fig. 1, Fixture A

4. A marking fixture (template) is used for each type of roof joint repair to locate the position of the additional screws. The three different fixtures, and their applications are listed in [Table 3](#).

11. To repair the standard roof joint, place the fixture A over the center rivet of the roof joint on the vehicle, as shown in **Fig. 8**.
12. The center rivet should fit securely in the medium-sized hole, located near the center of each fixture, as shown in **Fig. 9**.

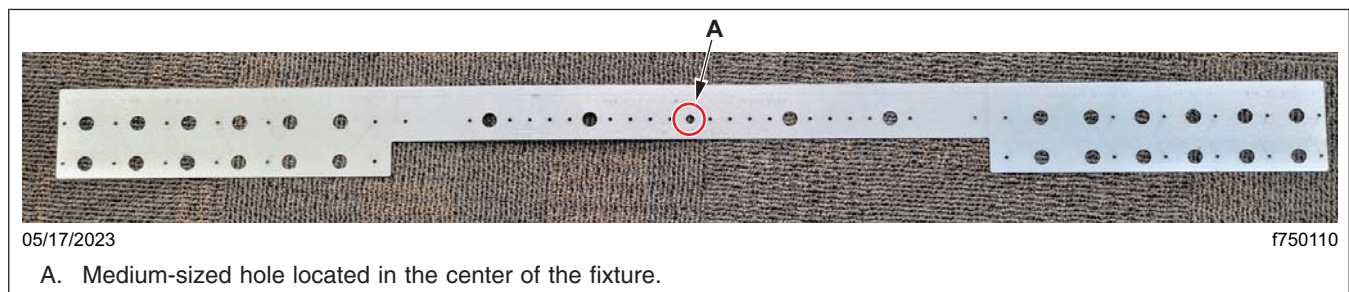
Fig. 2, Fixture B

- If the roof joint has a single rivet at the centerline of the vehicle, use fixture B (TBB 242524).
- If the roof joint has two rivets straddling over the centerline of the vehicle, as shown in [Fig. 19](#), use fixture C (TBB 242525).

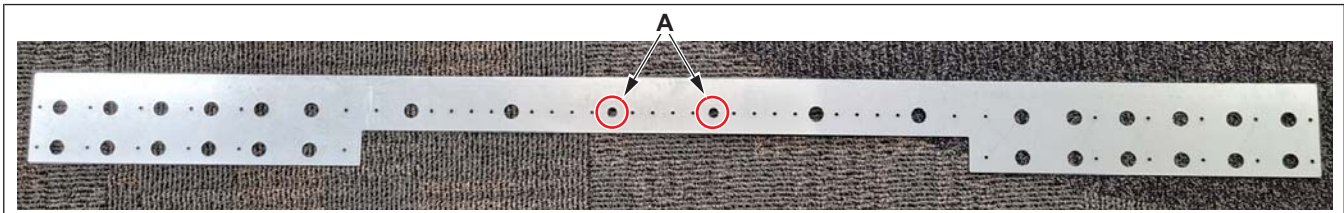
Fig. 3, Fixture C

A. Two medium-sized holes located in the center of the fixture.

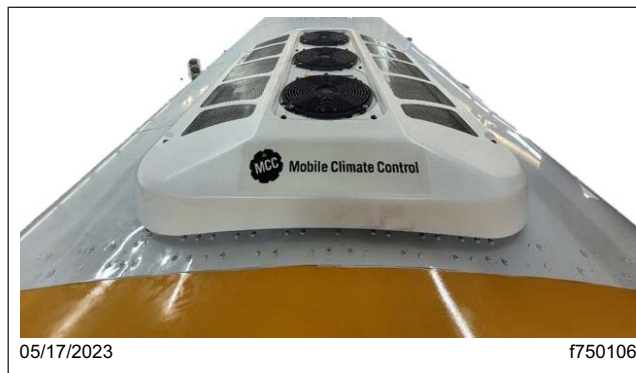
Fig. 4, Vehicle Equipped with Factory-Installed Roof-Top A/C Unit

5. If equipped with a roof-top air-conditioning (A/C) system, as shown in [Fig. 4](#), remove the A/C condenser unit to access the roof joint for repair.

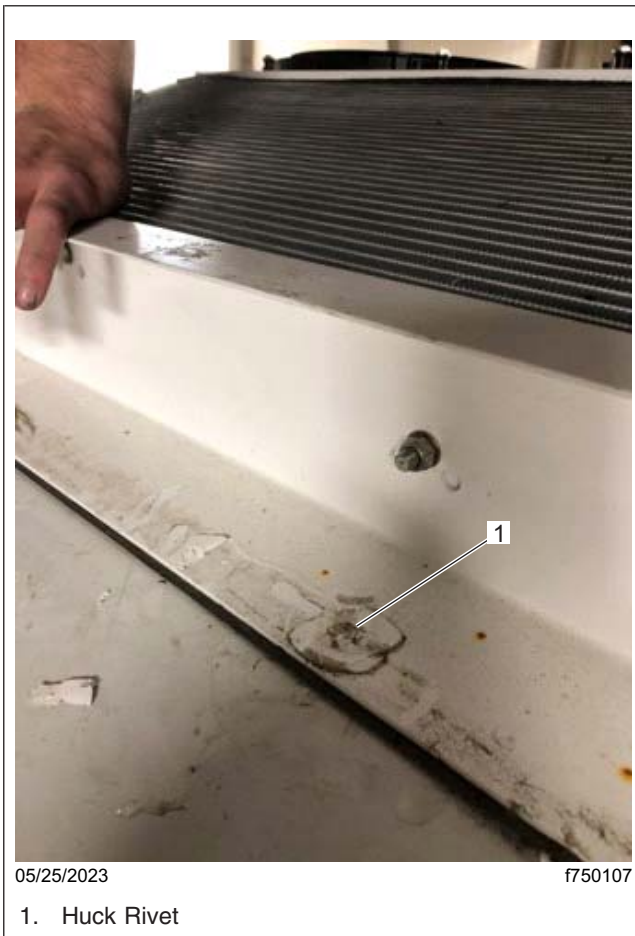
Fig. 5, Roof-Top A/C Secured with Huck Rivets

6. Remove the A/C roof-top guard, if so equipped.
7. Remove the six mounting screws that hold the plastic condenser cover in place. Set the cover aside.
8. Remove the ten Huck rivets that secure the condenser to the roof. See [Fig. 5](#).
9. Loosen the putty that seals the unit to the roof. See [Fig. 6](#).

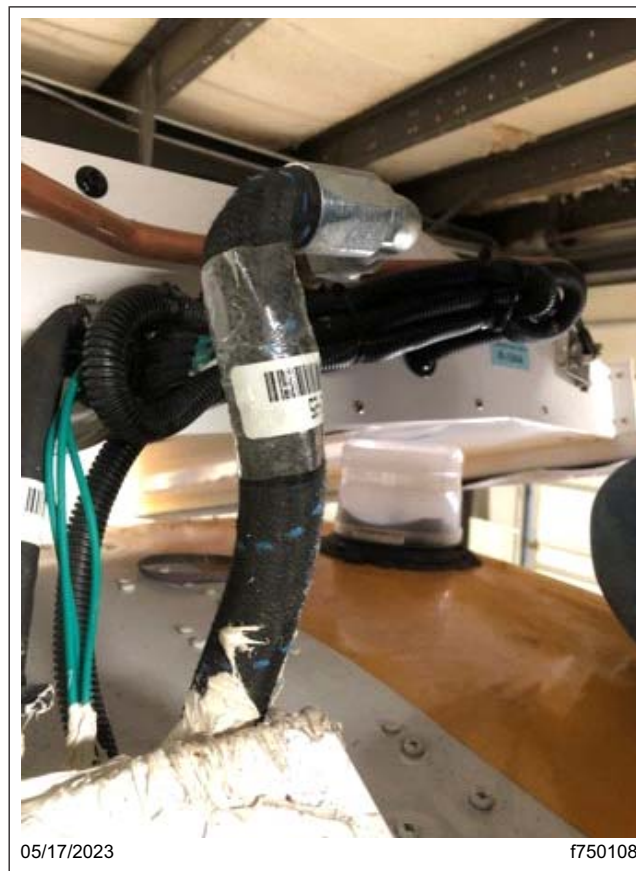
Fig. 7, Roof-Top A/C Plumbing

NO → Evacuate the refrigerant, and disconnect the roof-top A/C plumbing, shown in [Fig. 7](#). Reposition the A/C unit to access the roof joint.

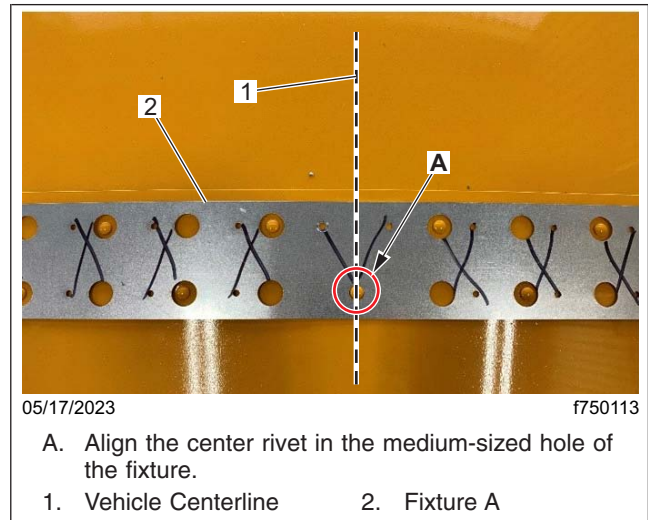
Fig. 9, Aligning the Center Rivet, Fixture A

NOTE: Some rivets may not be fitted in the exact center.

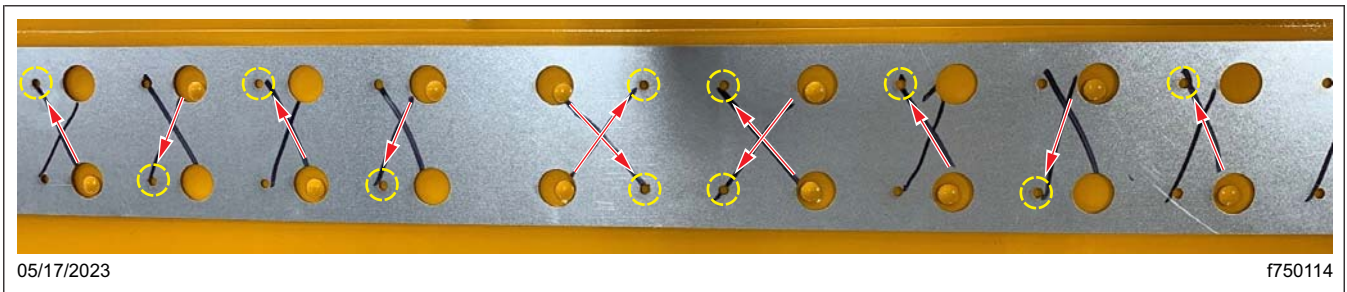
Fig. 10, Identifying the Marking Locations

Do not mark every hole on the fixture. Mark only the holes identified by yellow circles in [Fig. 10](#) and [Fig. 11](#).

15. Once the fixture is secured in place, locate the rivets, and follow the arrows shown in [Fig. 10](#) to identify the marking locations. Use a Sharpie marker to mark the pilot holes for drilling the holes in the roof.

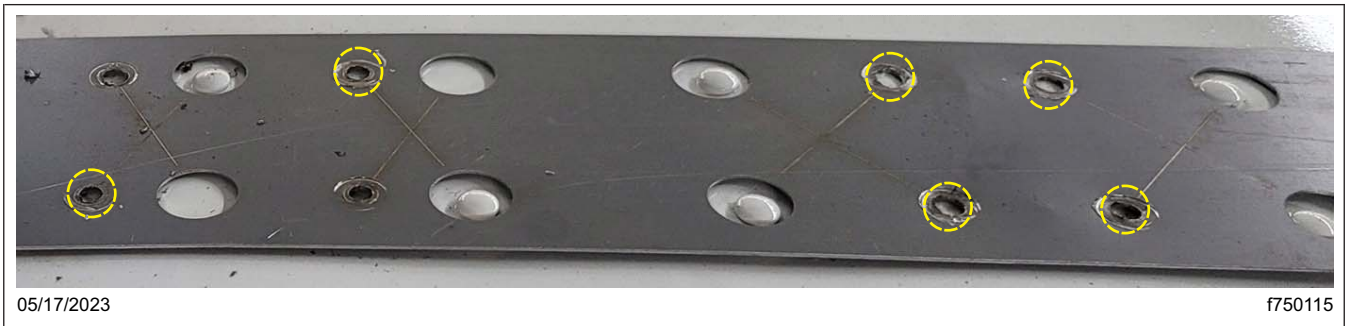
Fig. 11, Pilot Hole Locations

IMPORTANT: A standard joint should have 28 pilot hole marks.

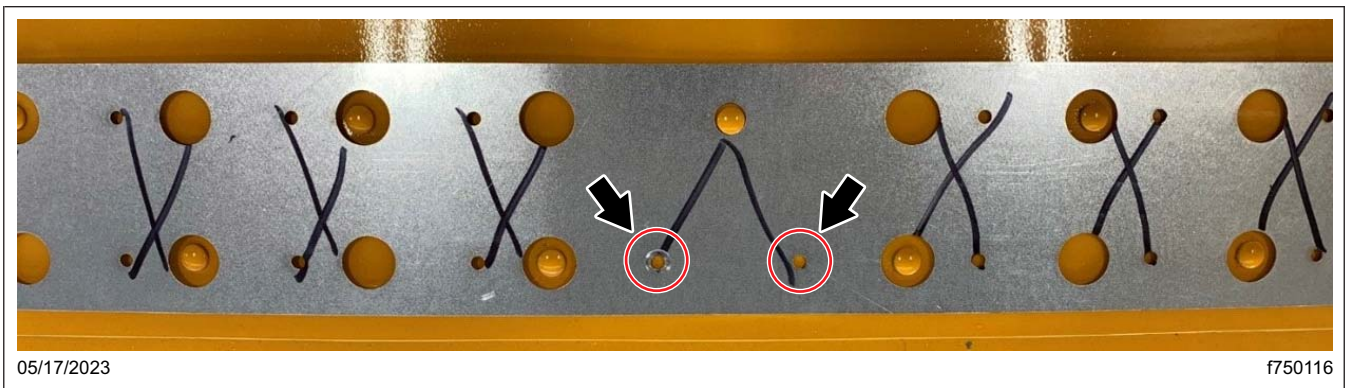
Fig. 12, Two Marked Locations Connected to the Center Rivet

16. The center rivet has two marked locations, connected by lines. See [Fig. 12](#).

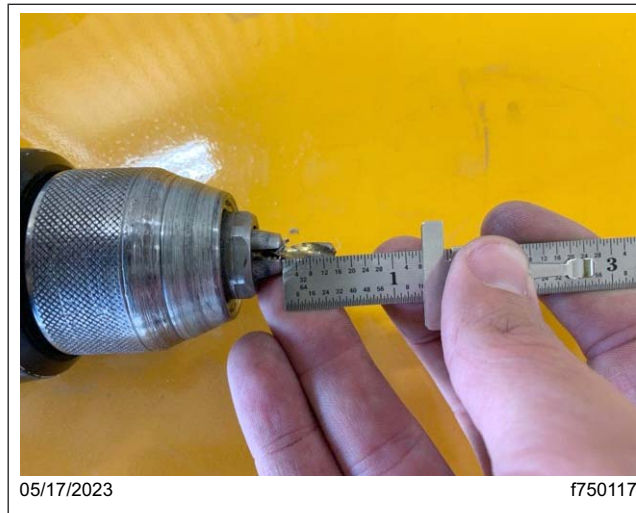
Fig. 13, Corded Drill with 3/16-Inch Drill Bit

17. Once all pilot holes are marked, remove the fixture. Make sure the number of markings is equal to 28.
18. Use a 3/16-inch drill bit and a drill stopper along with a corded drill to drill 1/2-inch deep holes in all the marked locations. See [Fig. 13](#).

32. Once all pilot holes are marked, remove the fixture.
33. Use a 3/16-inch drill bit and a drill stopper along with a corded drill to drill 1/2-inch deep holes in all the marked locations. See [Fig. 13](#).

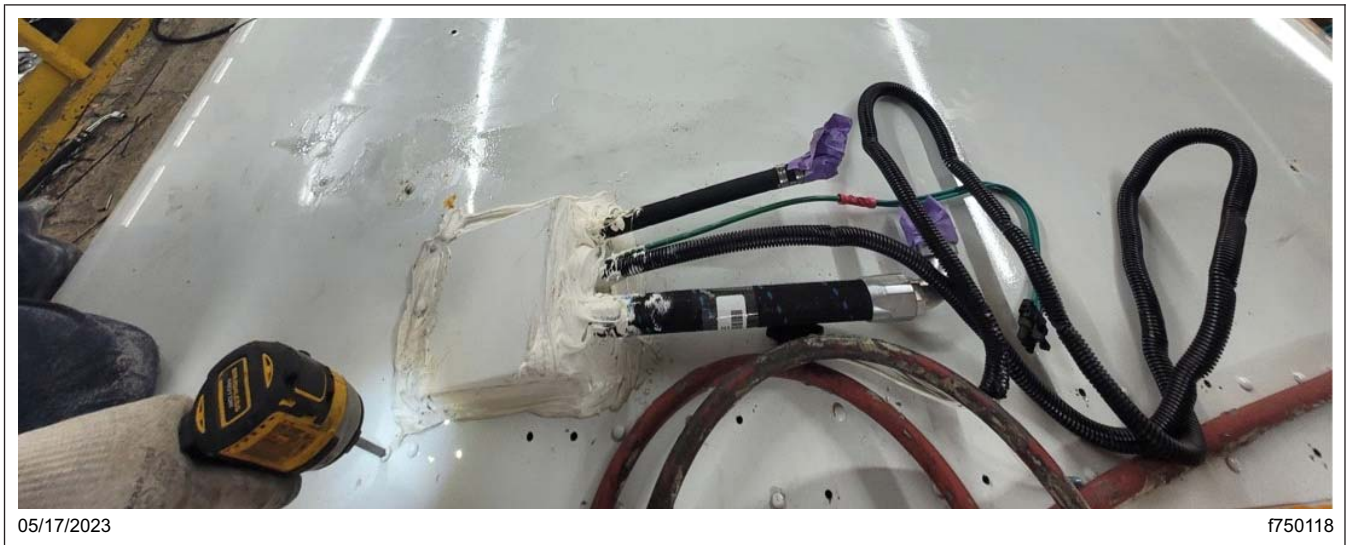
Fig. 14, Installing the Screws along the Joint

19. Remove any metal chips, and clean the drilled surface with a brush.
20. Install a screw in each pilot hole. See [Fig. 14](#). Verify that 28 screws are added per joint.

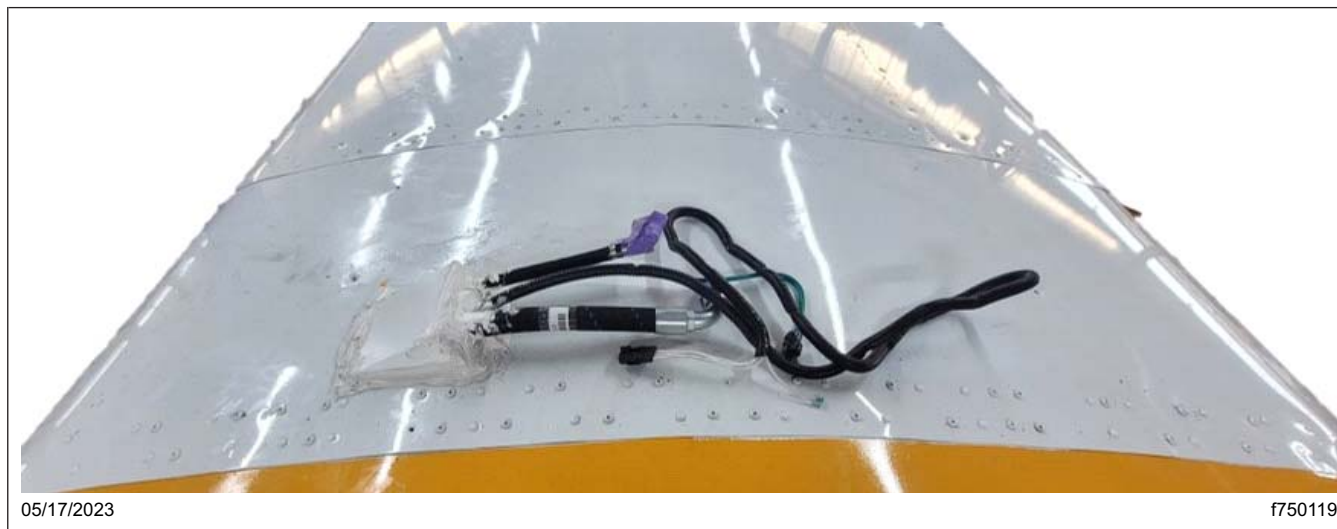
Fig. 15, Cleaned Surface

21. Remove any metal chips, and clean the surface with a cloth. See [Fig. 15](#).

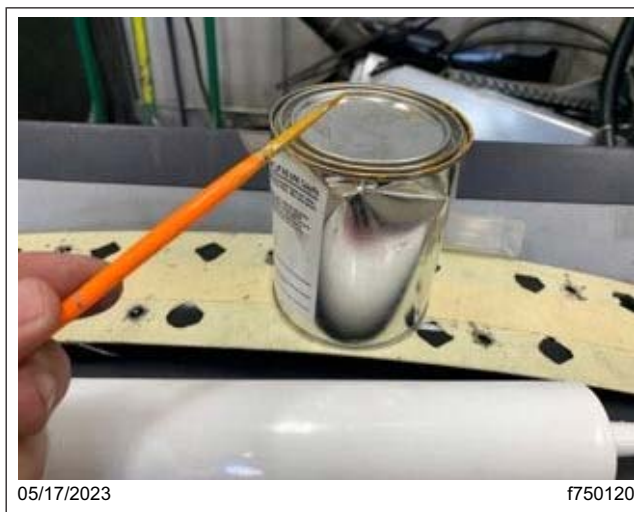
Fig. 16, Paint and Brush

22. Re-paint or touch-up wherever required. See [Fig. 16](#).

- 37. Re-paint or touch-up wherever required. See [Fig. 16](#).
 - 38. Add caulk on every gap between the roof sheets.
- IMPORTANT:** Any eight-inch span of the seam should have a minimum of six fasteners (including rivets and screws), as shown in [Fig. 17](#). If the number of fasteners is less than six, add additional screws wherever required.
- 39. After all roof joints are repaired, install the A/C, if so equipped. Evacuate and recharge the refrigerant.
 - 40. Connect the negative battery cables to the battery.
 - 41. Turn the MPDS to the ON position. Repair complete.

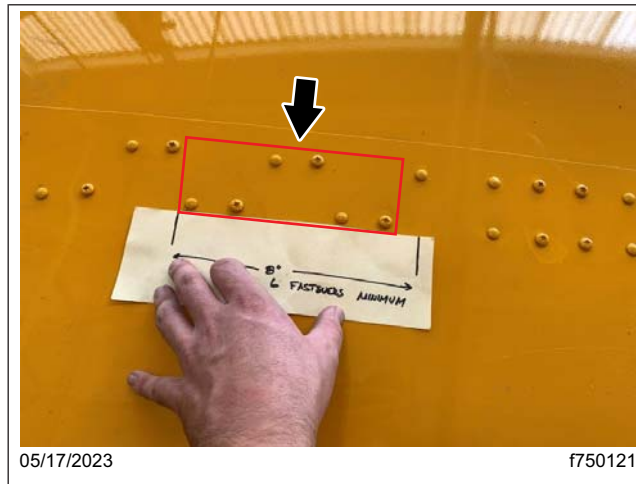
Fig. 17, Six Fasteners Installed in an Eight-Inch Span

IMPORTANT: Any eight-inch span of the seam should have a minimum of six fasteners (including rivets and screws), as shown in [Fig. 17](#). If the number of fasteners is less than six, add additional screws wherever required.

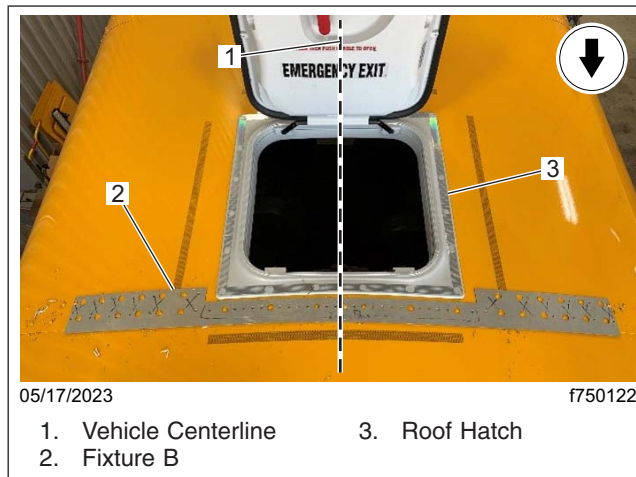
Fig. 18, Roof Hatch Joint Repair

25. Fixture B and fixture C are used to repair roof joints that have a roof hatch, as shown in [Fig. 18](#). Depending on the number of rivets at the centerline of the vehicle roof, the appropriate fixture is determined.

26. Position the appropriate fixture over the center rivet(s) of the roof joint on the vehicle. See [Fig. 18](#).

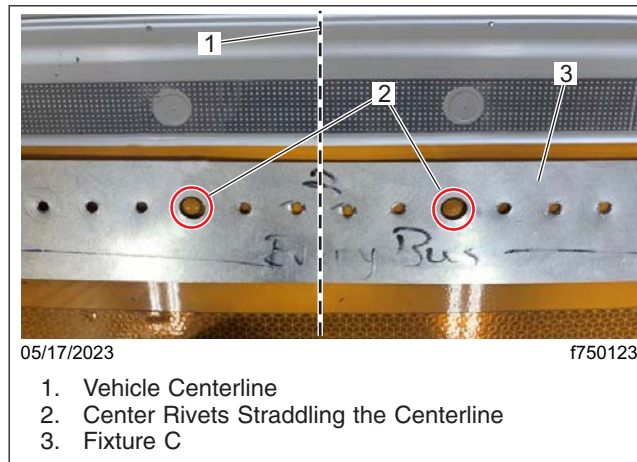
Fig. 19, Two Rivets Straddling the Centerline

27. The center rivet(s) should fit securely in the medium-sized hole, located near the center of each fixture, as shown in **Fig. 19**.

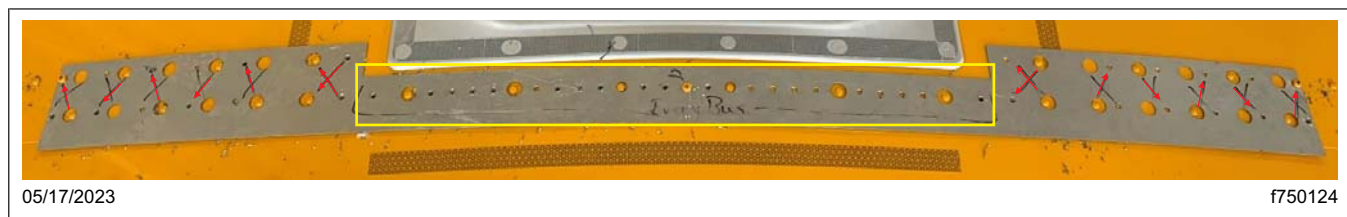
Fig. 20, Identifying the Marking Locations

Do not mark every hole on the fixture. Mark only the holes identified by the arrows and the yellow rectangle in **Fig. 20.**

30. Once the fixture is secured in place, locate the rivets, and follow the arrows to identify the marking locations. See **Fig. 20**. Mark all pilot holes falling in the region identified by the yellow rectangle. Use a Sharpie marker to mark the pilot holes for drilling the holes in the roof.

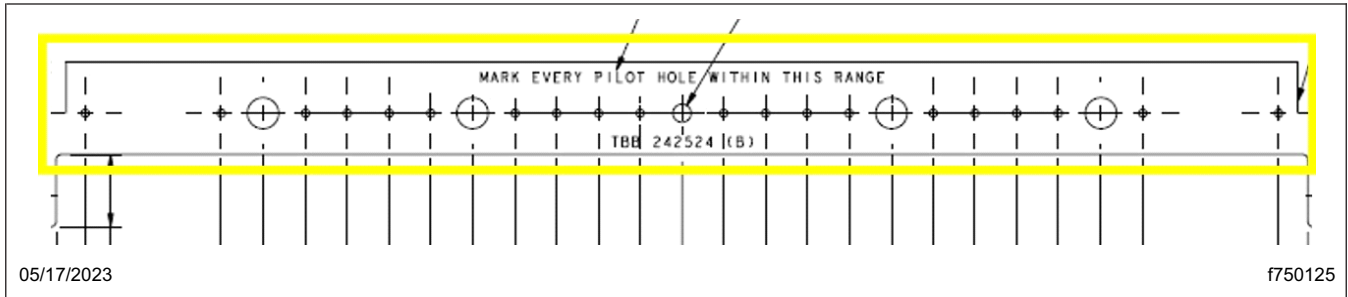
Fig. 21, Region Showing all Pilot Holes to be Marked, Fixture B

31. Mark all pilot holes in the region indicated by 'MARK EVERY PILOT HOLE WITHIN THIS RANGE.' See [Fig. 21](#) for fixture B, and [Fig. 22](#) for fixture C.

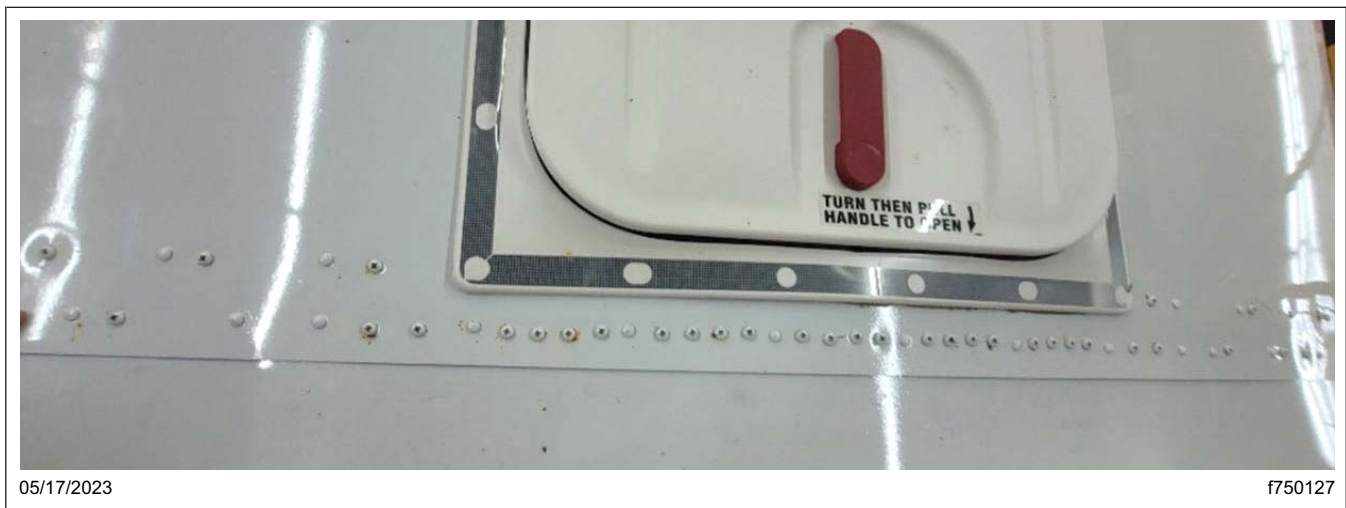
Fig. 23, Additional Screws Installed

- 34. Remove any metal chips, and clean the drilled surface with a brush.
- 35. Install a screw in each pilot hole, as shown in [Fig. 23](#). See [Table 4](#) for the number of screws to be added per joint.

Screw Usage		
Fixture #	Description	No. of Screws
Fixture B	Roof Hatch with One Hole on the Centerline	34
Fixture C	Roof Hatch with Two Holes straddling the Centerline	36
