**TO: Storyteller Overland, LLC Dealers**  
**SUBJECT: NHTSA Recall: 22V-770**

# NHTSA Recall # 22V-770

## Inspection & Repair Instructions

This document provides instructions for inspecting and repairing the wiring for the secondary alternator in accordance with NHTSA recall number 22V-770. Please contact Storyteller should you have any questions or need any assistance with these instructions.

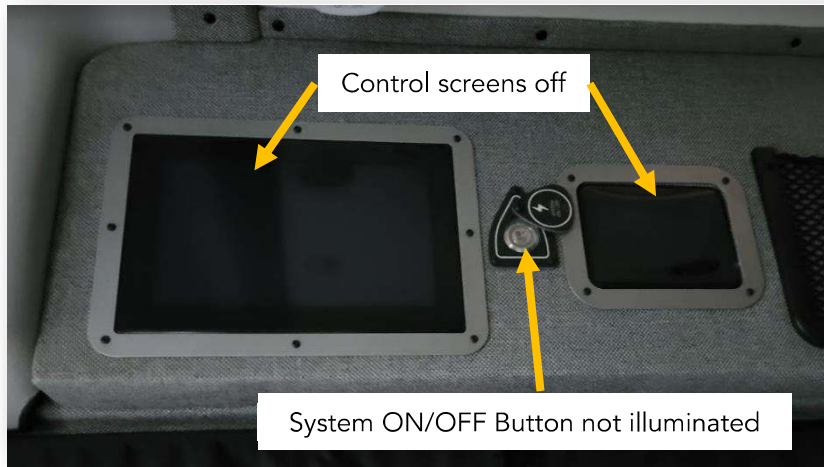
**Figure 1**  
Ensure the Volta system is turned off

1. Ensure the van ignition and the Volta system are turned off. To ensure the Volta system is off, check that the "System On/Off" button is not illuminated and the control screens are off on the wall just above the passenger's side sliding door. Press the "System On/Off" button once to turn off if needed. See figure 1.

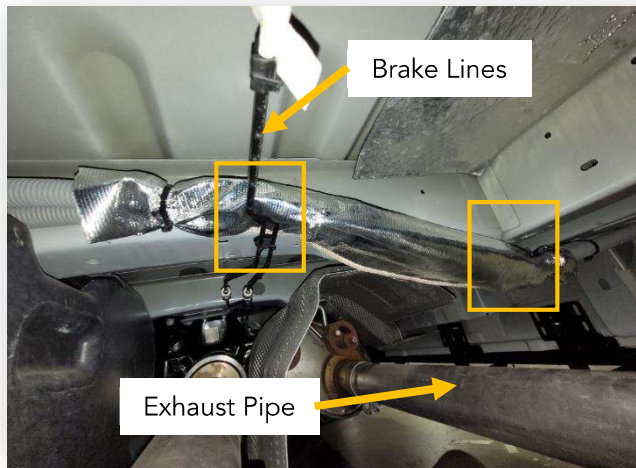
**Figure 2**  
Cables hanging unsupported on the brake lines and above exhaust pipes

2. Access underneath the rear of the van from the passenger side just in front of the rear wheel.  
**NOTE: It is highly encouraged to use a lift for easy access underneath the van.**
3. Locate the 2/0 awg cables wrapped in heat sleeving that are routed across the van floor from the passenger's side to the driver's side above the exhaust pipes, brake lines, driveshaft, etc. Verify the cables are **not** supported above the brake lines and exhaust pipes in the two locations as shown in figure 1 below. If they are **not** supported (such as the cables in figure 2), repair per the procedures in steps 14-16, then proceed to step 4 to continue inspection. If they are supported, continue to step 4.

14. Using one of the supplied heavy-duty cable ties, secure the heat sleeved cables above the brake lines by routing the cable tie through the small hole and out the large hole in the frame crossmember just above the brake lines. Fasten the cable tie around the cables, pull tight, and clip the excess cable tie end off with flush cutters. See figure 11.

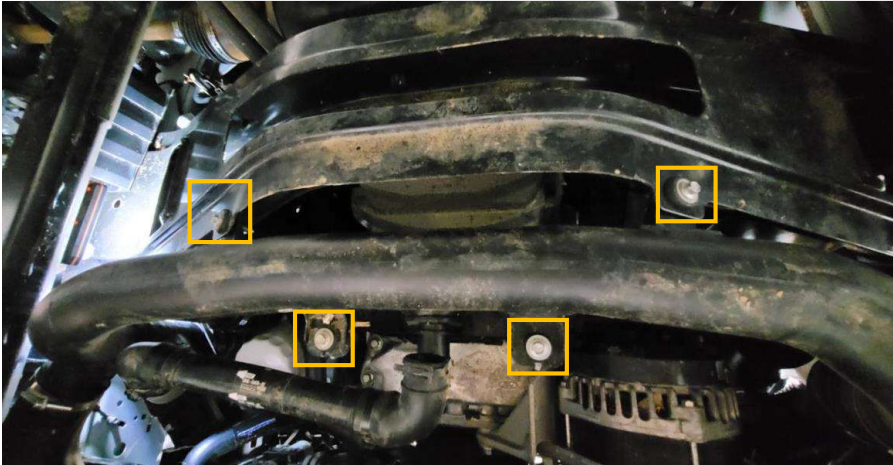
**Figure 3**

5. Use an 8mm socket and ratchet handle to remove the (4) bolts holding the intercooler and charge air pipes to the subframe as shown in figure 3. Set bolts aside for reassembly later.

Remove (4)  
Bolts

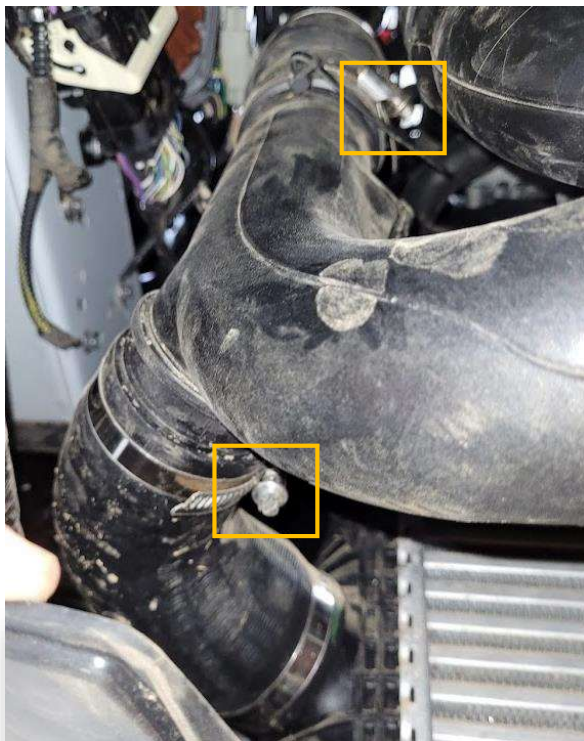
**Figure 4a**

6. Use a 7mm socket and ratchet handle to loosen the hose clamps on the large tube just before the intercooler: (2) clamps on the driver's side and (1) clamp on the passenger's side. See figures 4a and 4b.

Driver's Side – Loosen (2) hose clamps

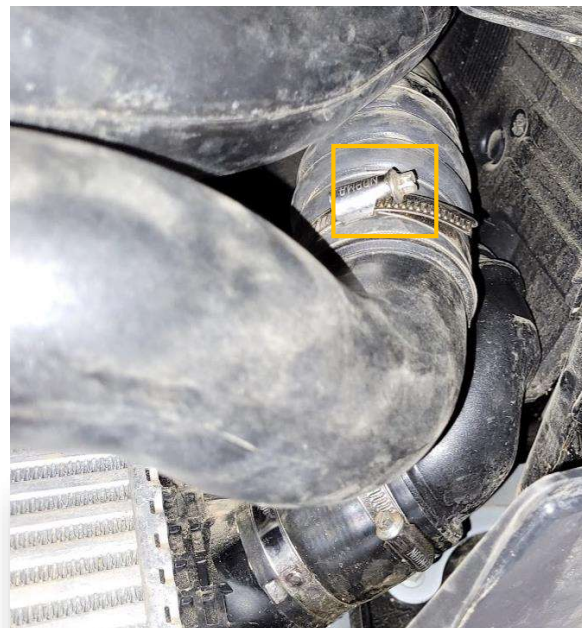
**Figure 4b**

Passenger's Side – Loosen (1) hose clamp

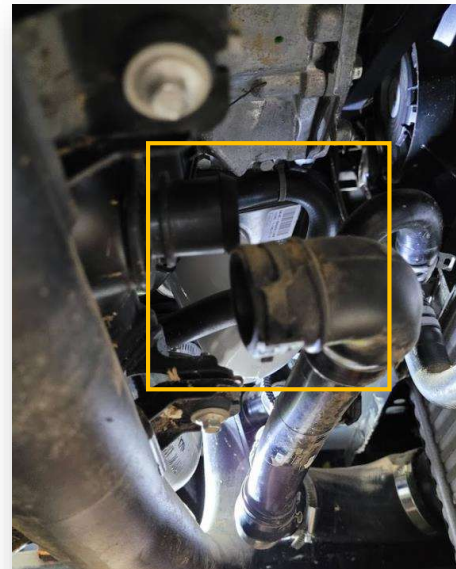
**Figure 5**

7. Use spring clamp pliers to loosen the spring clamp on the recirc hose and disconnect the hose from the front side of the charge air pipe tube. See figure 5.
8. Disconnect harness connector on the driver's side of the recirc hose and use a trim removal tool to pull out the cable tie mount securing the harness. See figure 6. Then, remove the intercooler pipe and set aside

Loosen spring clamp and disconnect hose

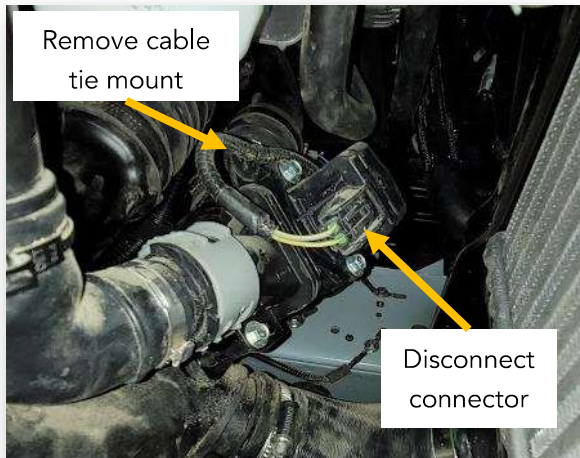
**Figure 6**

Disconnect connector and remove cable tie mount

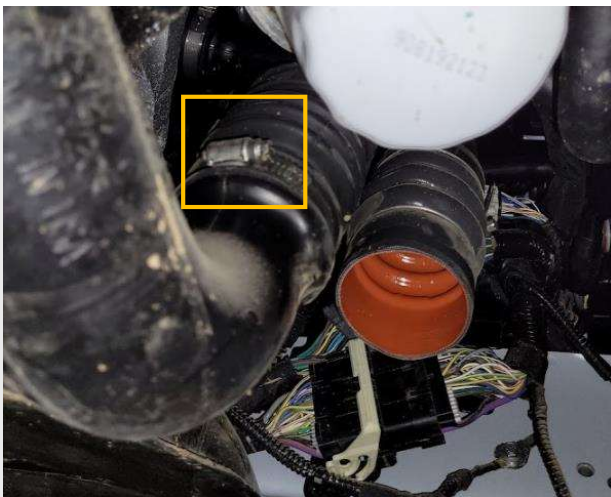
**Figure 7a**

9. Use a 7mm socket and ratchet handle to loosen the hose clamps on the charge air pipe: (1) clamp on driver's side and (1) clamp on passenger's side. See figures 7a and 7b. Then, remove the charge air pipe and set aside

Loosen hose clamp on driver's side

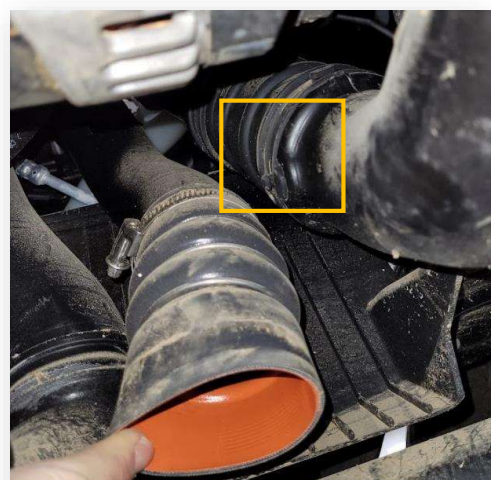
**Figure 7b**

Loosen hose clamp on passenger's side

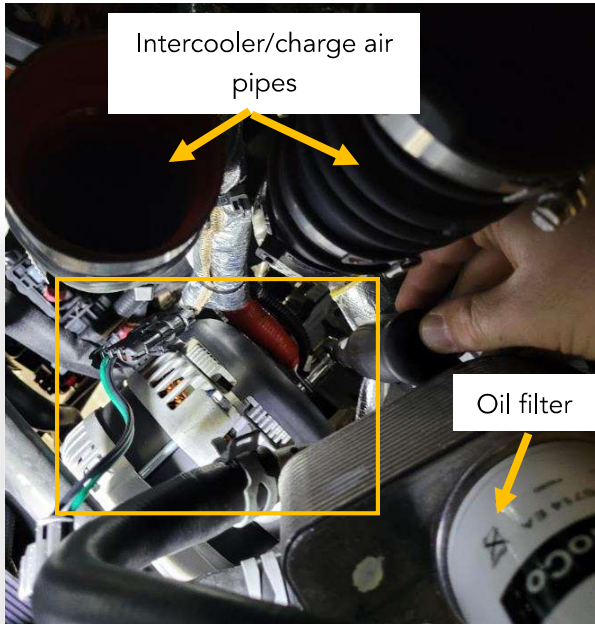
10. Cut any cable ties that secure the secondary alternator wiring (consisting of positive 2/0 awg cable, ground 2/0 awg cable, 58V ALT harness branch, ALT harness branch, and autostart harness branch) in place along the way from the front of the fuel tank to the end of the wiring.
11. Disconnect the "ALT" harness branch connector from the port at the top of the secondary alternator. Use a 13mm socket and small ratchet handle to remove the positive 2/0 awg cable and "58V ALT" harness branch from the alternator post. Set nut aside. The post is easily accessed from underneath the van and reaching up in between the intercooler/charge air pipes and the oil filter. See figures 8a and 8b

**Figure 8a: View from bottom**  
Locate secondary alternator and disconnect wiring

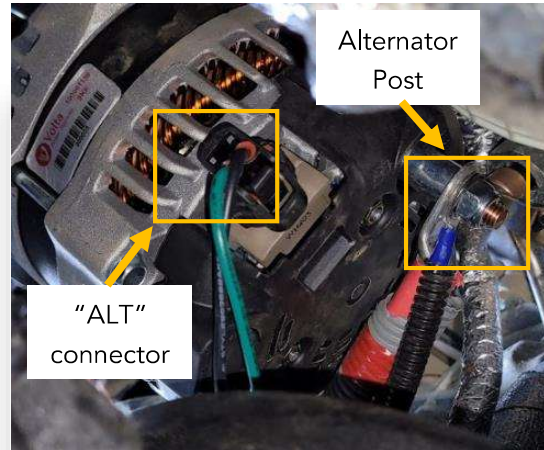
**Figure 8b: View from top**  
Locate secondary alternator and disconnect wiring

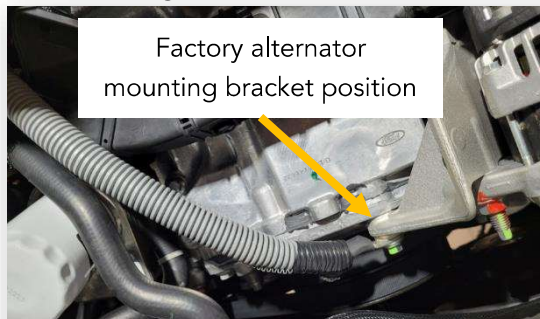
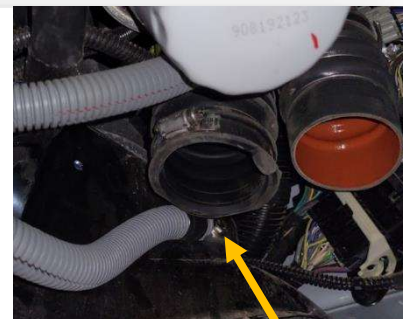
**Figure 9**  
Disconnect ground cable

12. Disconnect the ground 2/0 awg cable from the factory alternator's mounting bracket located toward the passenger's side using a 10mm socket and ratchet handle. Once cable is removed, reinstall bolt and **torque to 18 ft-lbs**. Note: If the cable is not found on the factory alternator, it may instead be fastened to the driver's side chassis subframe. If that is the case, remove the cable from the subframe and touch up the scuffed-up area with automotive black paint as needed. See figure 9

Grounded to subframe

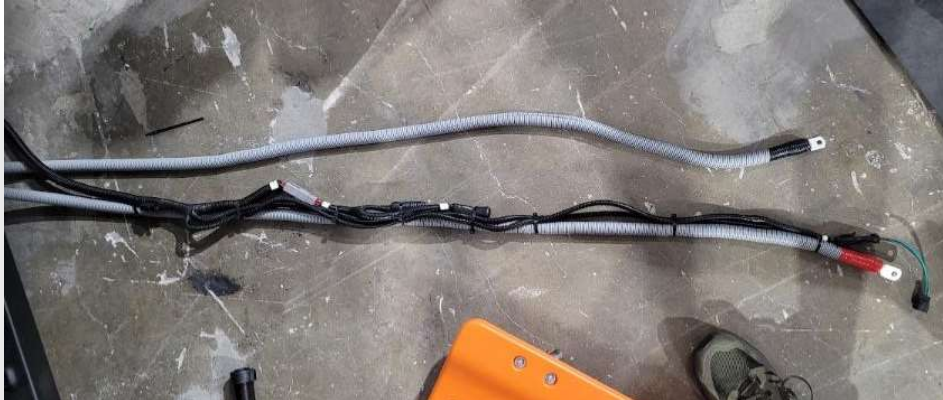
**Figure 10**

13. With all of the secondary alternator wires loose, pull the wiring out from under the chassis all the way back to the front of the fuel tank so the wiring can be inspected as shown in figure 10. Remove any existing heat sleeving from this section of the wiring. Fully inspect the condition of all wire loom, cable lugs, ring terminals, and harness connectors looking for signs of thermal and/or mechanical damage of any kind.

Remove wiring from chassis all the way back to front of fuel tank.  
Inspect for damage

**NOTE: If any damage is found, document and provide Storyteller Overland with pictures of all damage and contact Storyteller Overland for further instruction to repair the damaged wires/components. If no thermal or mechanical damage is found, proceed to step 17 for the remaining repair procedure.**

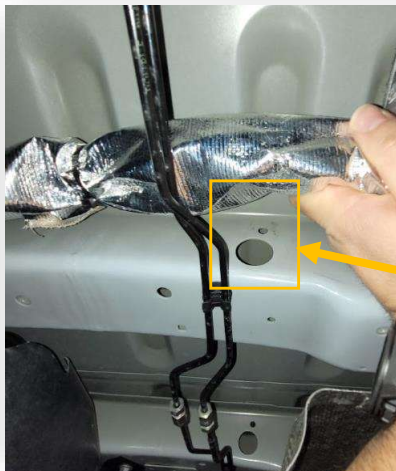
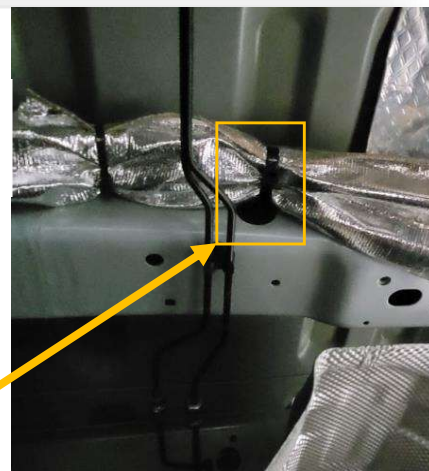
**Figure 11**

Secure cables above brake lines with a heavy-duty cable tie.

Use these holes in the crossmember

Should look like this after step 14

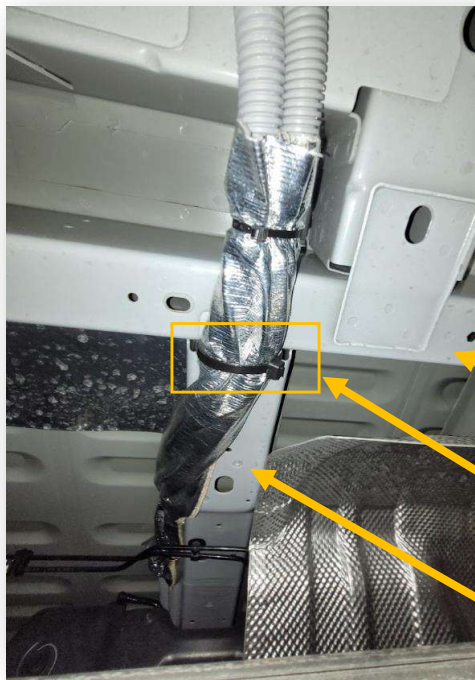
**Figure 12**

Fasten cable tie through the opening where the frame crossmember meets the frame rail, then around the cables

Frame Rail

Install and fasten cable tie

Frame Crossmember

15. Route another heavy-duty cable tie through the opening where the frame crossmember meets the frame rail on the passenger's side of the brake lines from the previous step. Fasten the cable tie around the cables, pull tight, and clip the excess cable tie end off with flush cutters. See figure 12.

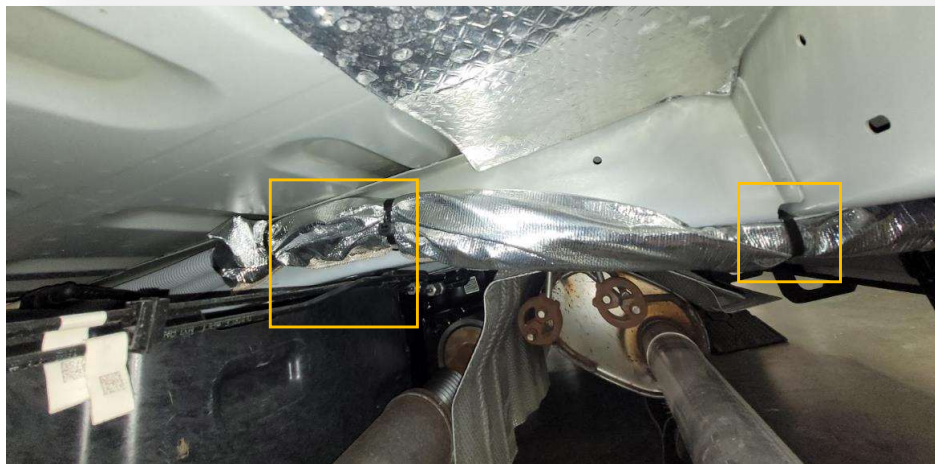
**Figure 13**

Harness now secured above brake lines and exhaust components

16. The cables should now be secured above the brake lines and exhaust components as shown in figure 13.

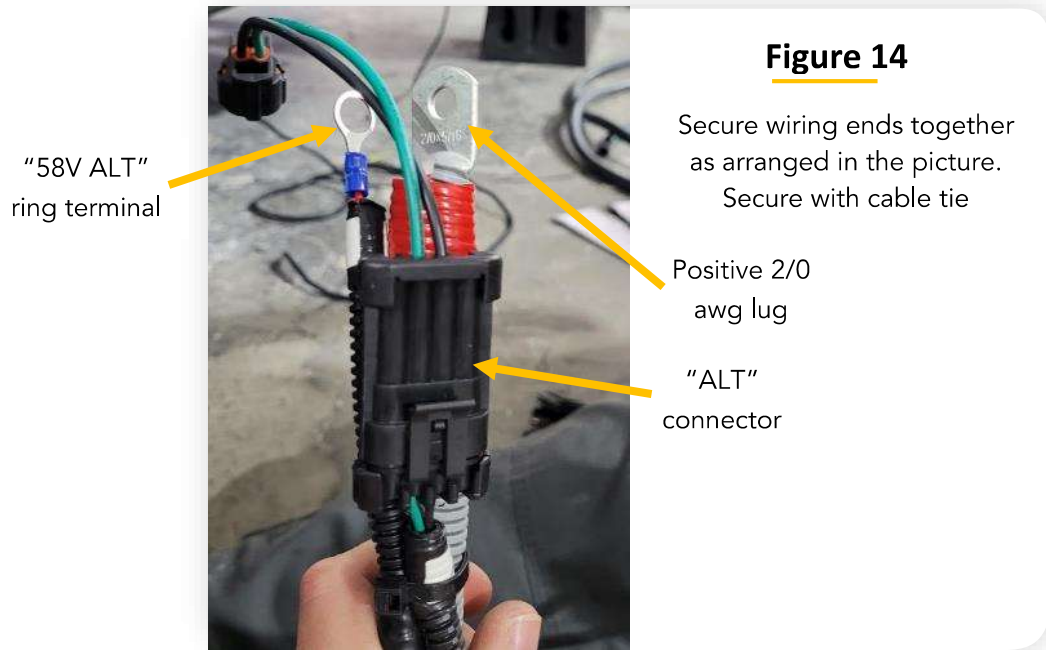
17. Hold the ends of the "58V ALT" harness and the positive 2/0 awg together so the ring terminal/lug can be overlapped. Then hold the "ALT" harness branch connector about 1" back from the cable lug. Secure wiring with a cable tie. See figure 14.

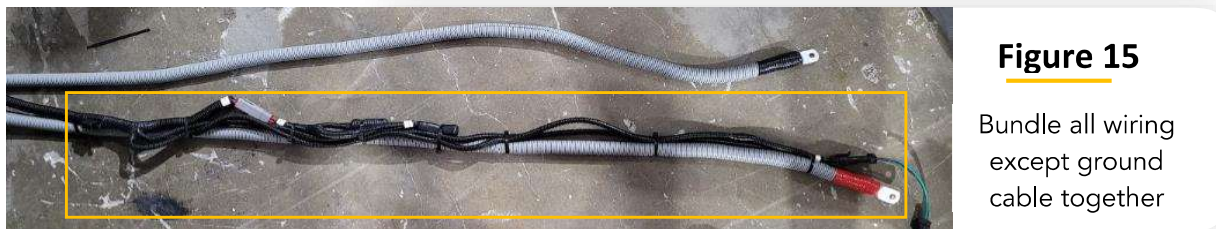
18. Use about (7) more cable ties to bundle the positive 2/0 awg cable with the other harness branches back to where the autostart harness branches out. NOTE: Leave the ground 2/0 awg cable separate. See figure 15.

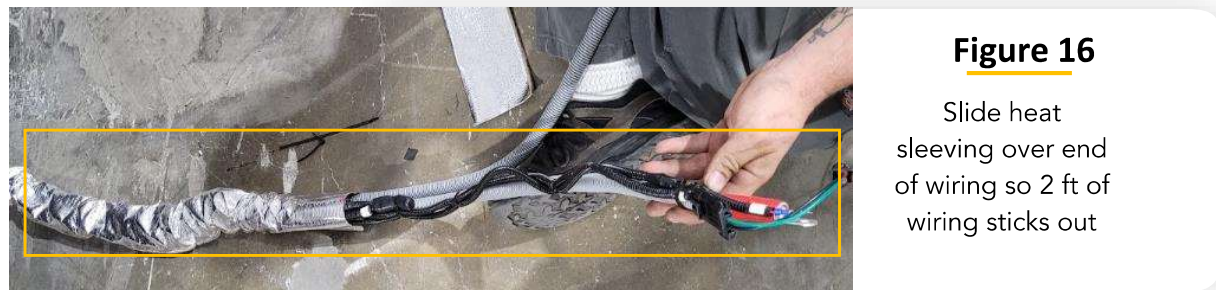
19. Cut a 66" long section of heat sleeving and slide onto the wiring (including the ground cable) until about 2 feet of wiring extends out the end of the heat sleeving. See figure 16.

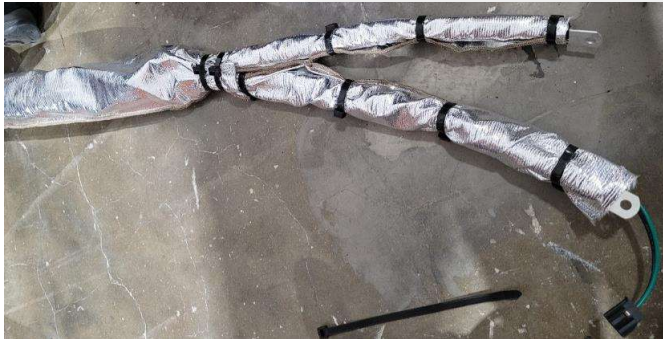
**Figure 17**

Slide 18" sections of heat sleeving over ends of wiring and secure with cable ties. Then overlap the end of the 66" heat sleeve section on top and secure with cable tie

20. Cut and install an 18" section of heat sleeving over the ground cable and the positive cable bundle so the sleeving stops just before the cable lugs. Secure the sleeving to the cables with cable ties. Then slide the end of the 66" section of heat sleeving just past the end of the two 18" sections and secure both ends of the 66" section with a cable tie. See figure 17.

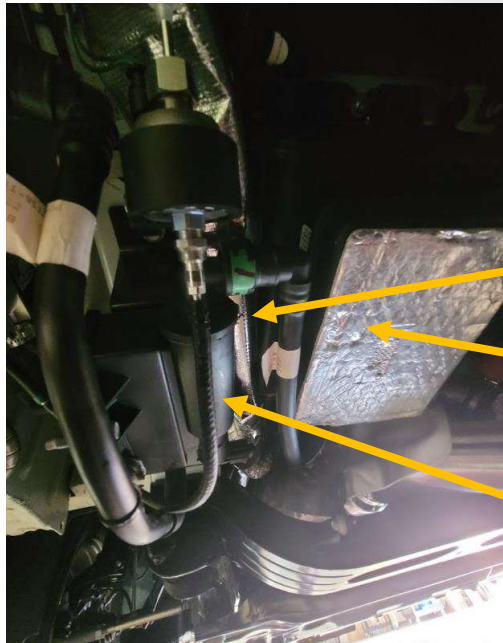
**Figure 18**

Route wiring along bottom of frame rail between the evap pump and evap canister

Wiring bundle

Evap canister

Evap Pump

21. Begin routing the wiring bundle from the front of the fuel tank forward along the bottom of the frame rail. The wiring should pass over the evap lines and between the evap canister and the evap pump. See figure 18

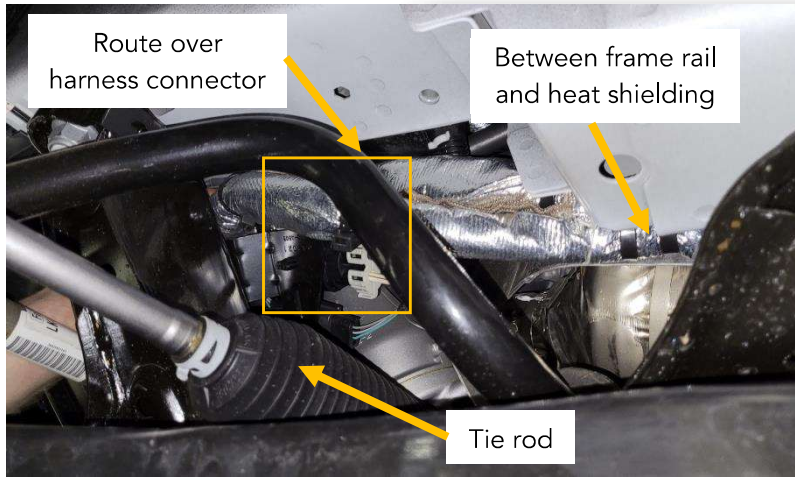
**Figure 19**

Route wiring between frame rail and heat shielding, then above harness connector that is above the tie rod

22. Continue routing the wiring forward between the frame rail and exhaust heat shielding toward the front CV axle shaft. Make sure the bundle goes above the factory harness connector mounted just above the tie rod. See figure 19

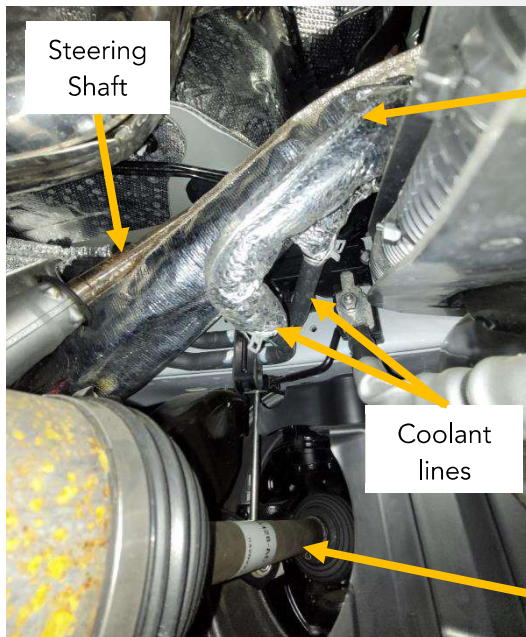
**Figure 20**

Route over frame crossmember

Ensure wiring runs along the frame rail, between the steering shaft and CV axle shaft then over the frame crossmember between the engine mount and frame rail.

CV Axle Shaft

23. When at the front CV axle shaft, run the wire bundle under the steering shaft then over the two factory coolant lines. Route the wiring between the frame rail and driver's side engine mount on top of the frame crossmember. See figure 20

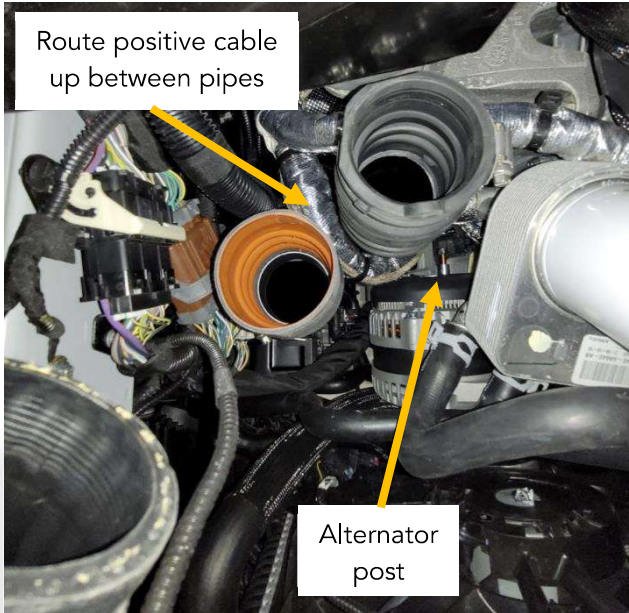
**Figure 21a**

Route positive cable bundle up between the charge air and intercooler pipes toward the alternator post

24. The loose ends of the wiring bundle should now be coming down near the driver's side intercooler and charge air piping. Route the positive cable bundle up between the pipes and toward the secondary alternator as shown in figure 21a. Slide the positive cable lug onto the alternator post first, then the "58V ALT" ring terminal second. Hand start the nut onto the post then **torque to 10.5 ft-lbs** with a 13mm socket and torque wrench. Use a paint pen to torque stripe the nut. Reconnect the "ALT" harness connector to the top of the alternator. See figure 21b.

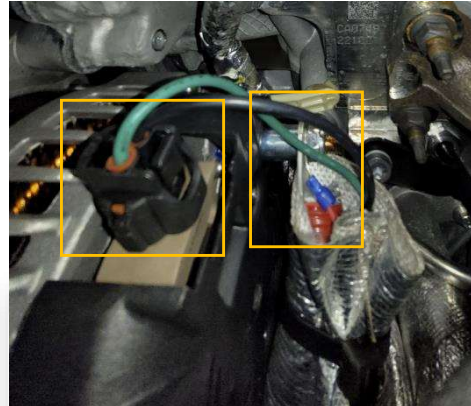
**Figure 21b**

Torque positive cable and "58V ALT" wire to alternator. Connect "ALT" harness connector

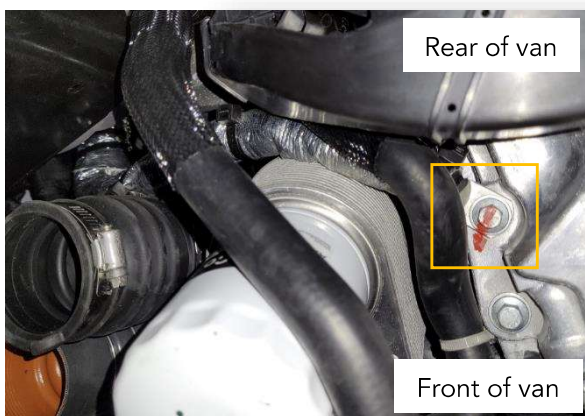
**Figure 22**

Fasten ground cable to oil pan bolt next to oil filter. Torque bolt to 18 ft-lbs and torque stripe

25. Next, route the ground cable over toward the engine. Using a 10mm socket, 3" socket extension and a ratchet handle, remove the rearmost oil pan bolt of the two bolts at the front driver's side corner of the engine next to the oil filter. Fasten the ground cable lug to this location and **torque the bolt to 18 ft-lbs**. Use a paint pen to torque stripe the bolt. See figure 22

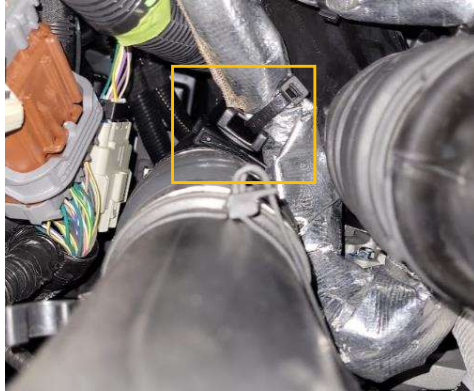
**Figure 23**

Secure wiring to intercooler pipe with dual swivel saddle spacer and cable ties

26. Using a dual swivel saddle spacer and (2) cable ties, secure the wiring to the intercooler pipe. See figure 23

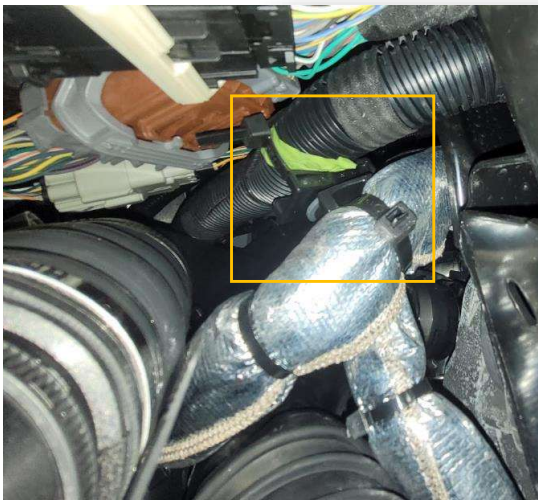
**Figure 24**

Secure wiring to factory harness along frame rail with dual swivel saddle spacer and cable ties

27. Using a dual swivel saddle spacer and (2) cable ties, secure the wiring to the factory harness along the frame rail just in front of the driver's side motor mount where the cables turn upward toward the alternator. See figure 24.

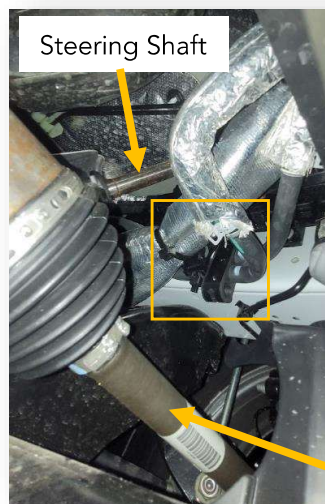
**Figure 25**

Secure wiring to the two coolant pipes above the CV axle shaft with dual swivel saddle spacer and cable ties

28. Use the third dual swivel saddle spacer and (2) cable ties to secure the wiring to the two coolant lines above the driver's side CV axle shaft. Ensure the wiring is pulled away from both the steering shaft and the CV axle shaft. See figure 25

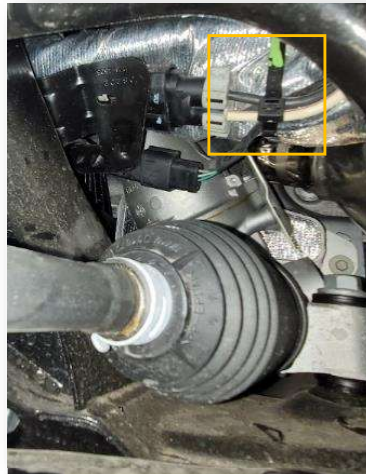
**Figure 26**

Secure wiring to the factory harness above the tie rod with a cable tie

29. Use a cable tie to secure the wiring to the factory harness above the tie rod as shown in figure 26.

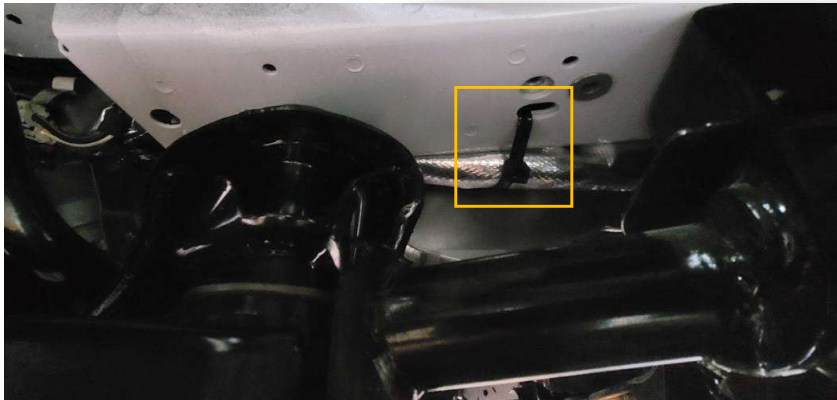
**Figure 27**

Secure wiring to the frame rail with a cable tie

30. Use a cable tie to secure the wiring between the frame rail and exhaust heat shield. As shown in figure 27, route the cable tie through the hole in the bottom of the frame rail then out the inboard side of the frame rail and around the wiring.

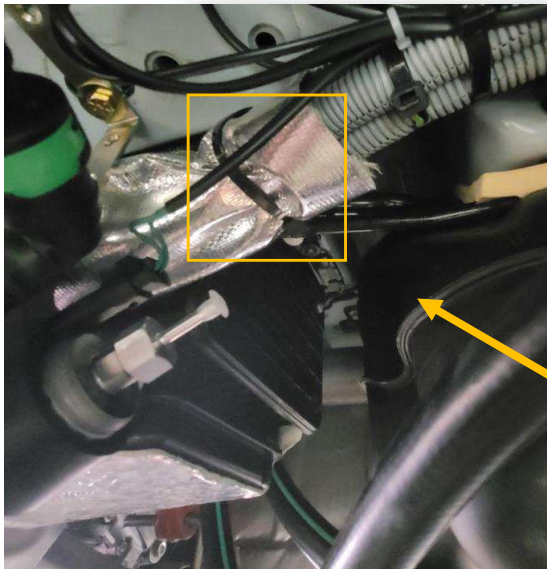
**Figure 28**

Secure wiring with a cable tie to the factory harness that is mounted to the frame rail just in front of the fuel tank

Fuel Tank

31. Use a cable tie to secure the wiring to the factory harness that is mounted to the frame rail just in front of the fuel tank. See figure 28

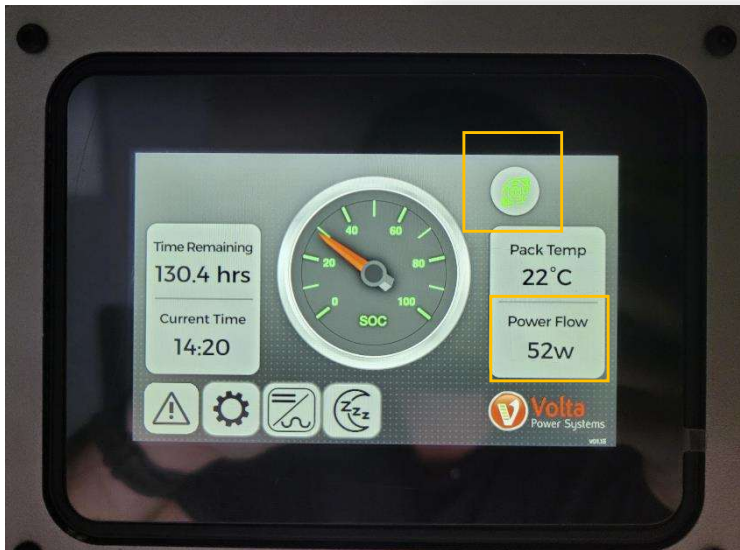
**Figure 29**

If system is working correctly, the green alternator icon shown in the picture will appear on the Volta screen and the power flow reading will be positive
