TO: Mercedes-Benz Dealer Principals, General Managers, Sales Managers, Service Managers, Parts Managers	FROM: Gregory Gunther, Department Manager, Vehicle Compliance and Analysis, Engineering Services
RE: Recall Campaign Launch Notification-STOP DRIVE Replace Rear Axle MY22 AMG G63 4x4 squared (463 platform)	DATE: May 23, 2023

Campaign No. 2023040001, May 2023

SUBJECT: **Model AMG G63 4x4 squared (463 platform)**
Model Year 2022

Replace Rear Axle

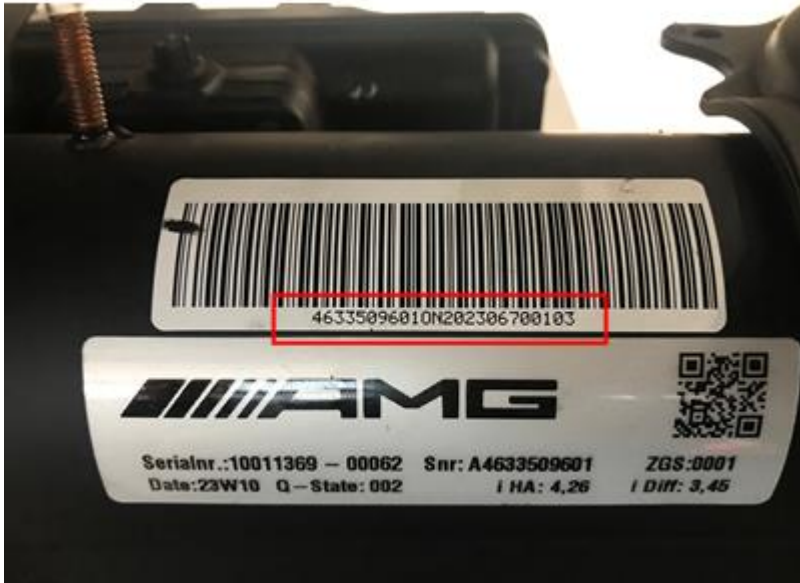
Figure 1

i The **serial number** of the new **rear axle centerpiece (Figure 1)** must be changed in the **VeDoc** system. (XSF ticket has to be created for the VeDoc change)

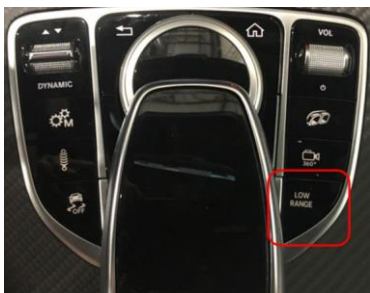
Figure 2

i **To do this,** "Start the engine – Release the parking brake – engage neutral position (N) – Engage Low Range (**Figure 2**) – Engage drive position (D) – engage center differential lock (1) – while wheels are rotating slowly, engage rear axle differential lock (2) – Ensure red confirmation light is illuminated for center and rear differential lock (**Figure 3**) – switch off ignition – disconnect electrical plug on lock actuator of rear axle and leave disconnected (**Figure 4**)."

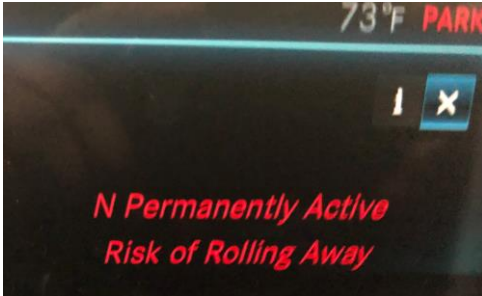
Figure 5

i Attention: The vehicle is now in permanent "N" position (Figure 5).

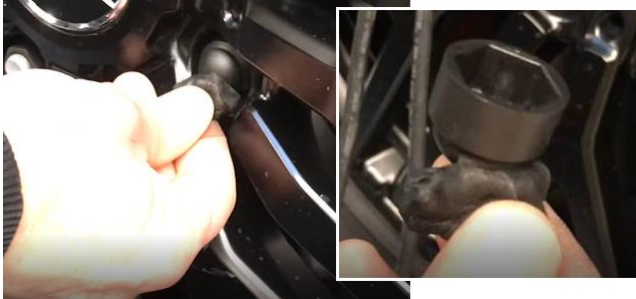
Figure 6

i For basic data, see AR54.10-P-0003XG.
5. Remove cover caps of wheel nuts on all four wheels (**Figure 6**).

i To do this, clean cover caps then press Butyl Tape firmly against the cover cap and pull off the cap.

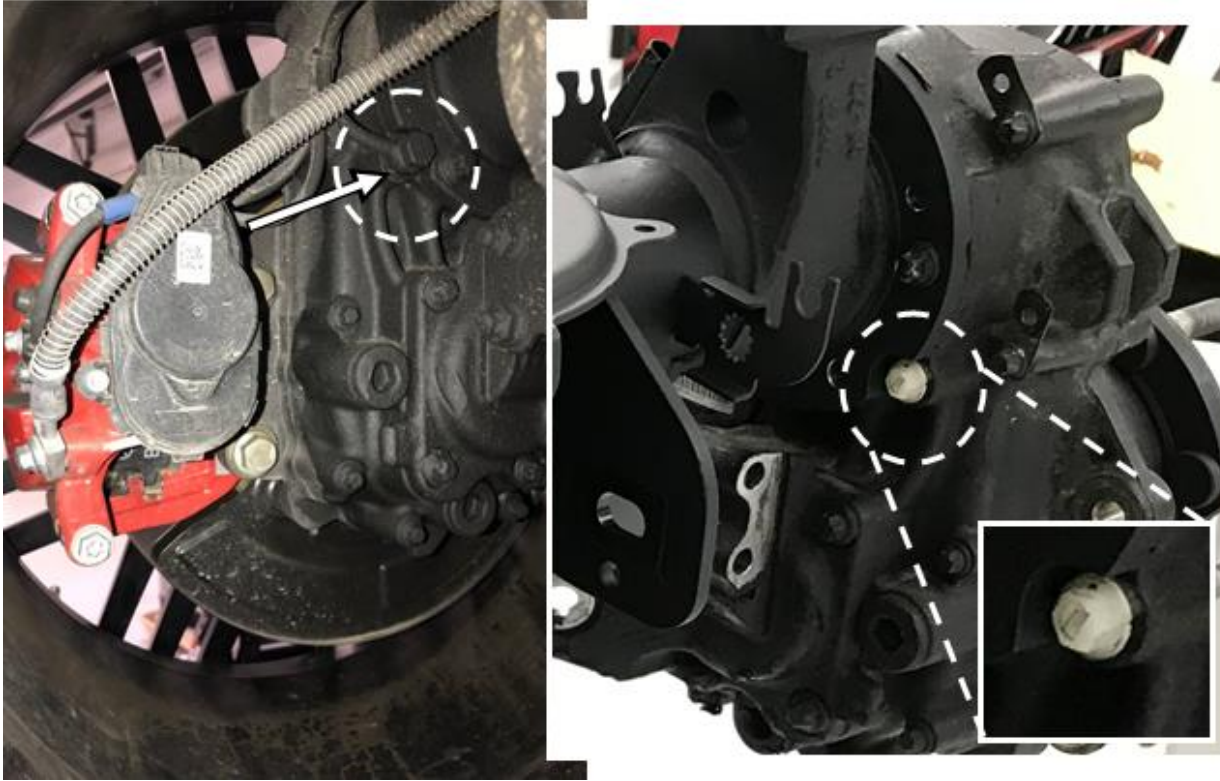
Figure 10

9. Unscrew banjo bolts for bleed lines at left and right rear axle hub reduction gears (**Figure 10**).

Nm M10 bleed line banjo bolt to rear axle hub reduction gear **15 Nm**.

i **Seal thread openings** on rear axle hub reduction gears with suitable stop plug/screw **immediately** to prevent oil from leaking out.

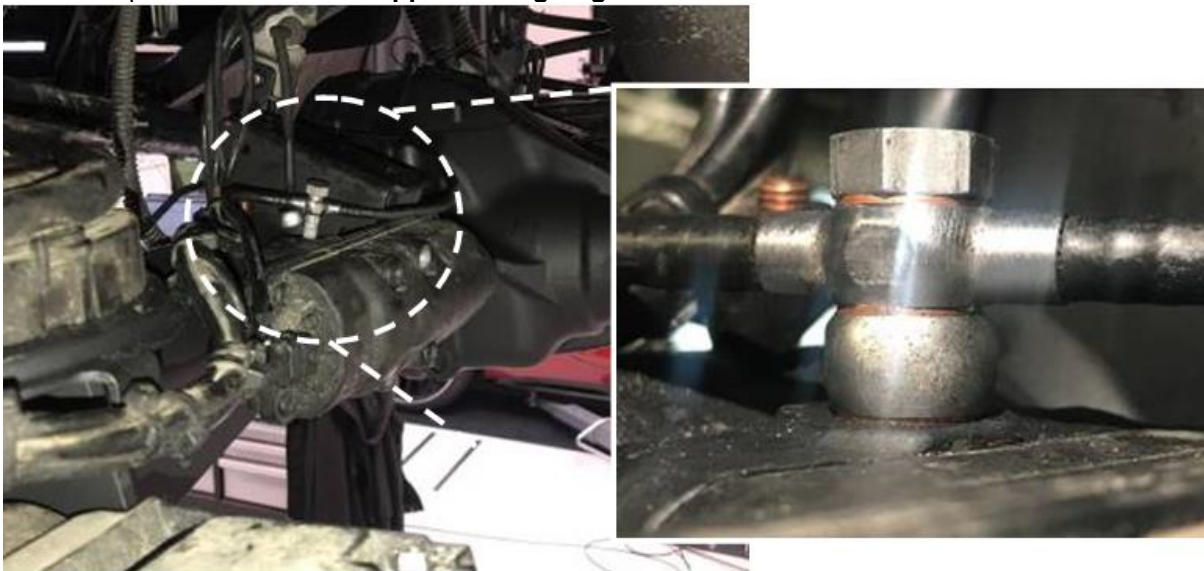
Figure 11

10. Unscrew banjo bolt for bleed lines at axle bridge above lock actuator (**Figure 11**).

Nm M8 bleed line banjo bolt to axle bridge **8 Nm**

i **Seal thread openings** on axle bridge with suitable stop plug/screw **immediately**.

i Important! A total of **3 copper sealing rings** are installed.

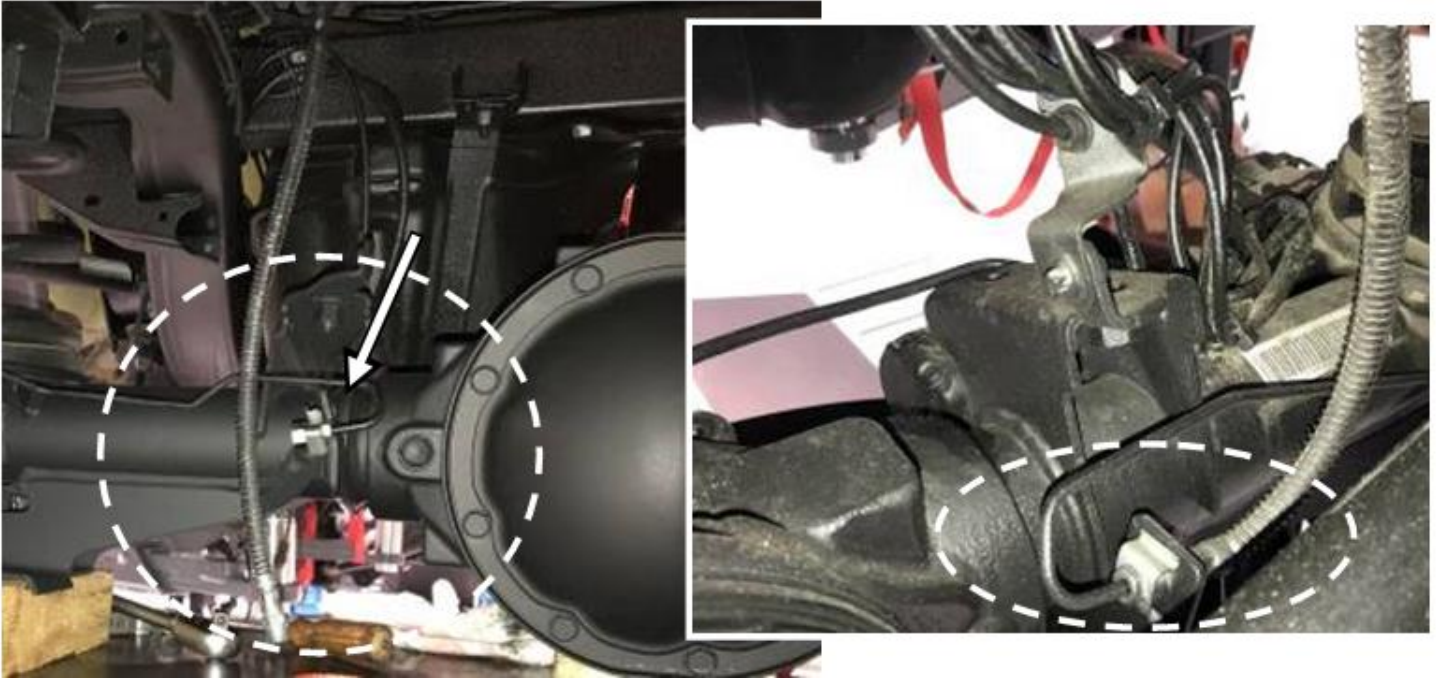
Figure 12

11. Unscrew brake hoses from brake lines on inside of axle (**Figure 12**) and seal open brake lines with suitable stop plugs e.g. W129 589 00 91 10.

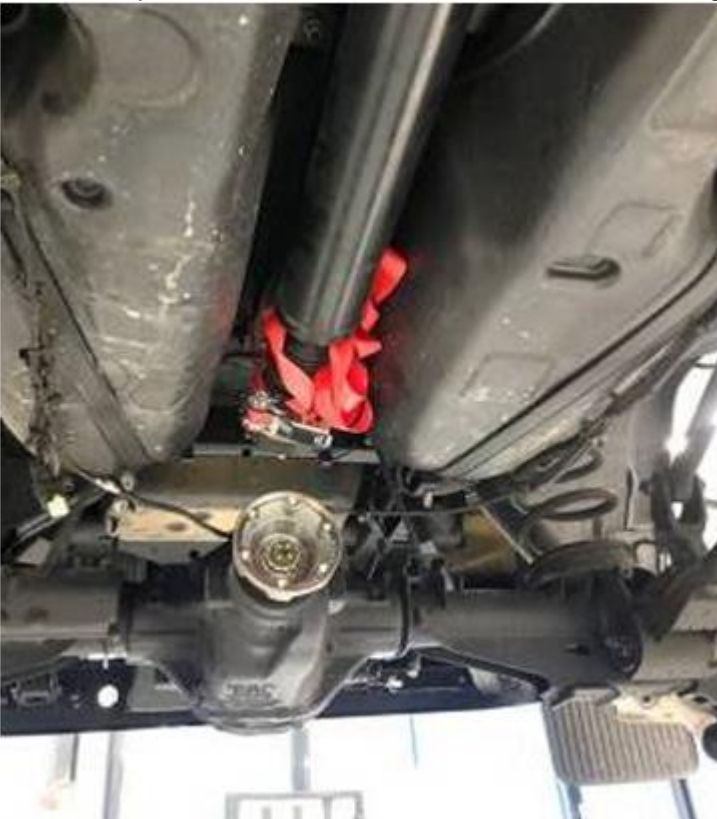
Figure 13

12. Unscrew propeller shaft from rear axle differential, and secure against falling by tying to the top (**Figure 13**).

Nm Propeller shaft screw at rear axle differential **1st stage 40 Nm – 2nd stage 90°**

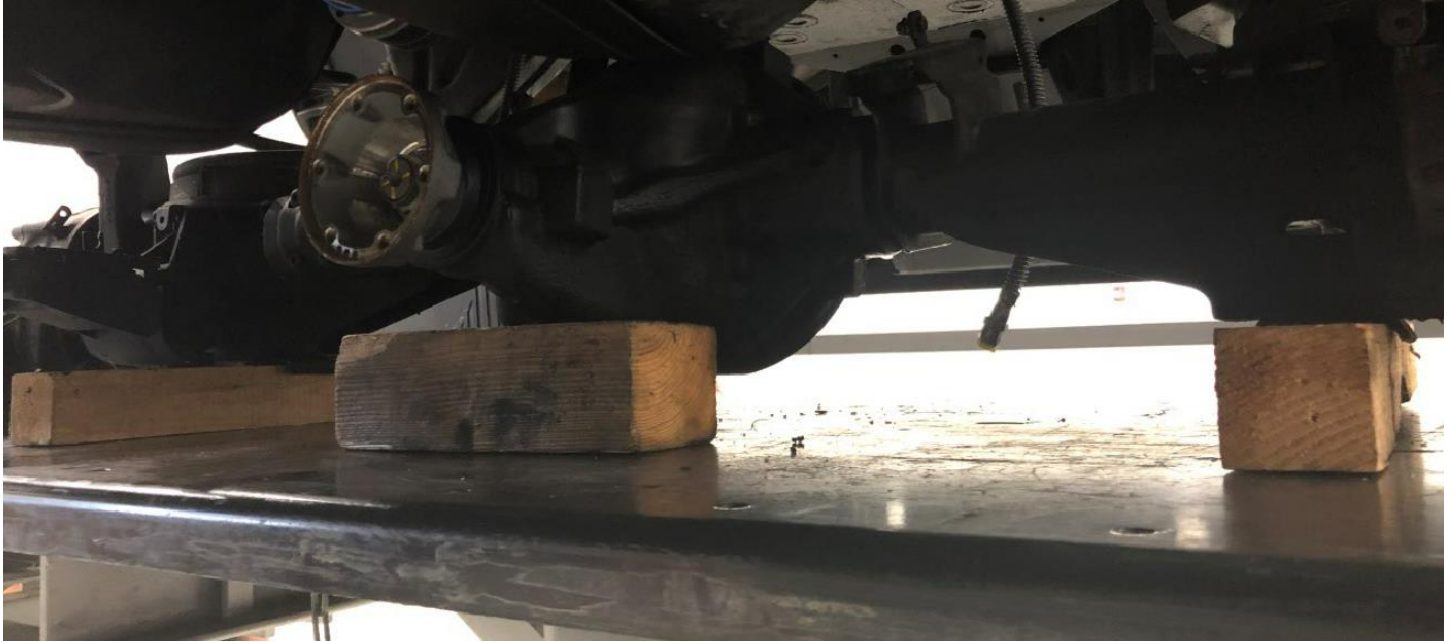
Figure 14

i Place a support block with a width of approx. 5.5 cm (e.g. a hardwood block), under the axle at the left and right and under the center front section of the differential to ensure that the rear axle is evenly supported (**Figure 14**).

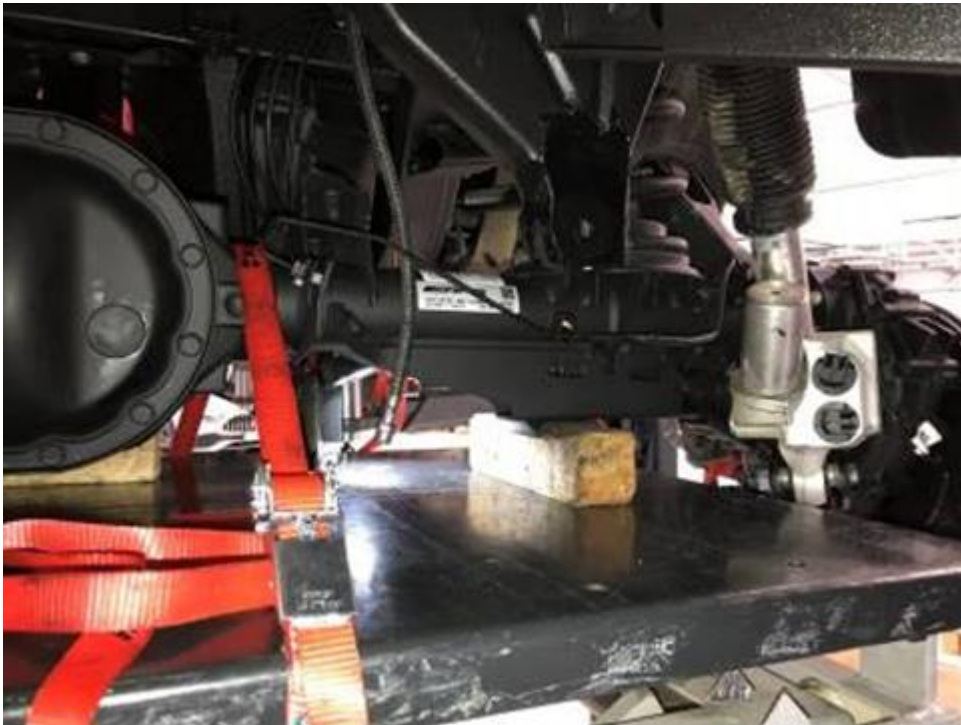
Figure 15

13. Position lift table under rear axle and use tension belt (**Figure 15**) to secure against falling.

i Lift table W 000 588 03 62 00.

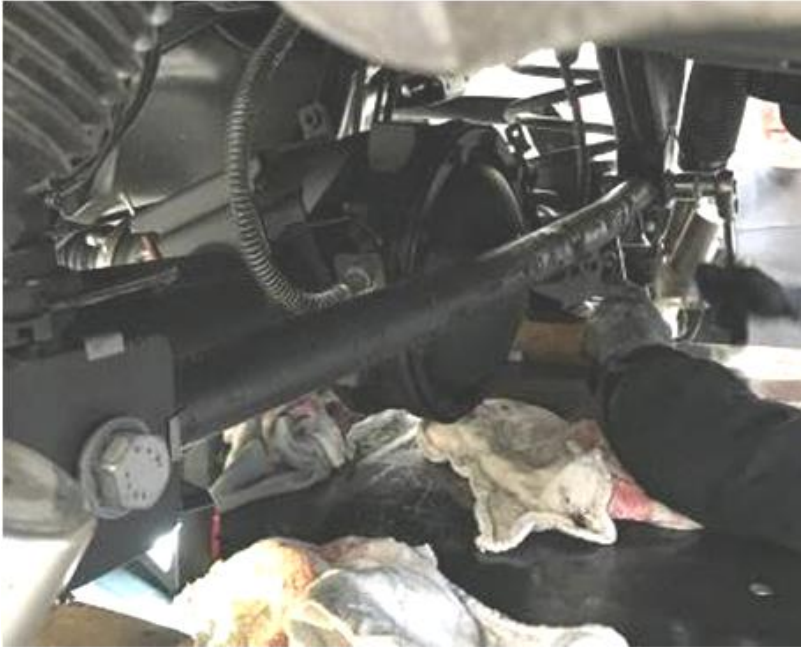
Figure 16

15. Remove transverse control arm of rear axle (**Figure 16**).

Nm Transverse control arm screw to rear axle **1st stage 150 Nm – 2nd stage 90°**

Nm Transverse control arm screw to frame **1st stage 150 Nm – 2nd stage 90°**

i During installation, the transverse control arm at the rear axle must be fit into the bearing using a shim.

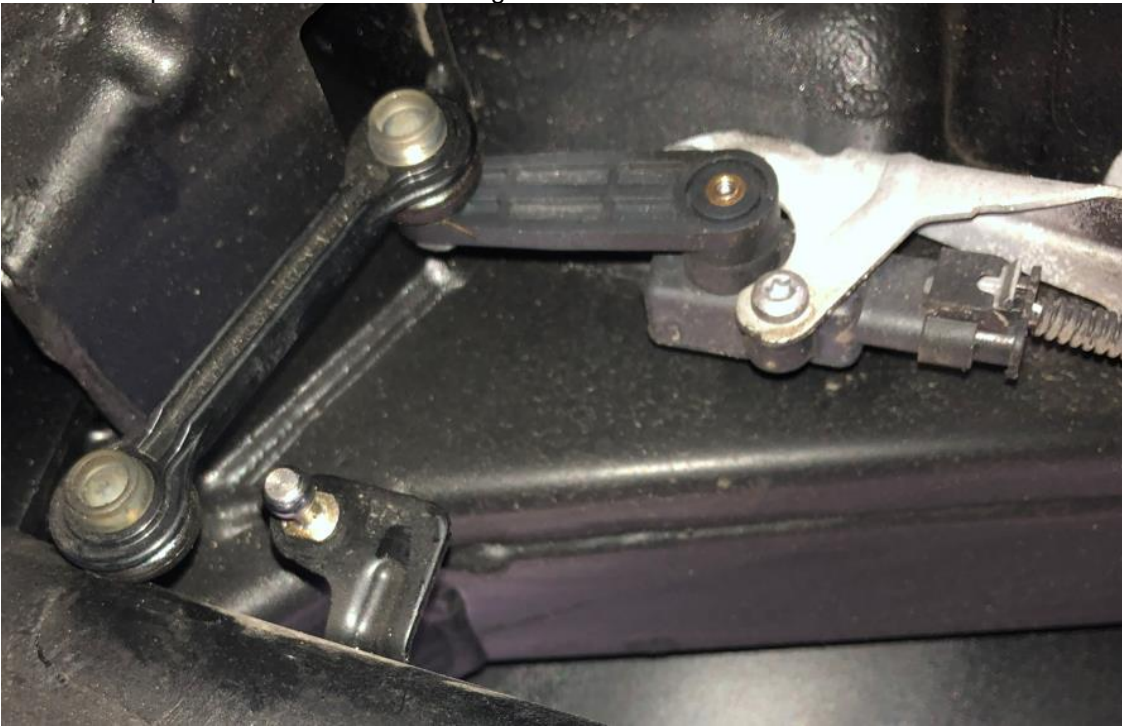
Figure 20

18. Mark adjusting plates for adjusting the drive line angle, disconnect level sensors on trailing arms (**Figure 20**) and unscrew the connection of the rear axle at left and right lower trailing arms (**Figure 21**).

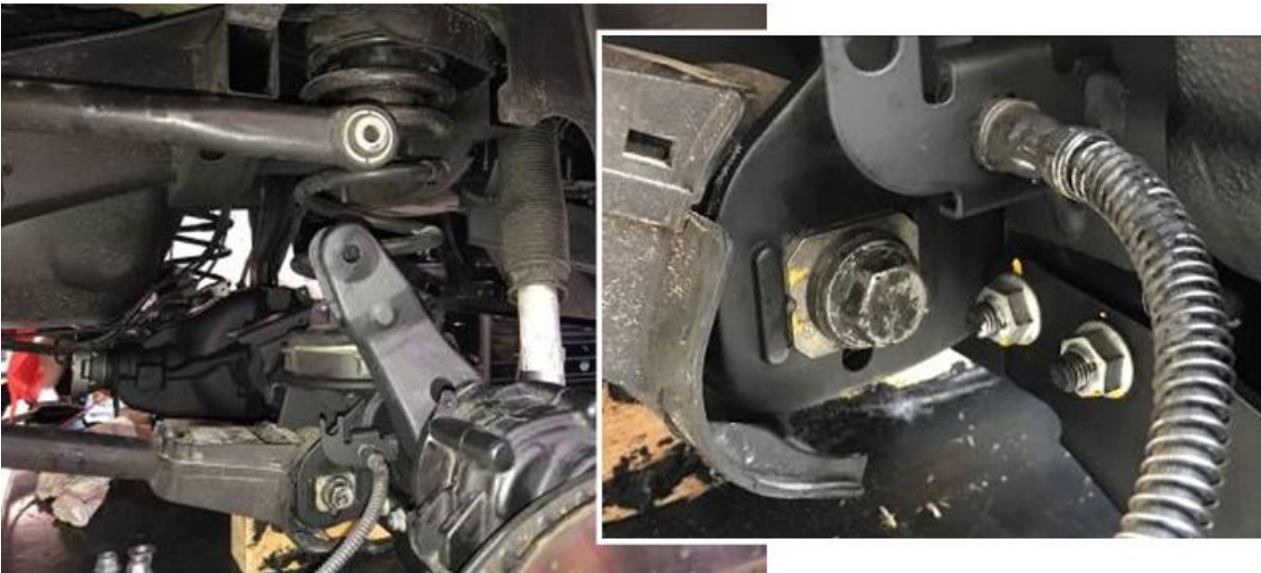
Figure 21

Nm Lower trailing arm screw to rear axle **1st stage 100 Nm – 2nd stage 180°**

i **Important!** Mark adjusting plates and install in the same position on the new axle.

i **Installation:** Install adjusting plates with opening pointing downward.

i **Installation:** The notch on the adjusting plate should point in the direction of travel.

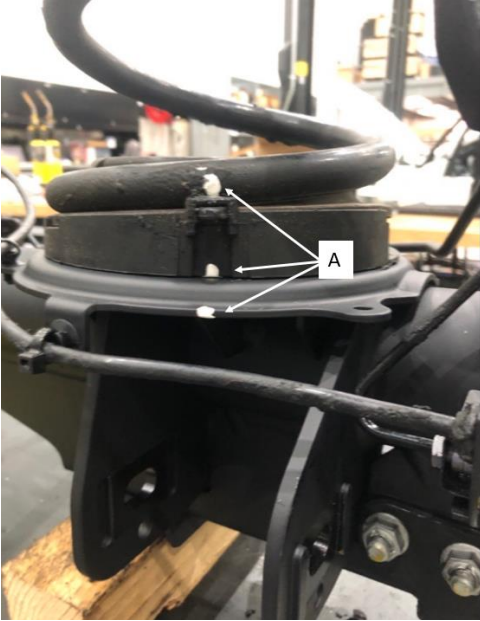
Figure 22

20. Mark the spring and the upper and lower spring retainer then remove the springs completely (**A, Figure 22**).

i **Installation:** Align installation position (**A, Figure 22**).

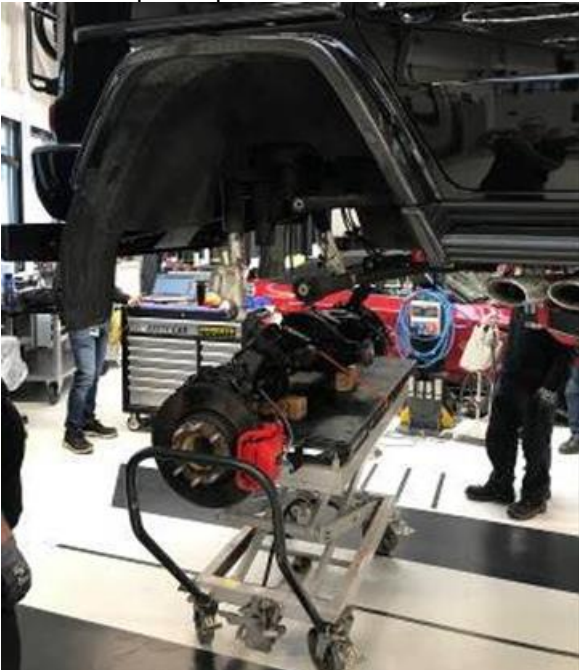
Figure 23

21. Fully lower rear axle and remove from underneath vehicle (**Figure 23**).

i Unthread lower trailing arms while lowering.

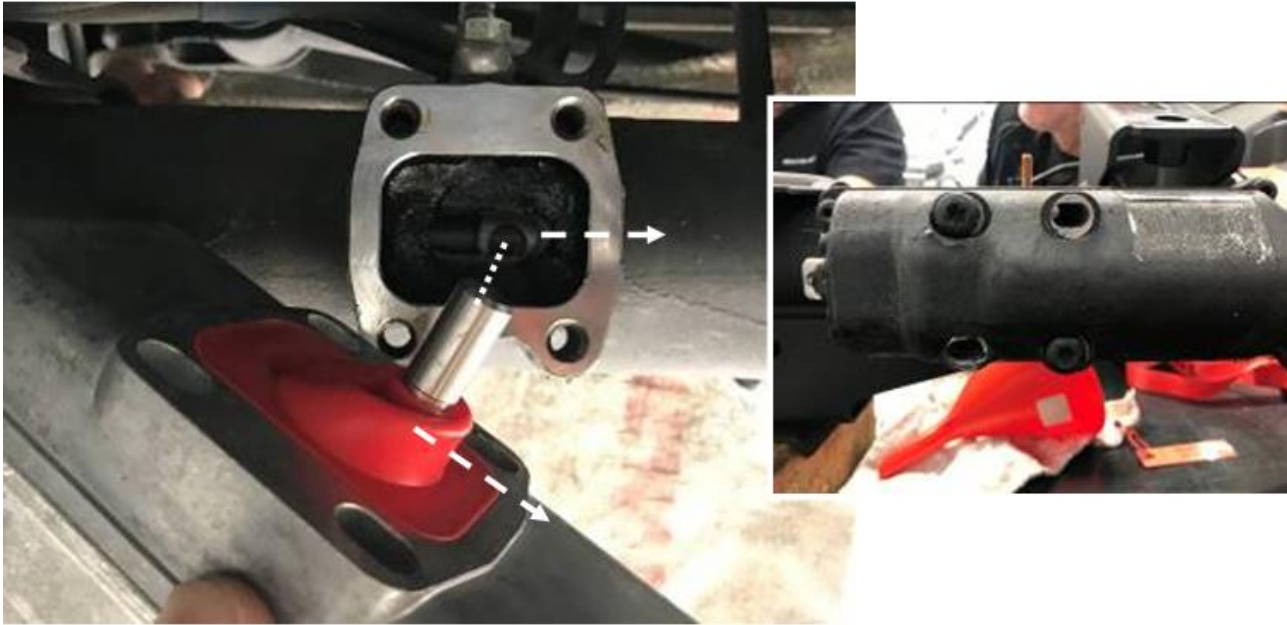
Figure 24

24. Remove rear axle actuator (**Figure 24**).

i Rear axle actuator is in **lock engaged position**.

i **Installation:** The slide in the axle tube for actuating the lock must be slid in the direction of the axle centerpiece. One of the wheel flanges must be turned at the same time.

Nm Actuator screw to axle tube **1st stage 10 Nm – 2nd stage 20 Nm – 3rd stage 60°**

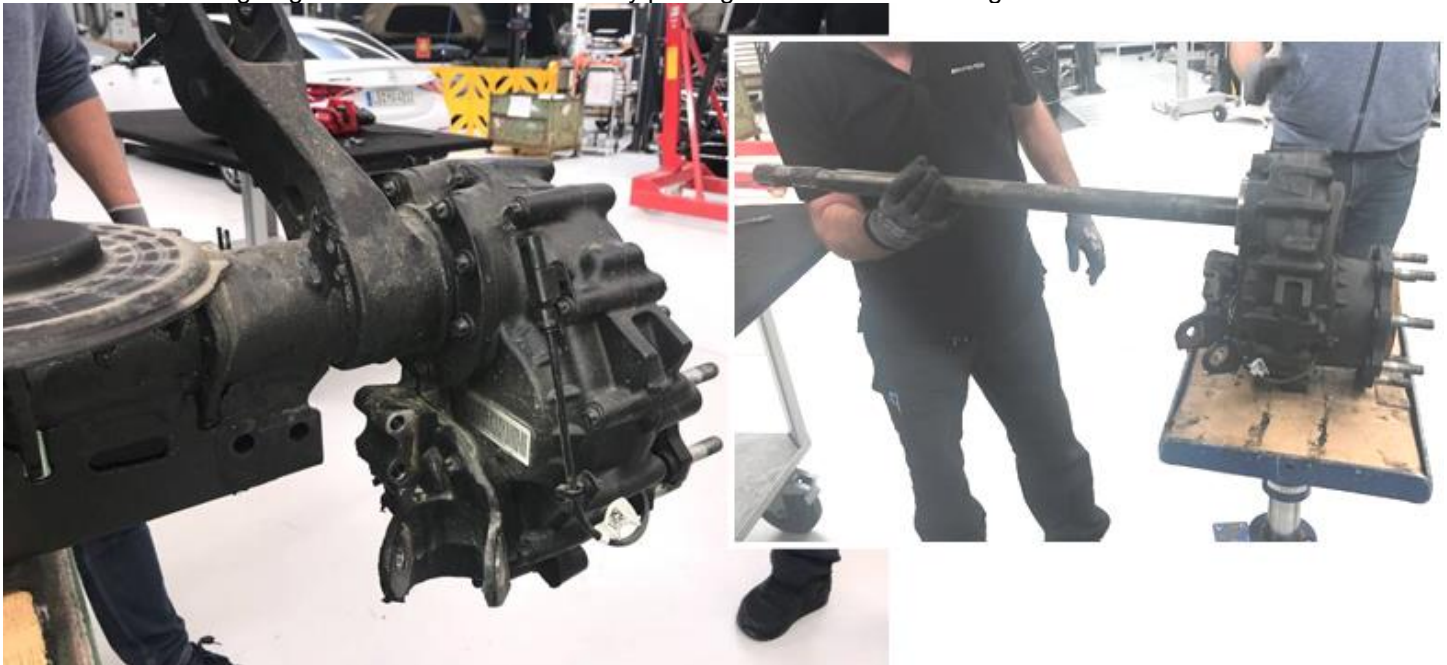
Figure 26

26. Remove left and right hub reduction gears (**Figure 26**).

Nm Hub reduction gear screw to axle tube **1st stage 40 Nm – 2nd stage 45°**

i **Installation:** Carefully slide hub reduction gear with axle shaft into rear axle differential while turning at the same time so that the gearing engages.

i **Installation:** Exercise particular caution when inserting the right portal to ensure that the slide for the lock actuation is not damaged.

i **Installation:** To install the right portal, **position the lock actuator temporarily** so that the lock tube has better guidance in the new axle centerpiece.

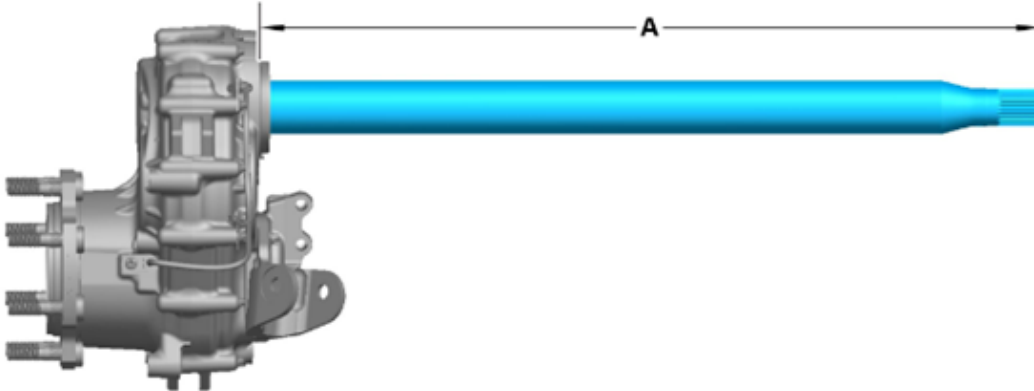
i Installed dimension of left rear axle drive shaft $727.2\text{mm} \pm 1.5\text{mm}$ (Figure 28).

Figure 28: Left hub reduction gear, (A) installed dimension $727.2\text{mm} \pm 1.5\text{mm}$

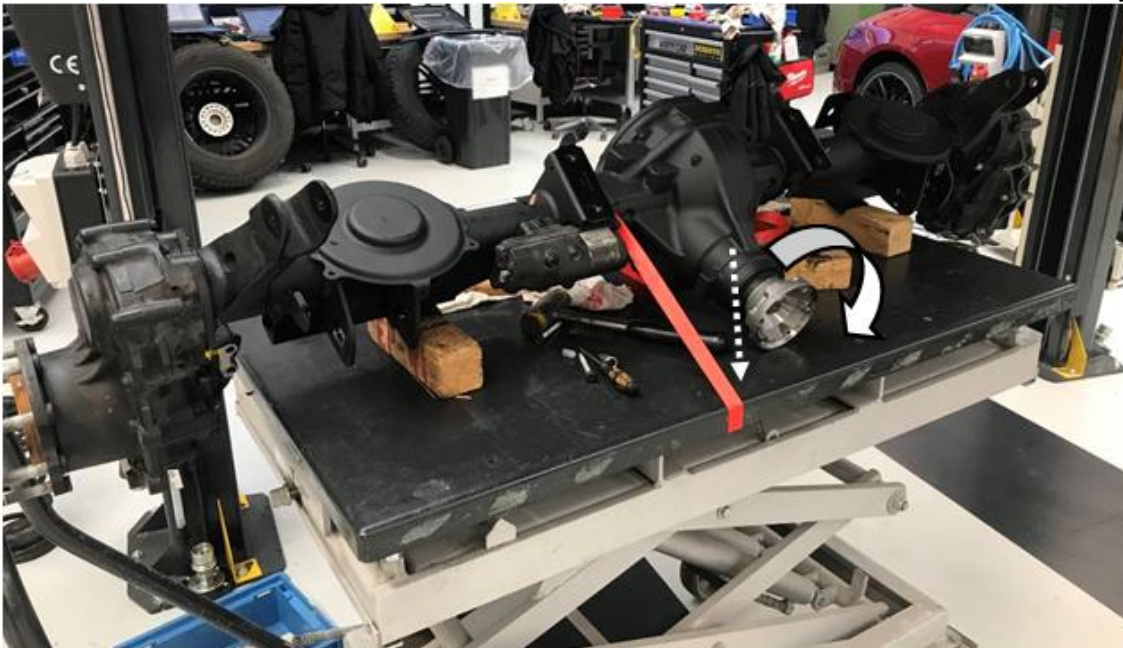
Figure 32

30. Fill rear axle centerpiece with 1.5 liters of oil and rotate the differential drive pinion multiple times for **at least 30 seconds** with the drive pinion tilted downward by **at least 5–10°** (**Figure 32**).

i **Attention, very important:** This ensures that the bearing of the drive pinion is sufficiently lubricated prior to initial use.

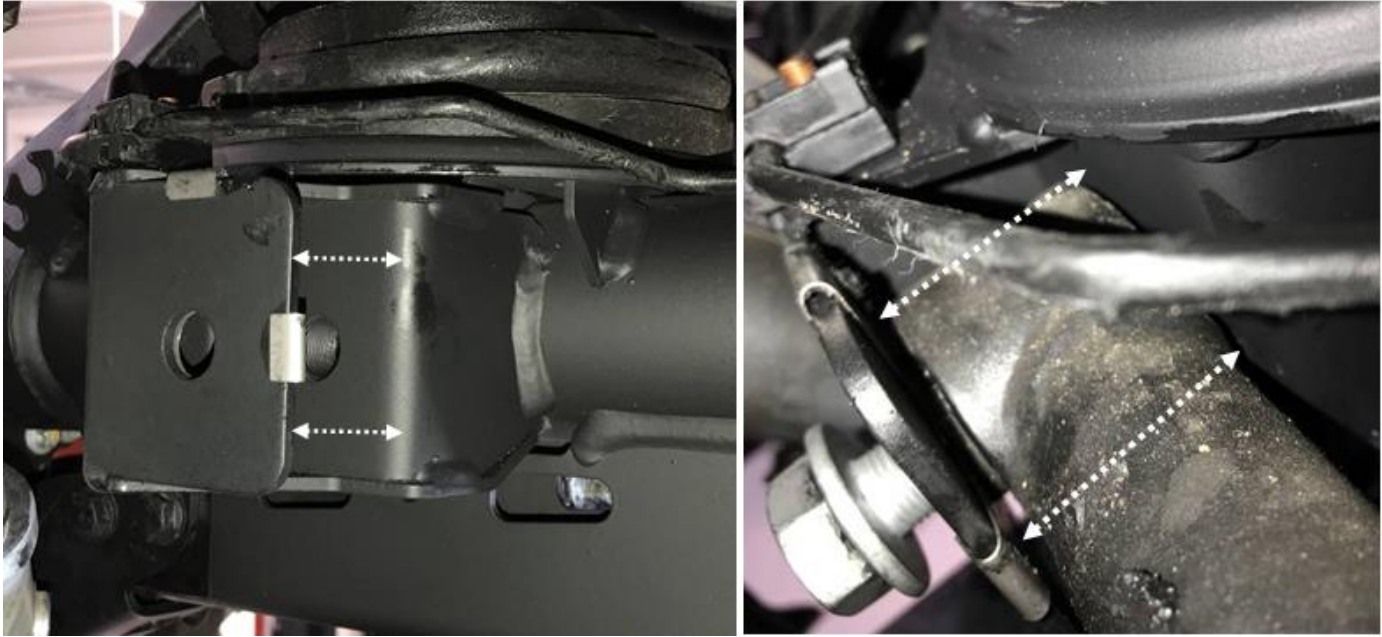
Figure 33

31. Install adjusting plate (If necessary) for transverse control arm on new axle bridge (**Figure 33, 34**).

i The left bearing of the transverse control arm must be installed with suction and with almost zero clearance, into the retaining tab of the axle bridge.

i The fit for the transverse control arm can be adjusted as required, either **without** an adjusting plate, or with a **0.5 mm** adjusting plate, or with a **0.8 mm** adjusting plate.

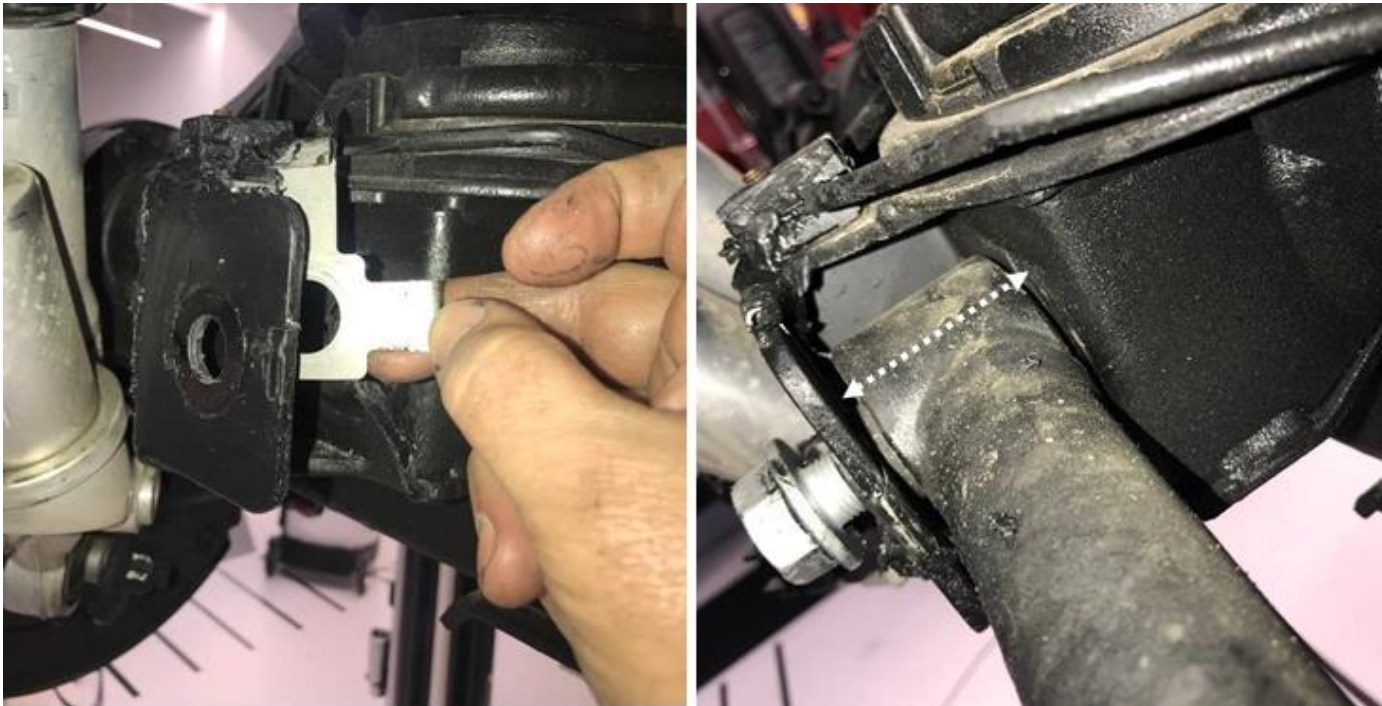
Figure 34

i A **maximum of one** adjusting plate may be installed.

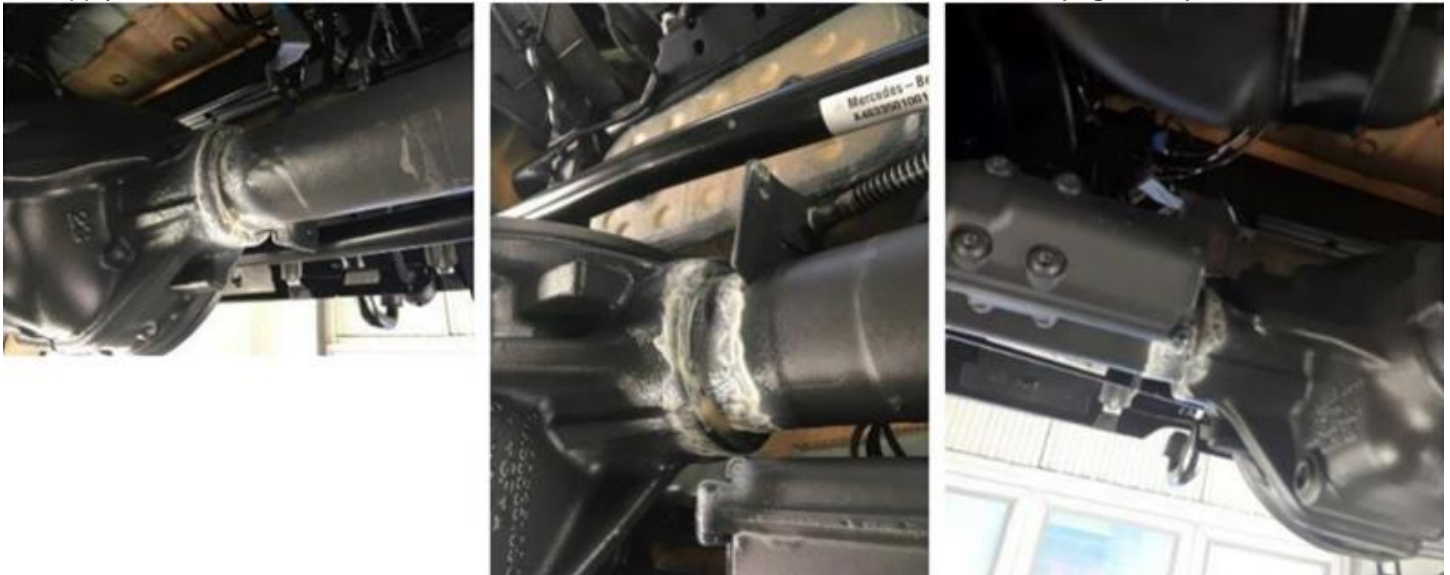
Figure 35

37. Apply wax **A 000 986 32 01 09** to rear axle in area between axle tube and differential (**Figure 35**).
