Recall Campaign Bulletin

Campaign No. 2023010005, January 2023

SUBJECT: **Model C-Class (203 platform)**
Model Year 2002-2005

Check Sliding Roof Bonding

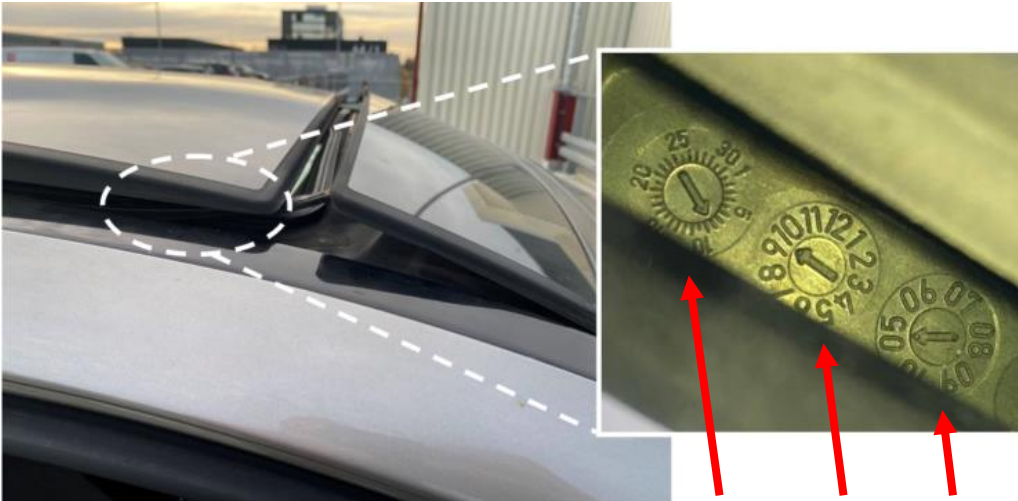
1. **Open** panoramic sliding sunroof **approx. 3 cm** and check manufacturing date (Figure 1).

Figure 1 (The manufacturing date in the sample picture is 08 day / 10 month / 5 year) (10/08/2005)

- a. Manufacturing date is **on or after 06/30/2005**: Carry out **check/test procedure B**.
- b. Manufacturing date is **on or before 06/29/2005**: **End measure**.

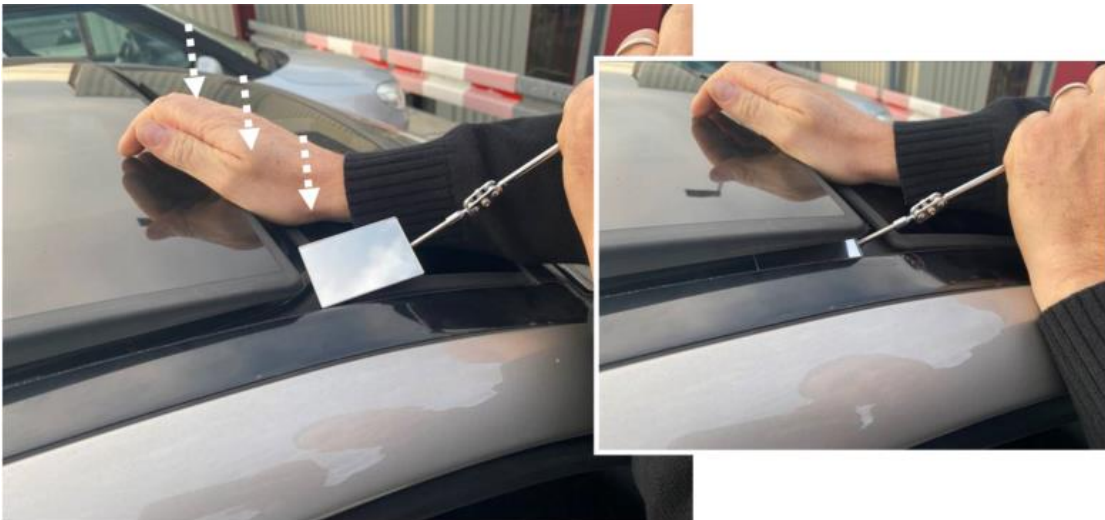
Figure 2

i Carry out check with a mirror as shown in Figure 2.

i To position the mirror, the wind deflector must be pushed downward by hand.

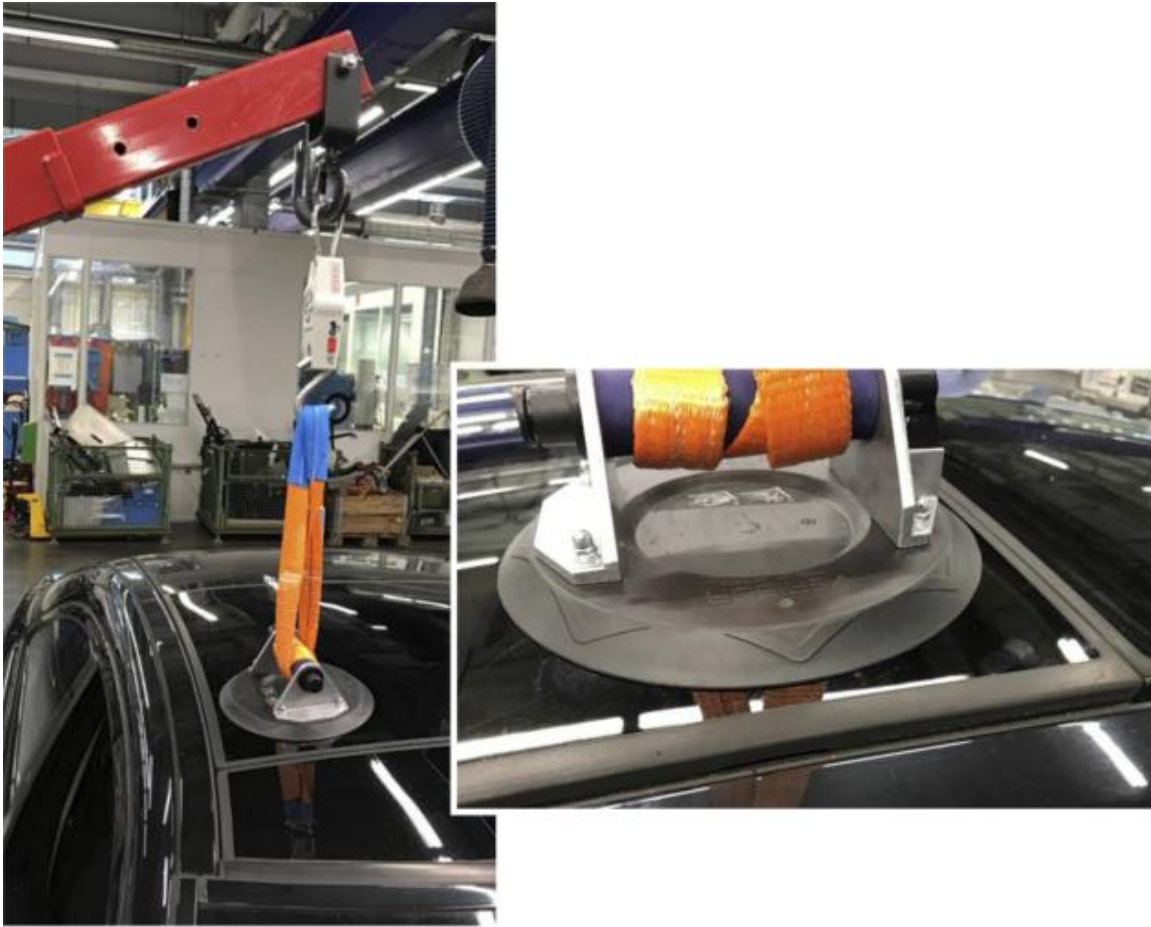
Figure 3

i The suction cup tool may be used for this check.
 3. Position suction cup tool (Figure 3) and pull as **vertically** as possible (tolerance of ± 10 degrees) using lifting tool.

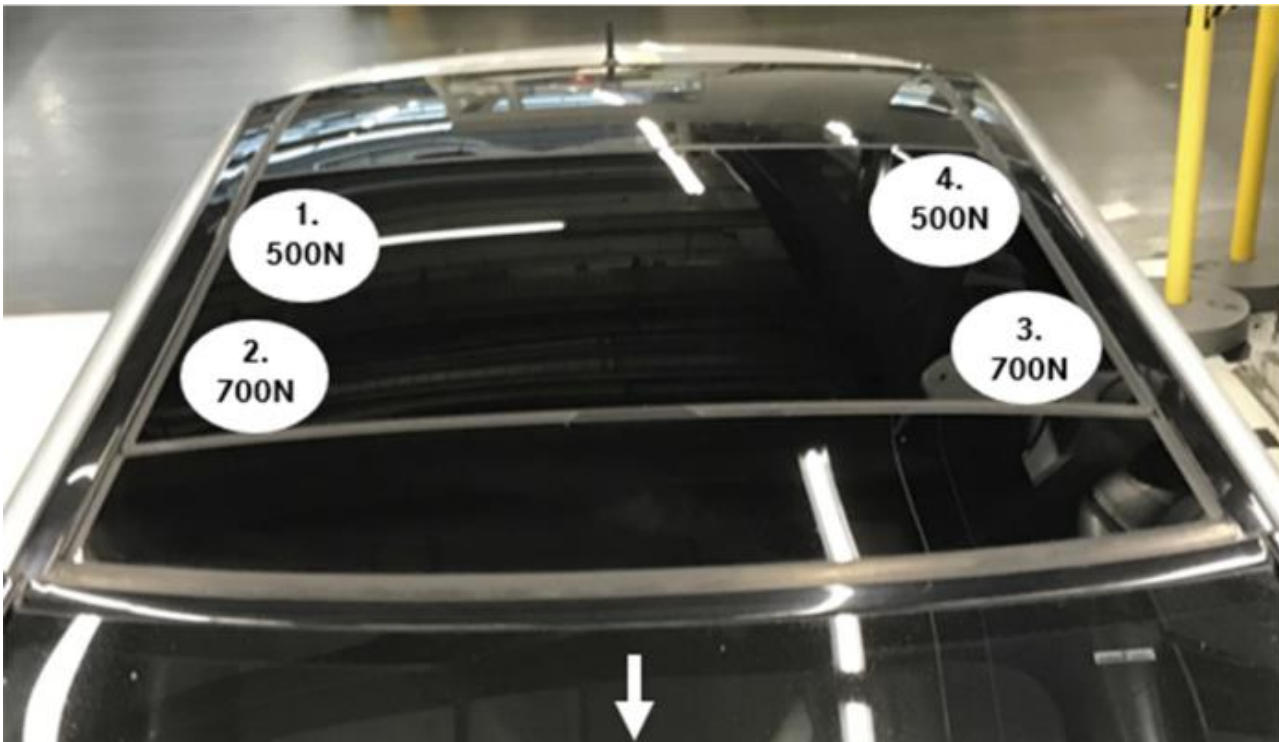
i Specified force **500N /700N** (Figure 4).

i Position suction cup tool at 4 positions in the sequence **1, 2, 3, 4:** (Figure 4).

Figure 4 (test sequence 1, 2, 3, 4 – arrow indicates direction of travel)

i The specified force must be monitored during the first minute and adjusted if necessary (tolerance ± 10 N). The specified force must not be exceeded. Pull as vertically as possible (tolerance ± 10 degrees) with the specified force. Not person sh be inside the vehicle during the check, and the vehicle must not be touched if possible.

i The holding time per position must be exactly **10 min!**
After the first minute, the holding force per position must be further monitored and readjusted if necessary (tolerance ± 10 N).

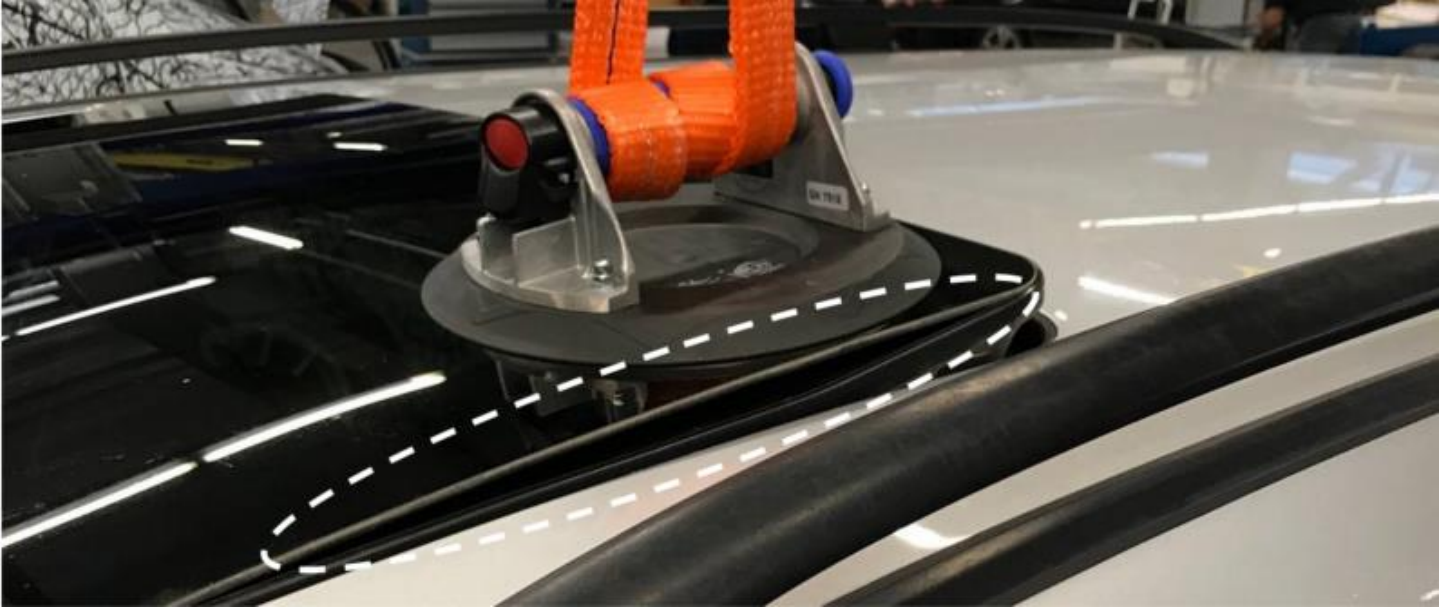
i If the panoramic sliding sunroof panel detaches from the padding of the tilting/sliding sunroof frame at one of the test positions (see Figure 5), the glass cover must be replaced.

Figure 5, not OK (shown on an SHD)

- c. If the panoramic sliding roof panel detaches from the padding: Carry out **work procedure**.
- d. If the panoramic sliding roof panel **does not** detach from the padding: Carry out operation step 4 and **end measure**.

1. Replace panoramic sliding sunroof cover (AR77.21-P-0500PB).
-
