## IMPORTANT SAFETY RECALL

**NHTSA Recall # 22E098**

### Possible Defective LP Service Valve

### RegO Model 901C Service Valves

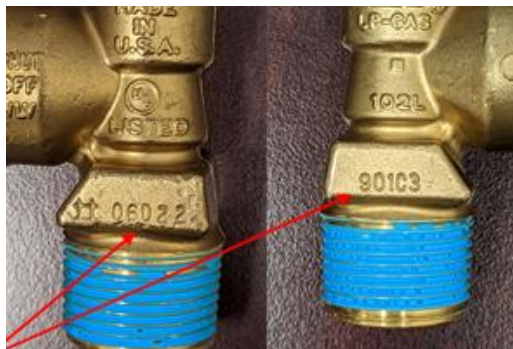
Please have a **qualified individual** check the valve dates on your propane tank. The affected valves have manufacturing date codes between 02X21 and 02X22. The 'X' represents any letter between A through E, which denotes the week of the month that the valve was assembled. The date code is marked on a wrench flat.

Date code and Model Number Location

If your tank is within the specified date range, have a **qualified individual** perform paragraph 3A in the attached RegO Field Safety Advisory document. If no leak is found, contact LDV to confirm and no further action is needed.

If a leak is found, contact LDV for a replacement valve and one will be provided free of charge.

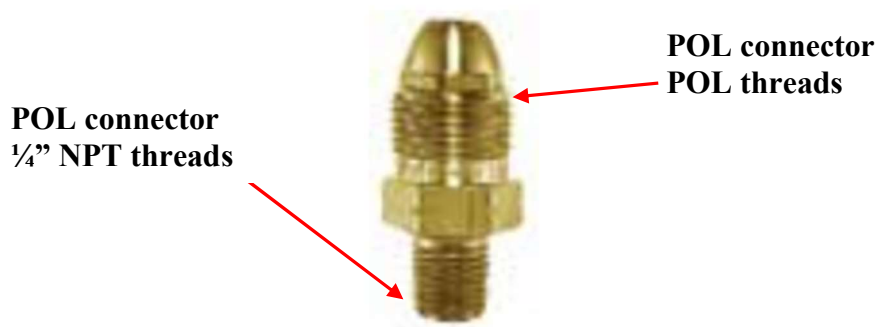
*Figure 3: POL Connector for Air Test*

- b. Alternatively, close the service valve and attach a POL connector to the service valve outlet with an air fitting installed on the ¼" NPT threads. (See Figure 3.)
  - i. Apply 50-100 psi air pressure back towards the outlet of the valve;
  - ii. Use a leak detection solution to determine if this connection is leak tight;
  - iii. If the connection is not leak-tight, securely close the valve, remove the container from service, and contact your OEM, distributor, or dealer for further guidance. Do not use the container without first replacing the valve.

- b. Alternatively, close the service valve and attach a POL connector to the service valve outlet with an air fitting installed on the ¼" NPT threads. (See Figure 3)

- i. Apply 50-100 psi air pressure back towards the outlet of the valve;
  - ii. Use a leak detection solution to determine if this connection is leak tight;

- iii. If the connection is not leak-tight, securely close the valve, remove the container from service, and contact your OEM, distributor, or dealer for further guidance.

- ii. Alternatively, close the service valve and attach a POL connector to the service valve outlet with an air fitting installed on the ¼" NPT threads. (See Figure 3 above.)
    1. Apply 50-100 psi air pressure back towards the outlet of the valve;
    2. Use a leak detection solution to determine if this connection is leak tight;
    3. If the connection is not leak-tight, securely close the valve, remove the container from service, and contact your OEM, distributor, or dealer for further guidance.

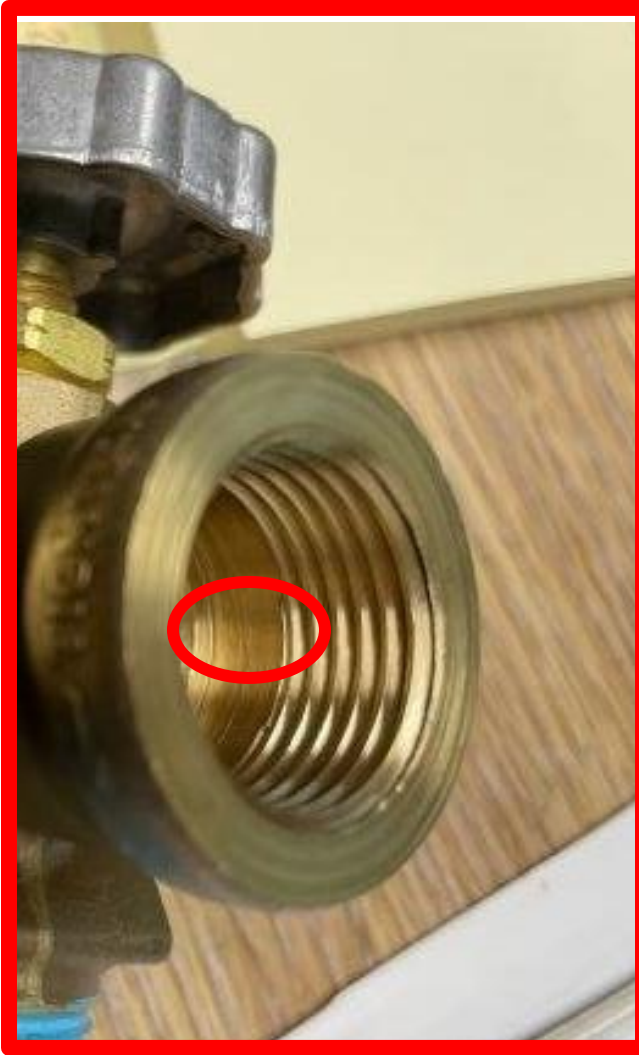
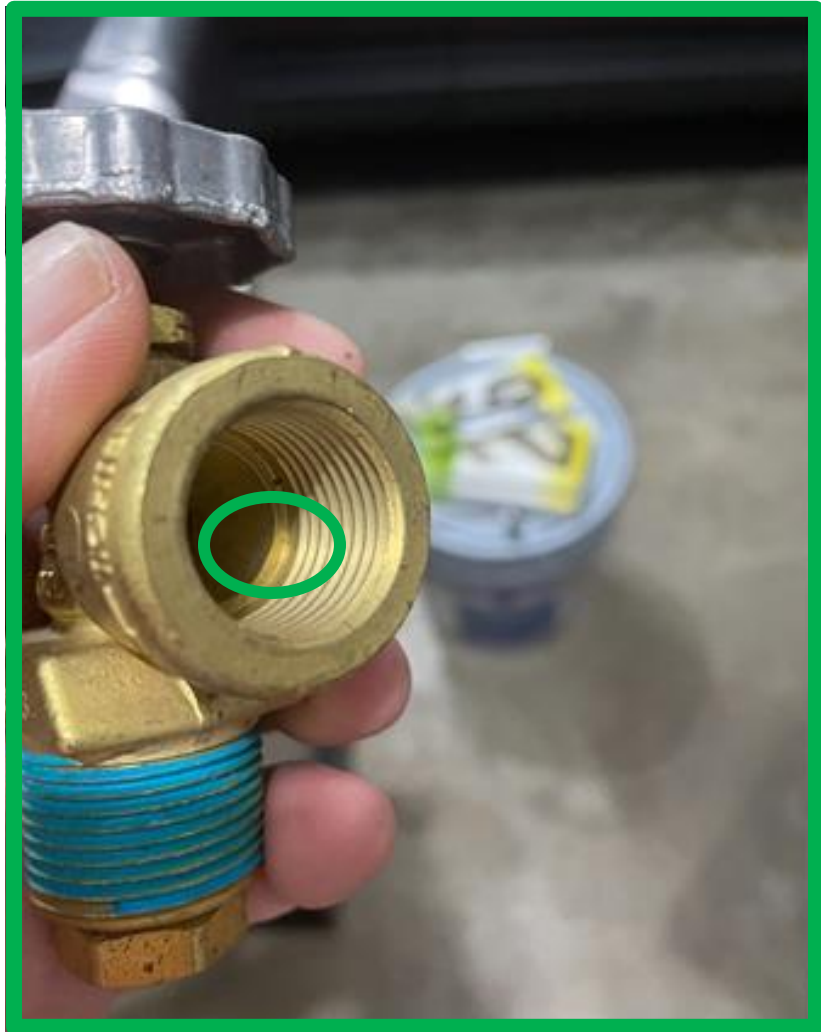
## *Put Manchester Tank and Equipment Quality Alert*

**Reason for Alert:** Threads not machine deep enough
