N222364860 Driver Front Airbag Inflator May Rupture

Release Date: February 2024 Revision: 01

Condition	General Motors has decided that a defect, which relates to motor vehicle safety, exists in certain front-
	driver airbag modules produced for use as service replacements in 2011–2012 model year Chevrolet
	Silverado 1500, Tahoe, and Suburban vehicles and 2011–2012 model year GMC Sierra 1500, Yukon,
	and Yukon XL vehicles. In these vehicles, the front-driver airbag modules may contain an inflator that
	was built with a supplier-manufacturing defect that may result in inflator rupture during deployment. An
	inflator rupture may cause metal fragments to pass through the airbag and into the vehicle interior, which
	may result in injury or death to vehicle occupants.
Correction	Dealers are to inspect the front-driver airbag module and replace if necessary.

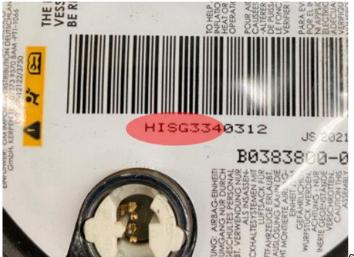
2. Locate the lot number on the back of the airbag inflator.

- 6148316
- If the lot number begins with HISG334,HITG334 OR HIUG333, proceed to step three.
- If the lot number does not begin with HISG334, HITG334 OR HIUG333, no further action is required. Record the serial number of the steering wheel airbag. Reinstall the steering wheel airbag assembly. Refer to Steering Wheel Airbag Replacement in SI.

- 6087079
- 3. Record the serial number of the removed Steering Wheel Airbag.
- 4. Record the serial number of the New Service Steering Wheel Airbag.
- 5. Replace the steering wheel airbag assembly. Refer to *Steering Wheel Airbag Replacement* in SI. **Do Not Deploy the AIRBAG.**
