Tesla, Inc.
Service Bulletin

Inspect Door Mirror Glass

SB-22-12-002

November 23, 2022

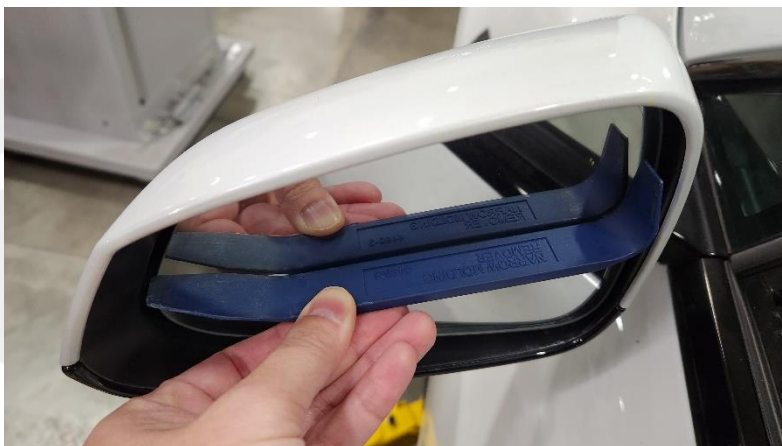
Figure 1

1. Place the straight edge of a small trim tool on the LH door mirror glass (Figure 1).

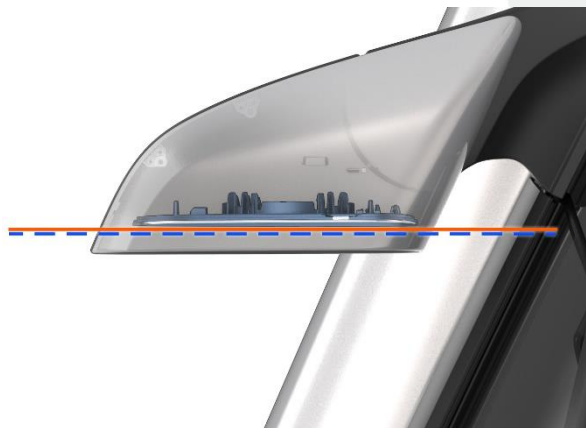
- If the trim tool sits flush to the glass (Figure 2), the LH door mirror glass is flat. No repairs are needed.
- If the trim tool wobbles or does not sit flush to the glass (Figure 3), the LH door mirror glass is convex. Replace the LH door mirror assembly (refer to Service Manual procedure [12091102](#)).

✓ Figure 2 – Top view: Mirror is flat

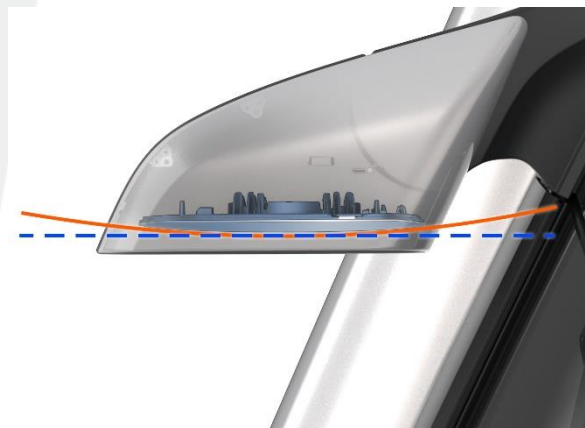
✗ Figure 3 – Top view: Mirror is convex

Inspect the LH and RH door mirror glass for symptoms related to the condition. If symptoms are present, replace the LH and/or RH door mirror assemblies.

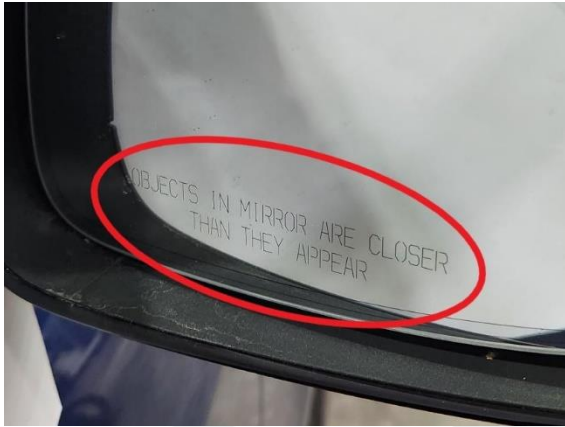
- If the RH door mirror glass contains the text, “OBJECTS IN MIRROR ARE CLOSER THAN THEY APPEAR” (Figure 4), no repairs are needed.
- If the RH door mirror glass does not contain the text, “OBJECTS IN MIRROR ARE CLOSER THAN THEY APPEAR” (Figure 5), replace the RH door mirror assembly (refer to Service Manual procedure [12091102](#)).

✓ Figure 4 – Mirror has text

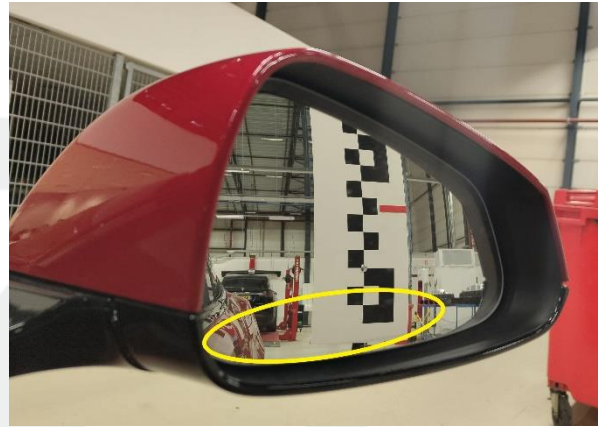
✗ Figure 5 – Mirror does not have text
