TECHNICAL BULLETIN

| Heating Systems | June 2, 2022 | Bulletin Identification No.: MTB-229-20 |

Affected Model(s): All heaters with 1/4" fuel line

Description: Incorrect Fuel Line

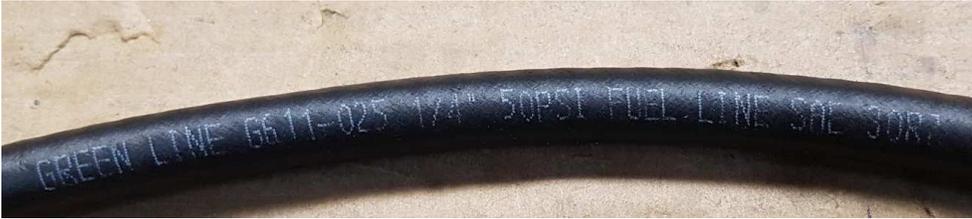
The above fuel line is the correct type. It has "FUEL LINE SAE30R7" marked on it. The incorrect hose can be identified by either marking of "VALUFLEX/GS" or by what appear to be holes in the hose as shown below.

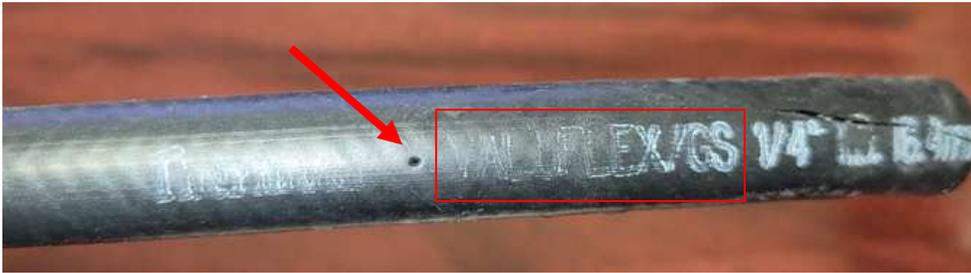
This hose is subject to leaking. If a heater is discovered to have this hose, it must be changed out with the appropriate fuel line as per the instructions below.
