| Safety Recall Campaign | 2016-2018MY K900(KH) |
| SC227A | April 2022 |

HECU FUSE REPLACEMENT (SC227A)

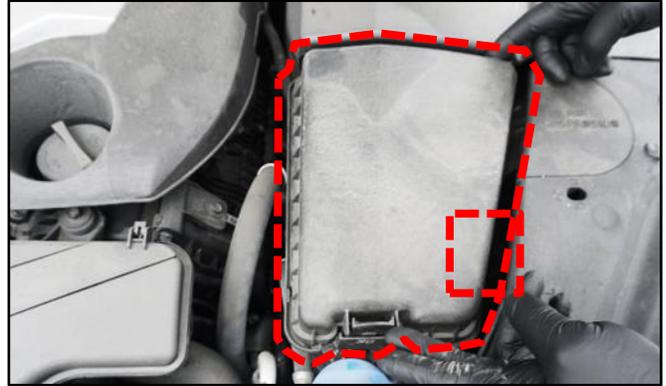
1. Open the hood.
2. Remove the junction box fuse cover.

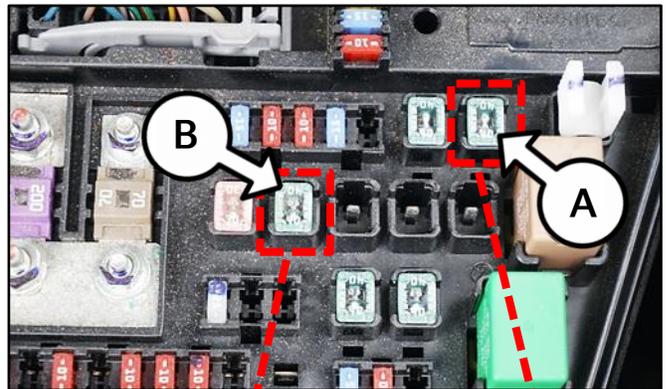
- 3a. Remove two (2) 40A fuses (A) and (B).
- 3b. Install the new amperage fuses as follows:

- A. ESC1 fuse → new 20A
- B. ESC2 fuse → new 25A

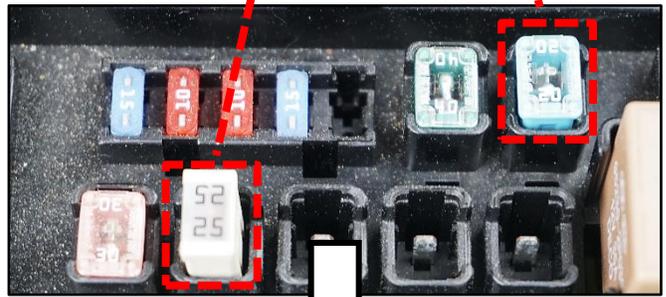
Ensure to replace ESC1 fuse (A) with the 20A fuse and ESC2 fuse (B) with the 25A fuse.

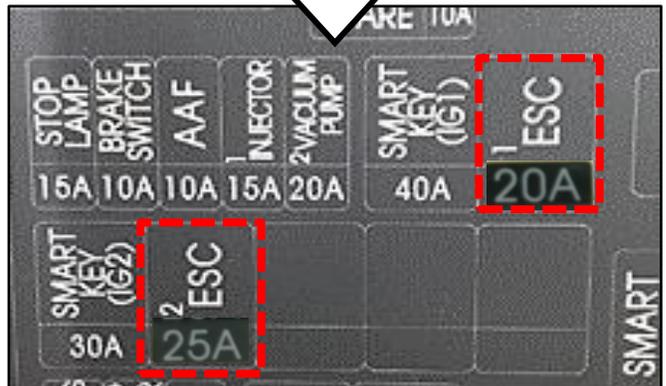
5. Adhere the new ESC1 20A and ESC2 25A labels to the bottom of the junction box fuse cover as shown.

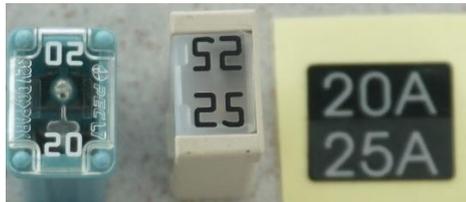
| Part Name | Part Number | Figure | Qty. |
|---|---|--|---|
| Fuse(s) and Label Kit | 91940 3T001QQK* | | 1 |
