## Metal Junction Box Grounding Instructions

<b>Bulletin Type:</b>	Recall	<b>Publication Date:</b>	March 2022
<b>Bulletin #(s):</b>	22V-054 US_2022-048 CAN	<b>Make(s):</b>	Jayco
<b>Job Code(s):</b>	9901574	<b>Model(s):</b>	Eagle FW
<b>Flat Rate(s):</b>	.50 / Hour	<b>Model Year(s):</b>	2022

<b>Incident:</b>	Metal junction box was not grounded
<b>Affected Units:</b>	2022 Jayco Eagle FW
<b>Parts List:</b>	<b>Parts List: (Purchase locally)</b> - MN cable (Copper Wire)
	<b>Parts Kit Contents: None</b>
<b>Misc. Tools &amp; Supplies:</b>	- Flathead Screwdriver - Wire Pliers/strippers

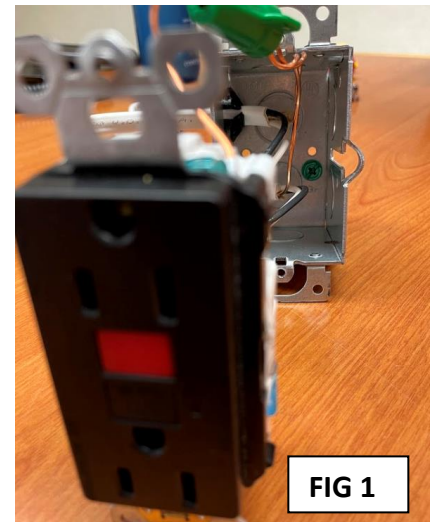
1. Disconnect unit from the 120V power source
2. Locate metal junction box with a GFCI receptacle at the Kitchen.
3. Remove faceplate and receptacle (Fig. 1) to expose wires.
