**PROTERRA**

## FLEET CHECK

<b>ISSUE DATE:</b>	3-23-2022
<b>SERVICE BULLETIN SUBJECT:</b>	Steering Gearbox Bolt Torque Stripe and Re-torque Fleet Check
<b>VINs or MODELS AFFECTED:</b>	Service Specified Buses
<b>COMPLETE BY:</b>	Next Service Opportunity
<b>SERVICE BULLETIN #:</b>	FC-22-35
<b>Labor Operation Code:</b>	N/A

## **STEERING GEARBOX TORQUE STRIPE AND RE-TORQUE FLEET CHECK**

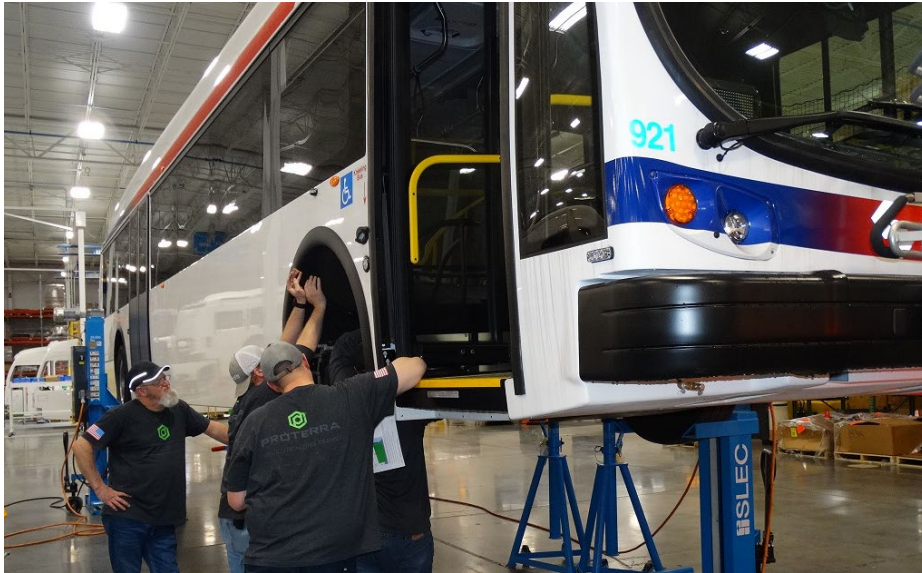
1. Complete the Proterra approved Lockout/Tagout procedure to make the bus safe for work.
2. Using four Wheel Lifts, raise the bus into the air. Using four Jack Stands, support the bus for safety.

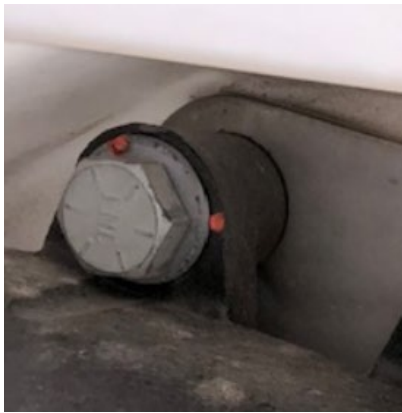
6. The following photograph shows an example of a bad torque stripe. Notice the torque stripes are broken due to rotation of the bolt.

10. If the Torque Stripes are in good condition and none of the bolts failed the re-torque test no further inspection is required and this check is complete. The bus may be lowered and returned to service.
11. If bad/broken torque stripes are identified or any of the bolts failed the re-torque test, contact Proterra Customer Service to receive additional instructions after filling out the inspection form linked above. If a Proterra team member performs the inspection the Work Order should be escalated to the Proterra back office in addition to submitting the form.
12. If bad/broken torque stripes were found or any of the bolts failed the re-torque test, the bus may be lowered and Lockout/Tagout devices removed but the bus should not be returned to service until additional inspections are performed.

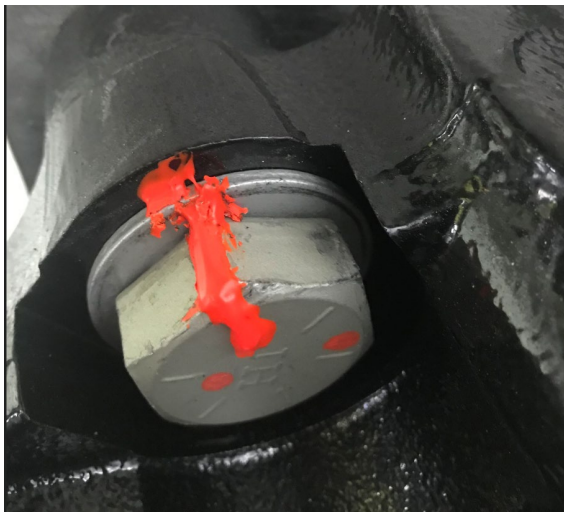
7. The following photograph shows an example of a good torque stripe. Although it is broken, the bolt has rotated clockwise for a small portion of one turn. This can occur when the bolts have been re-torqued prior to shipment during a factory inspection.

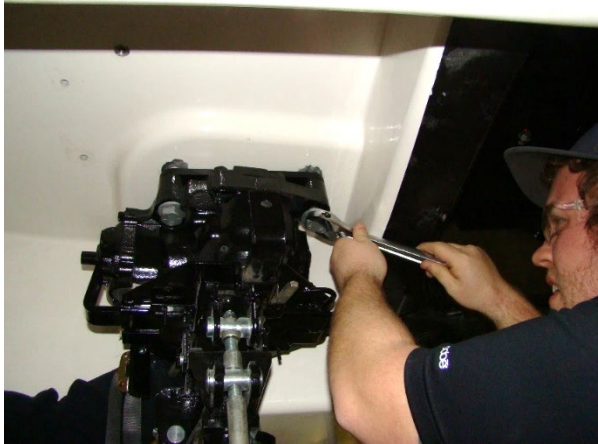
9. Using a Calibrated Torque Wrench with a 1-5/16 Inch Ratchet/Socket, **set the torque wrench to 450 ft-lb**. Slowly tighten the bolt. If the bolt rotates before the wrench clicks, please report that bolt failed the re-torquing check on the inspection form linked above.
10. Using a 1-5/16 Inch Ratchet/Socket, remove that bolt (018758-031) and add Loctite 248 to the threads. The Loctite 248 should fill the threads on the bolt where it engages the fastener.
11. Using a Calibrated Torque Wrench with a 1-5/16 Inch Socket, **torque the re-installed bolt to 150ft-lb**. Then test the re-application of the torque, remove, and reinstall the other three (3) remaining bolts in the same manner in the sequence shown in the illustration on the right below.

12. Using a Calibrated Torque Wrench with a 1-5/16 Inch Socket, **torque each of the four bolts to 300 Foot Pounds**. Cross-torque the bolts by following the sequence shown above.
7. Using a Calibrated Torque Wrench with a 1-5/16 Inch Socket, **torque each of the four bolts to 500 Foot Pounds**. Cross-torque the bolts by following the sequence shown above.
8. Using Alcohol and Shop Towels, remove any Orange Torque Stripe Paint from previous torquing operations.
9. Using Orange Torque Stripe Paint, mark the four bolts as shown below.
