(Revision 1) February 2023

Dealer Service Instructions for:

Safety Recall Z18 / NHTSA 22V-154

Steering Gear

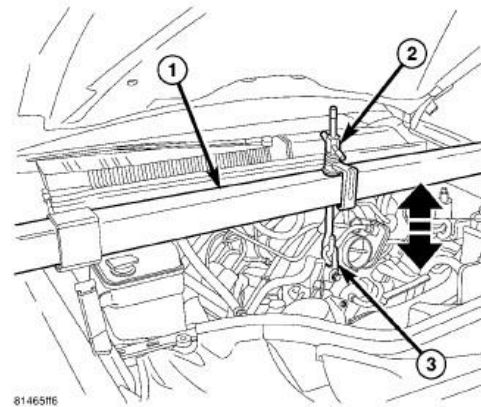
Figure 1 – Engine Lifting Fixture

1. Disconnect and isolate the negative battery cable.
2. Remove the air cleaner body.
3. Disconnect the throttle body wire harness connector and disengage the wire harness clip from the throttle body.
4. Remove the four bolts and the throttle body and set aside.
5. Support the engine using **Fixture, Engine Lifting 8984C Fixture, Driveline Support 8534C** or equivalent (Figure 1).
6. Raise and support the vehicle.
7. Remove the front wheels and tires.

29. Remove the engine support tool (Figure 1).
30. Tighten the engine mount nuts to 61N·m (45ft. lbs.) (Figure 8).
31. Install the brake calipers and tighten to 55N·m (41ft. lbs.).

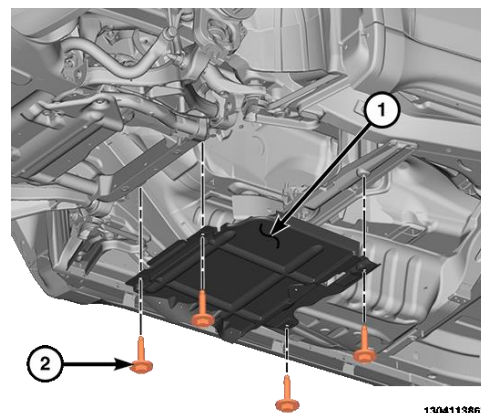
Figure 2 – Transmission Skid Plate

8. Remove the bolts (2) and remove the transmission skid plate (1) (Figure 2).

40. Install the transmission skid plate (1) and bolts (2). Tighten bolts to 55 N·m (41 ft. lbs.) (Figure 2).
41. Install the wheels and tires.
42. If removed, Install the throttle body and tighten the four bolts in a criss-cross pattern. For 3.6L engines, tighten to 9Nm (80 in. lbs.). For all other engines, tighten to 12Nm (9 ft. lbs.).
43. Perform wheel alignment, paying special attention to thrust angle. If engine cradle crossmember needs to be shifted to align thrust angle, Reference to 02 Front/Wheel Alignment- Standard Procedure.
44. Return the vehicle to the customer.

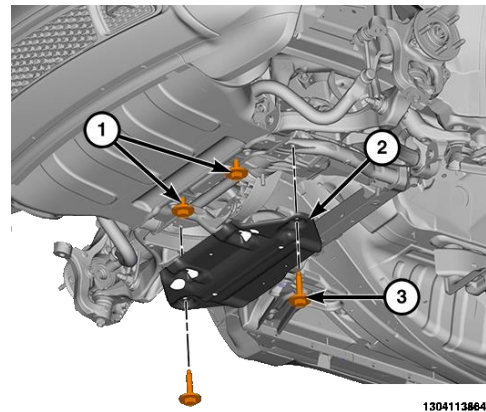
Figure 3 – Front Suspension Skid Plate

9. Remove the front suspension skid plate by loosening the front bolts (1), removing the rear bolts (3), then the skid plate (2) (Figure 3).

38. Install the front skid plate on standard models by installing the front (1) and rear (3) bolts and tightening to 55 N·m (41 ft. lbs.) (Figure 4).
39. Install the front suspension skid plate by sliding under the front bolts (1), installing the rear bolts and tightening to 28 N·m (21 ft. lbs.) (Figure 3).

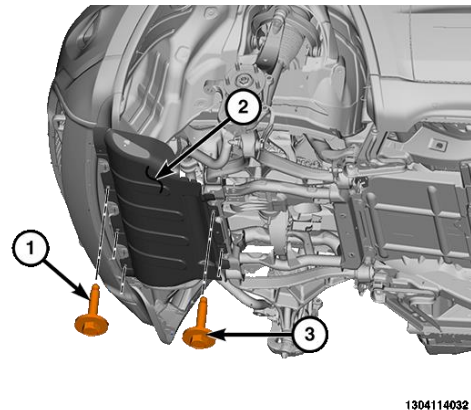
Figure 4 – Front Skid Plate

10. Remove the front skid plate on standard models by removing the front (1) and rear (3) bolts, then removing the front skid plate (2) (Figure 4).

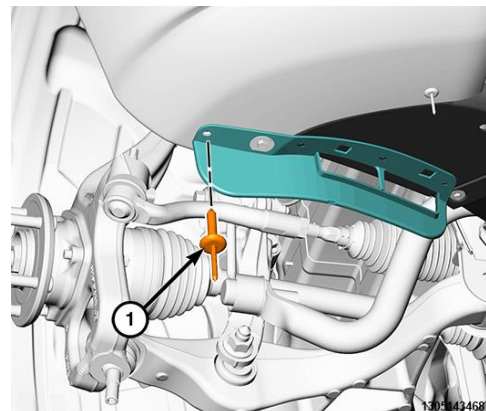
Figure 5 – Outer Spat Limit (Trackhawk Models)

11. For Trackhawk models, remove the outer spat rivet (1) (Figure 5).

36. For Trackhawk models, install the four fasteners (1) from each wheel well (Figure 6).
37. For Trackhawk models, install **NEW** outer spat rivet (1) (Figure 5).

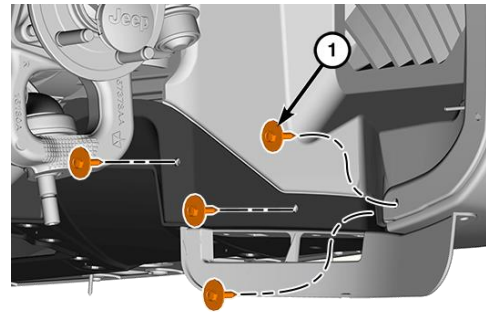
Figure 6 – Wheel Well Fasteners (Trackhawk Models)

12. For Trackhawk models, remove the four fasteners (1) from each wheel well (Figure 6).

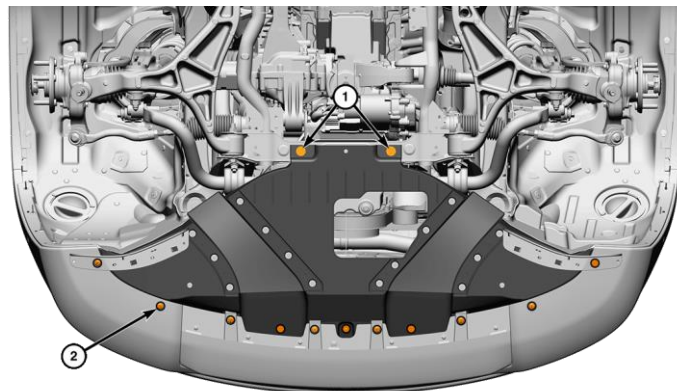
Figure 7 – Skid Plate Fasteners (Trackhawk Models)

13. For Trackhawk models, remove the two rear fasteners (1) and the 11 front fasteners (2) then remove the skid plate (Figure 7).

34. Attach the wheel speed sensor wiring to the knuckle.
35. For Trackhawk models, install the two rear fasteners (1) and the 11 front fasteners (2) with the front skid plate (Figure 7).

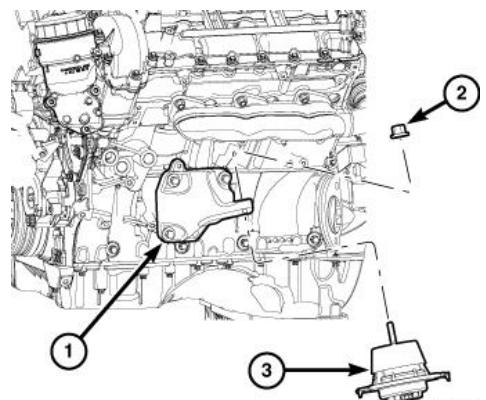
Figure 8 – Engine Mount Nuts

14. Remove the engine mount nuts (2) (Figure 8).

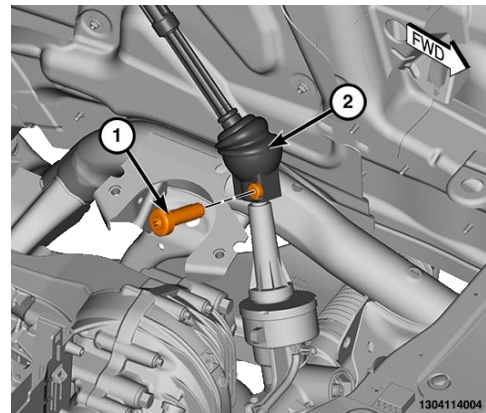
Figure 9 – Steering Shaft Coupler Pinch Bolt

17. Remove the steering shaft coupler pinch bolt (1) and disconnect the coupler (2) from the steering shaft. **Discard** the steering shaft coupler pinch bolt (Figure 9).

27. Connect the steering shaft coupler to the steering shaft, install a **NEW** coupler pinch bolt and tighten to 45N·m (33ft. lbs.).
28. Lower the engine fully onto the engine mounts.

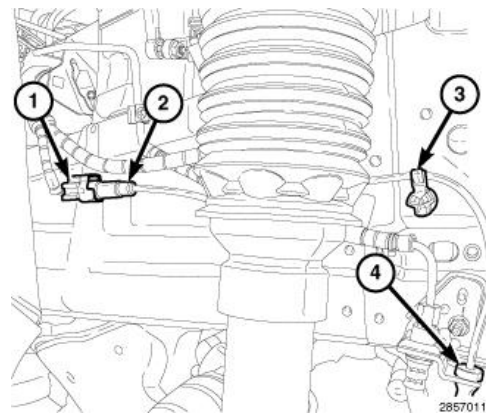
Figure 10 – Wheel Speed Sensor Connections

18. Disconnect the wheel speed sensor electrical connector (1), the wheel speed sensor wiring routing clips (2, 3), and remove the wheel speed sensor wiring (4) from the brake flex hose bracket (Figure 10).

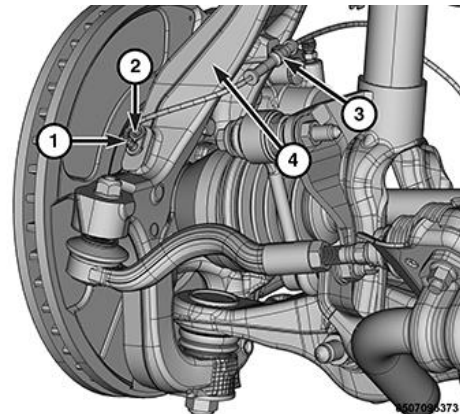
Figure 11 – Wheel Speed Sensor

19. Disconnect the sensor wire routing clips from the brake hose and remove the wheel speed sensor wiring (3) from the knuckle (4) (Figure 11).

20. Remove the front wheel sensor mounting bolt (2) and remove the sensor (1) from the knuckle (4) (Figure 11).

32. Position the wheel speed sensor in the knuckle, install the mounting bolt, and tighten to 10.7 N·m (95 in. lbs.).
33. Attach the sensor wire routing clips to the brake hose.

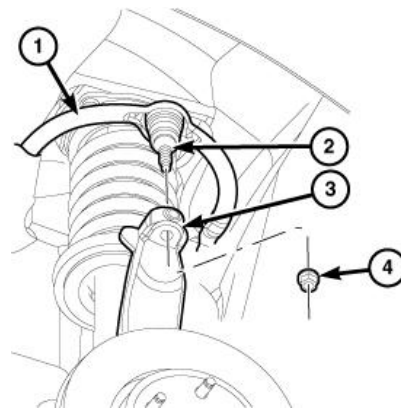
Figure 12 – Ball Joint Nut

24. Remove the upper ball joint nuts (4) and **DISCARD** (Figure 12).

26. Install the **NEW** upper ball joint nuts (4) and tighten to 165Nm (122ft. lbs.) (Figure 12).

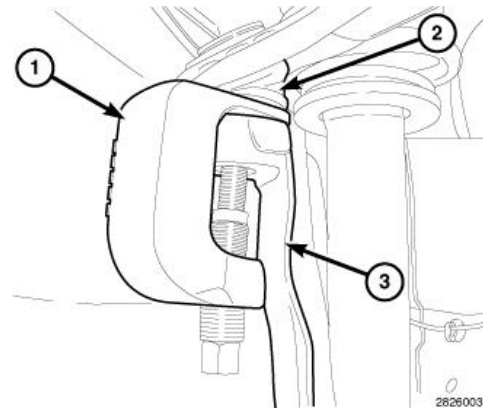
Figure 13 – Ball Joint Press 4150A

- 25. Separate the upper ball joints (2) from the knuckles (3) using **Press, Ball Joint C-4150A** (1) (Figure 13).
- 26. Remove the shock clevis bracket to lower control arm nut/bolts and **DISCARD**.

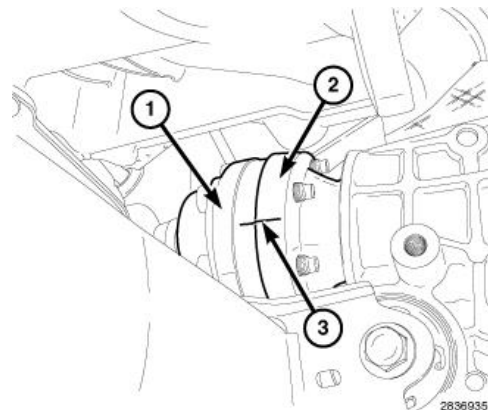
Figure 14 – Driveshaft & Pinion Flange

- 27. Mark (3) the front driveshaft (1) and pinion flange (2) for installation reference if applicable (Figure 14).
- 28. Remove the driveshaft (1) from the pinion flange (2) if applicable (Figure 14).
- 29. Disconnect the steering gear wire harness connectors.

19. Connect the steering gear wire harness connectors.
 20. Install the driveshaft with reference marks aligned (Figure 14).
- NOTE: Clean the driveshaft bolts and apply Mopar Lock and Seal Adhesive or equivalent to the threads before installation.**

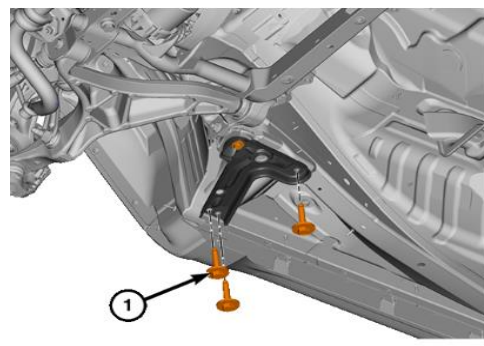
Figure 15 - Bracket

- 30. Remove the bolts (1) from the rear brackets (Figure 15).

17. Tighten the four engine cradle support bolts to 180 N·m (133ft. lbs.) (Figure 16).
 18. Install and tighten the six engine cradle stiffener bracket bolts to 20N·m (15ft. lbs.) (Figure 15).

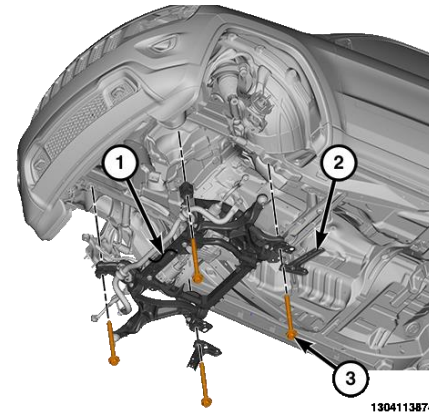
Figure 16 - Cradle

31. Using a grease pencil or equivalent, mark the location of the cradle on the underbody.
32. Support the cradle with suitable lifting device.
33. Remove the four cradle bolts (3) and separate the cradle crossmember (1) and brackets (2) from the vehicle (Figure 16).

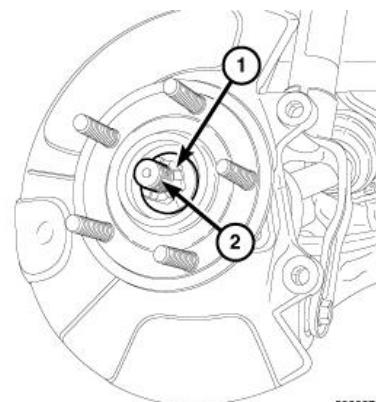
Figure 17 – Hub/Bearing Nut

NOTE: Always install a NEW hub nut. The original hub nut is one-time use only and should be discarded when removed.

35. Remove halfshaft hub/bearing nut (1) and **DISCARD** (Figure 17).

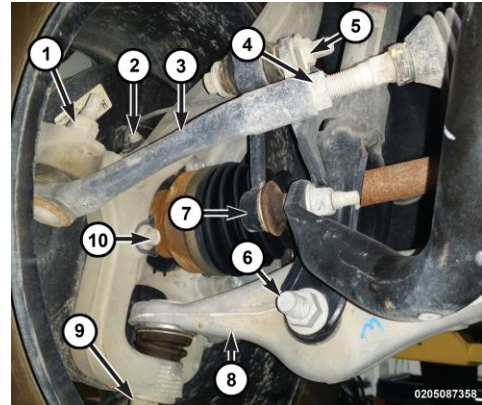
Figure 18 – Tie Rod End Nut

36. Remove tie rod end nut (1) (Figure 18).

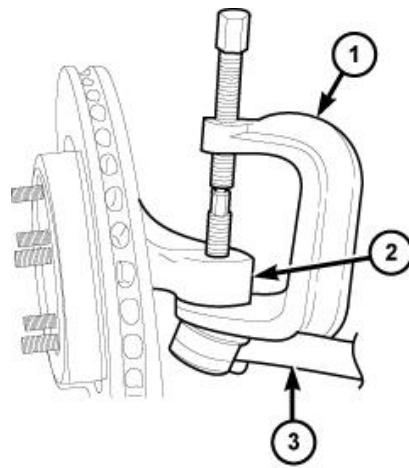
Figure 19 – Ball Joint Remover 8677

37. Separate the outer tie rod end (3) from the knuckle (2) with **Ball Joint Remover 8677** (1) (Figure 19).

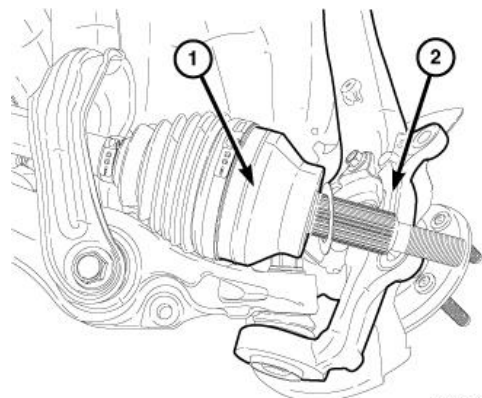
Figure 20 – Halfshaft from Hub/Bearing

38. Lean the knuckle (2) out and push halfshaft (1) out of the hub/bearing. Discard the coated washer between the outer CV joint and the hub (Figure 20).

12. Install **NEW** coated washer on the outer C/V joint shaft.
 13. Install halfshaft (1) through the hub/bearing (2) (Figure 20).
 14. Raise the engine cradle into position guiding the engine mounts into the engine mount brackets.

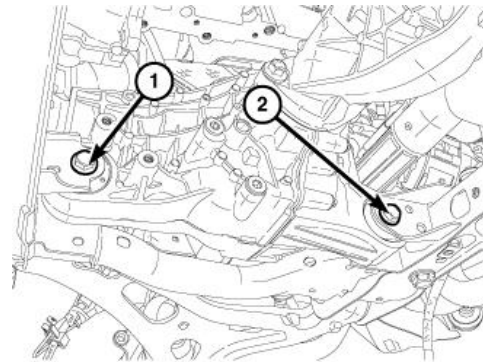
2837086
Figure 21 – Front Axle Bushing Bolts

40. Remove and **DISCARD** the front axle cover bushing bolt (2) and front axle pinion nose bushing bolt (1) from the crossmember (Figure 21).

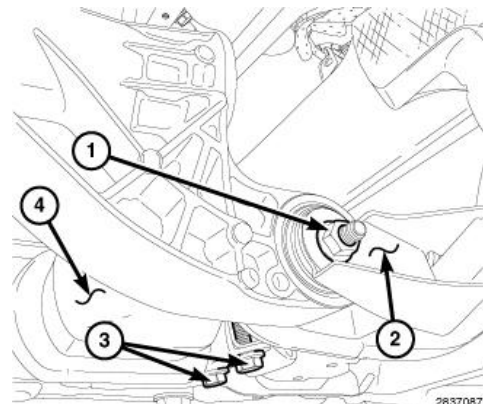
2837087
Figure 22 – Front Axle Tube Bushing Nut & Bolt

41. Remove and **DISCARD** the nut and bolt (1) from front axle tube bushing (2) bracket (Figure 22).
42. Remove the bolts (3) from frame dampener (4) (Figure 22).

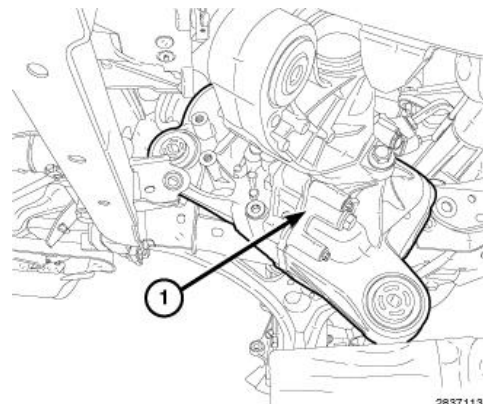
2837113
Figure 23 – Front Axle Removal

43. To remove the axle (1), tilt the front side of the axle downward while maneuvering the axle bracket. Then lower the axle and slide it to the RH side of the vehicle to clear the front axle cover mounting bracket (Figure 23).

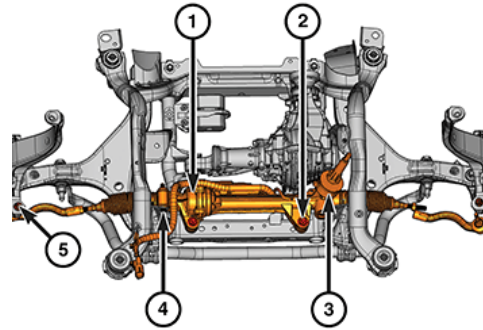
Figure 24 – Steering Gear Bolts**B. Installation**

44. Remove the two steering gear bolts (2) (Figure 24).
45. Remove the one steering gear bolt (4) (Figure 24).
46. Remove the steering gear (3) (Figure 24).

1. Drill out the rivets with a 9/64 drill bit, transfer the steering gear heat shield, secure the heat shield with the **NEW** self-tapping screws provided with the new steering gear.
2. Position the **NEW** steering gear (3) to the crossmember cradle (Figure 24).
3. Install the two steering gear bolts (2) and tighten to 250N·m (184 ft. lbs.).
4. Insert both outer tie rod end studs into the steering knuckles.
5. Install the two outer tie rod end nuts (5) and tighten them to 54N·m + 110° (40 ft. lbs. + 110°) (Figure 24).
6. Lift the axle into the cradle (if applicable).

25. Install the two outer tie rod end nuts (5) and tighten them to 54Nm + 110° (40ft. lbs. +110°) (Figure 24).

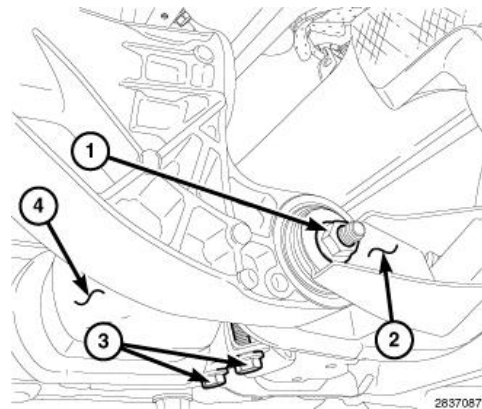
Figure 25 – Front Axle Fasteners

7. Install **NEW** front axle tube bushing mounting fasteners (1) in the RH axle bracket (2) and tighten to 61N·m (45 ft. lbs.) (Figure 25).
8. Install frame dampener (4) and bolts (3) and tighten to 61N·m (45 ft. lbs.).

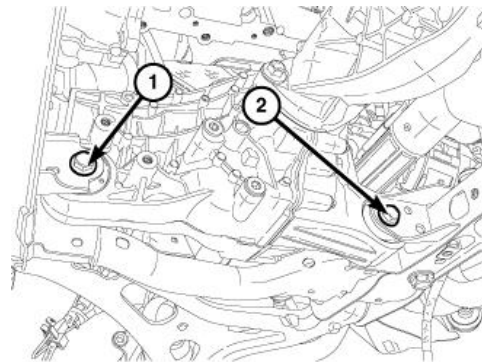
Figure 26 – Front Axle Fasteners

9. Install a **NEW** front axle cover bushing bolt (2) and a **NEW** front axle pinion nose bushing bolt (1) and tighten to 118N·m (87 ft. lbs.) (Figure 26).
10. Install front axle vent tube and ensure orientation is correct. Vent Tube needs to be fully seated to vent nipple and then can be orientated to correct position.

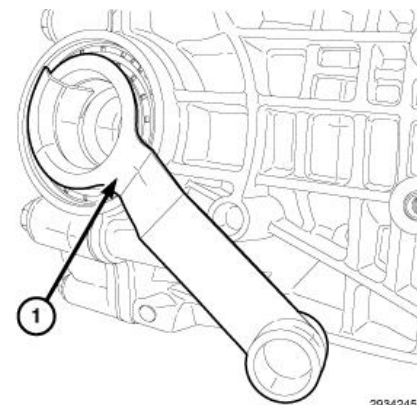
Figure 27 – Axle Seal Protector 10270

11. Using axle seal protector 10270 (1), install halfshafts in the axle. Verify halfshaft has engaged (Figure 27).

NOTE: Use care when removing seal protector to prevent damaging the seal.
