# Safety Recall

## Code: 10H5

<b>Subject</b>	Engine Design Cover																									
<b>Release Date</b>	March 22, 2022																									
<b>Affected Vehicles</b>

**Subject: Safety Recall 10H5 - Engine Design Cover**

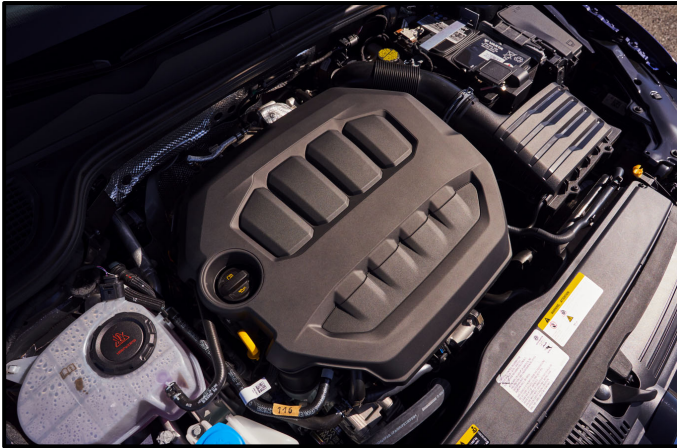
## Section B – Repair Procedure

- Pull the engine cover off the ball pins one after the other. Do not pull sharply on the engine cover or pull it to one side.
- Render the engine cover unusable and dispose of the engine cover.
