# Recall Campaign Bulletin

Campaign No. 2022050006, May 2022

SUBJECT: **Model Maybach S-Class (223 platform)**  
**Model Year 2021-2022**

## **Trim of Front Seat Backrests**

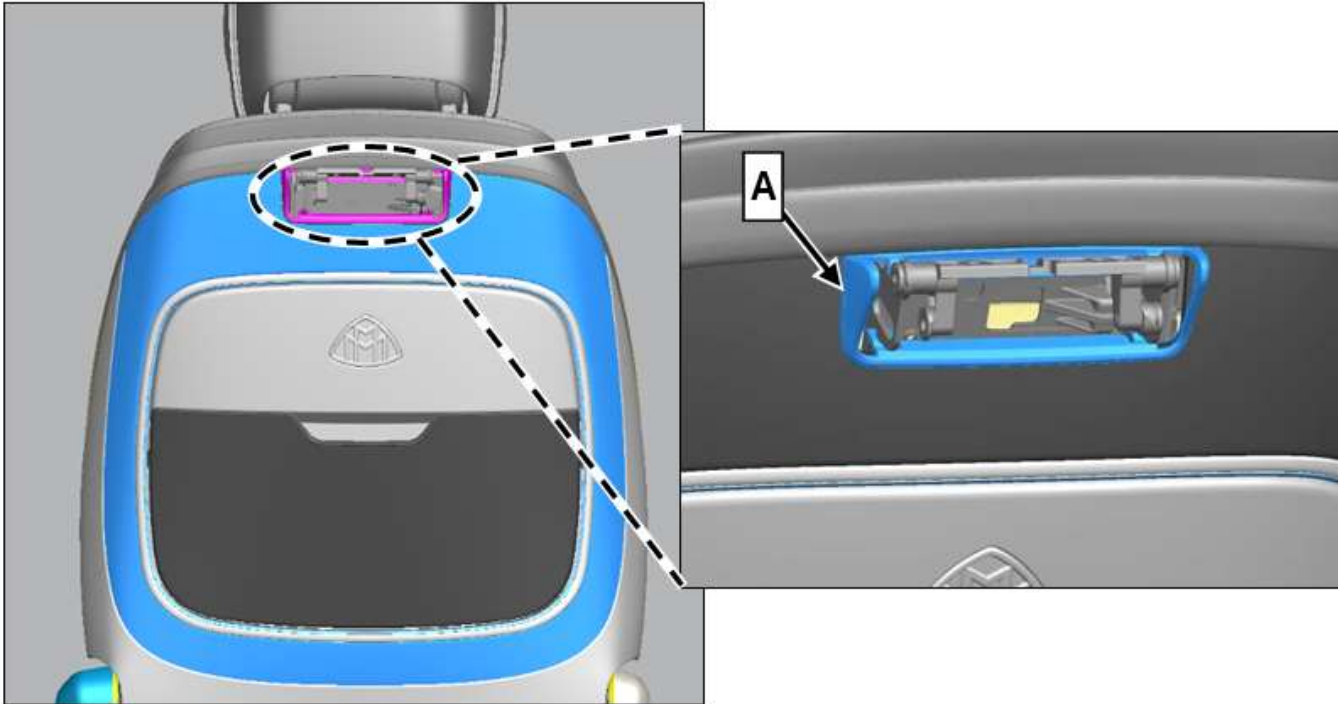
Figure 1

2. Unclip cover (A, figure 1).

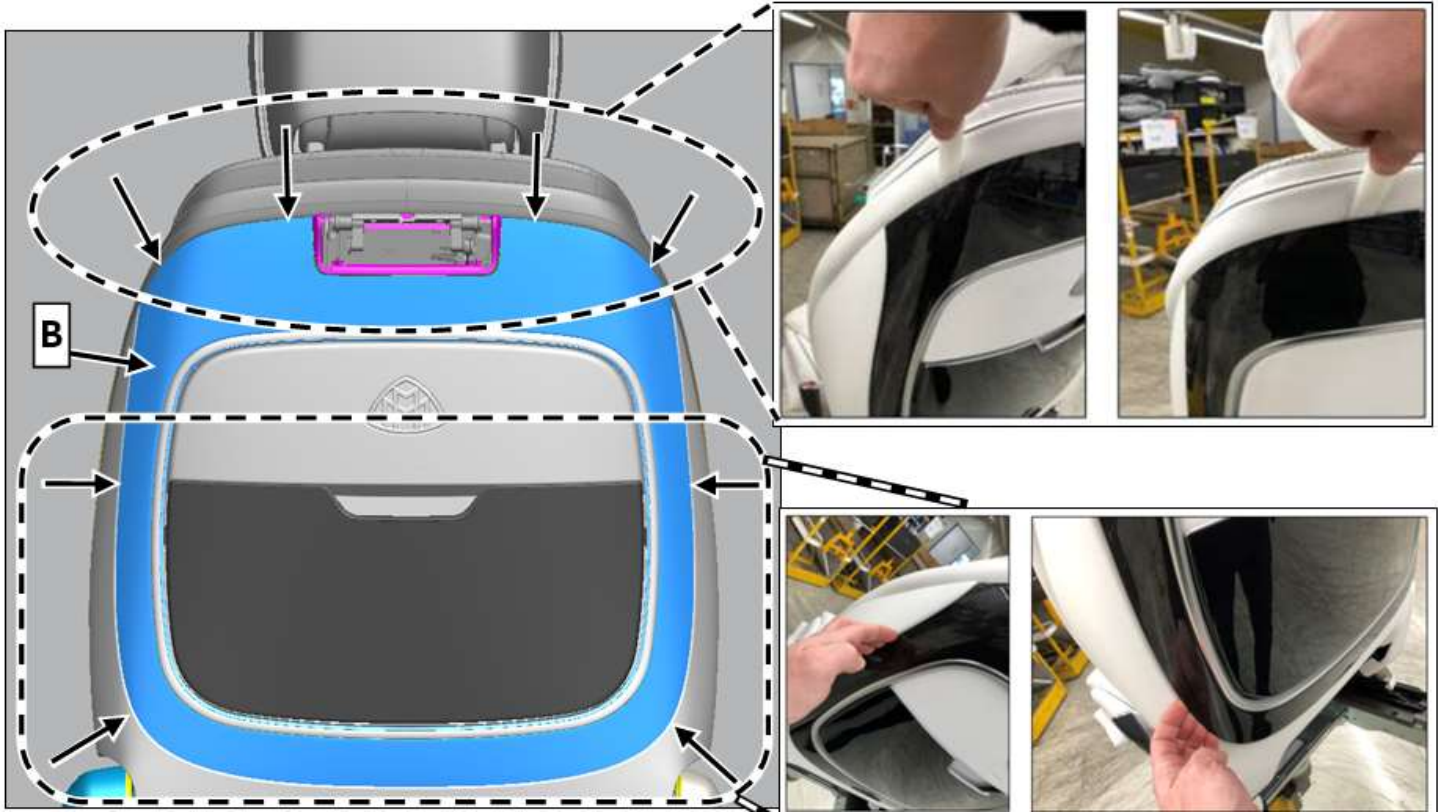
Figure 2

3. Unclip outer backrest mounting strip (B, figure 2).

**i** Unclip left and right outer backrest mounting strip with wedge (arrows, figure 2).

**i** Unclip outer backrest mounting strip on the lower left and right by hand (arrows, figure 2).

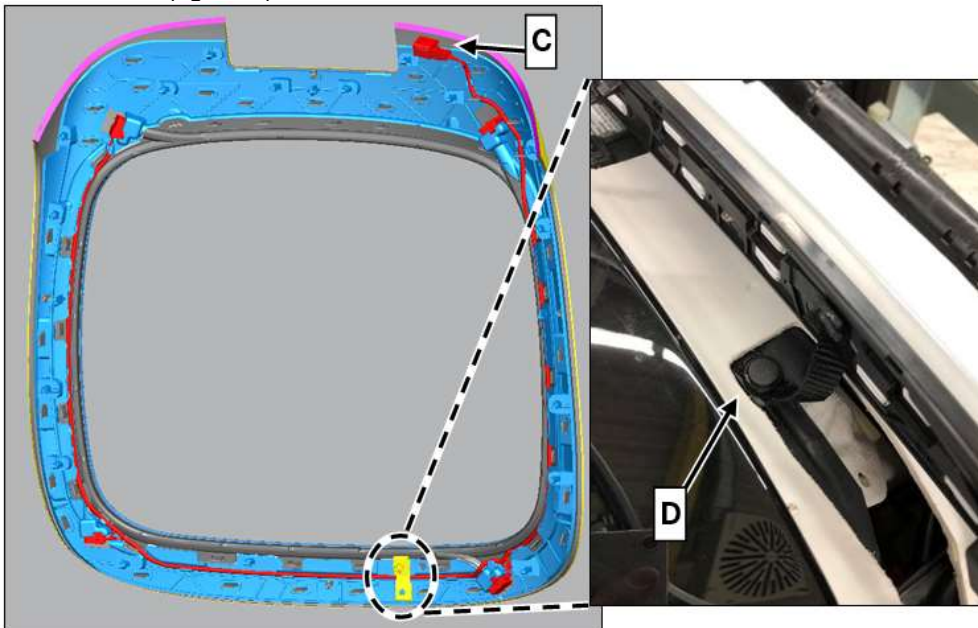
Figure 3

4. Disconnect electrical connectors (C), pry out lower securing clip (D), and remove outer backrest mounting strip from front seat (figure 3).

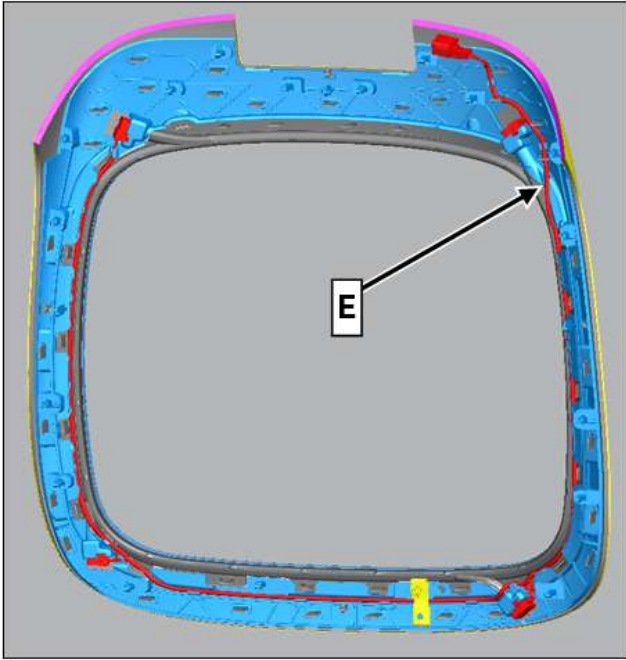
Figure 4

5. Remove electrical wiring harness (E, figure 4) from outer backrest mounting strip.

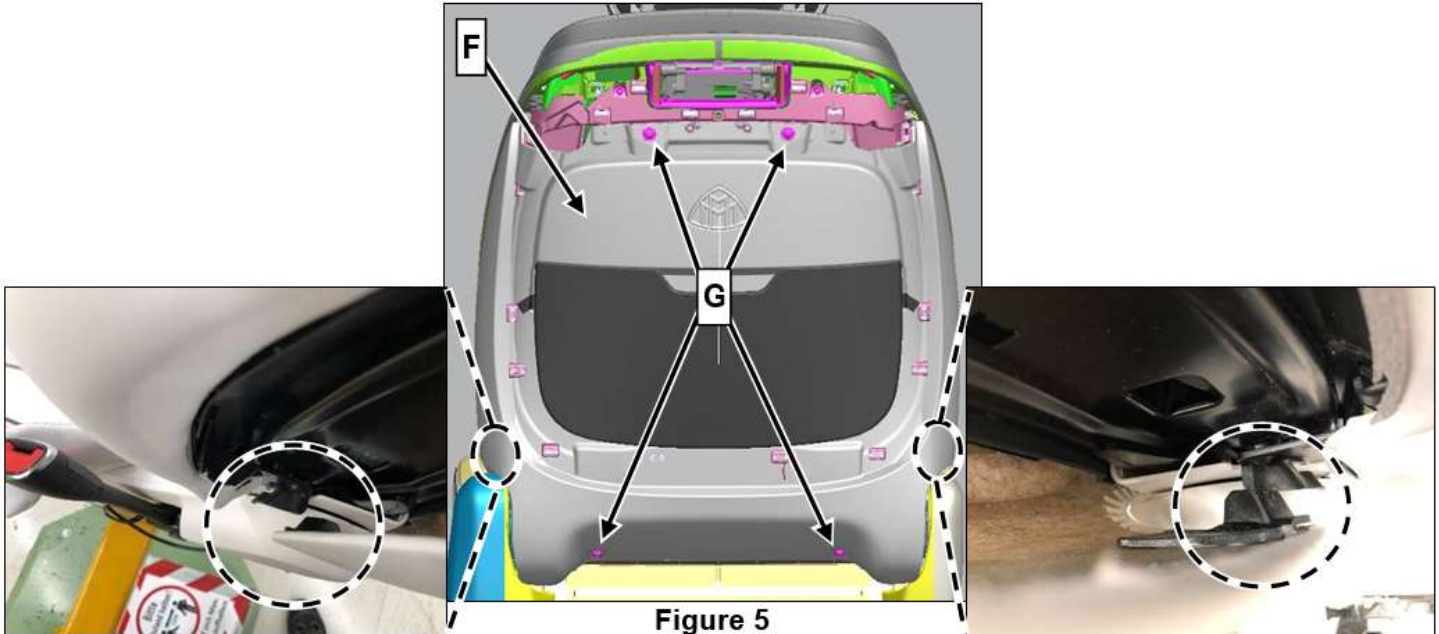
Figure 5

6. Remove seat base trim (F, figure 5).

Remove **i** screws (G, figure 5).

**i** Remove seat base trim toward rear and lift out of side guides (figure 5).

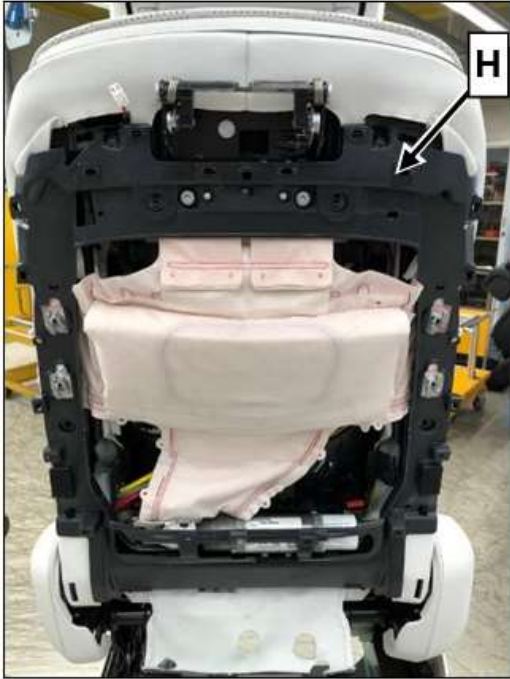
Figure 6

7. Remove bracket (H, figure 6).

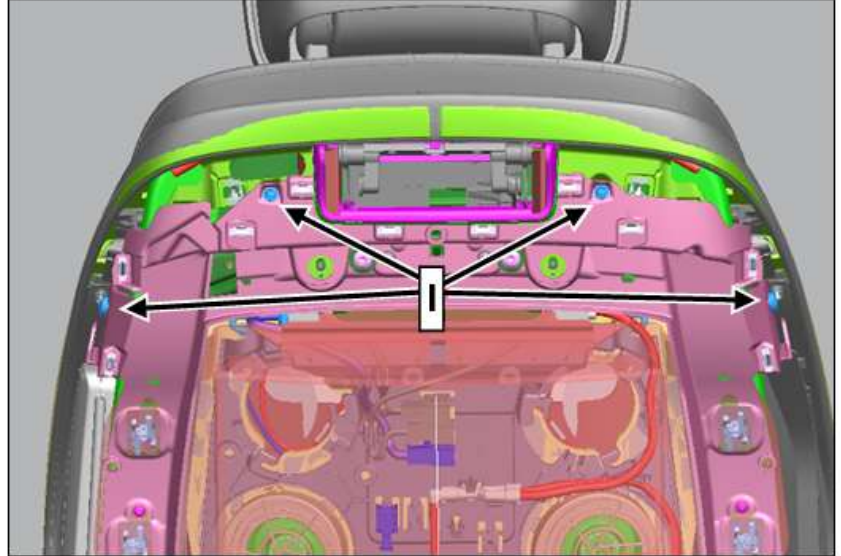
Figure 7

7.1. Remove screws (I, figure 7).

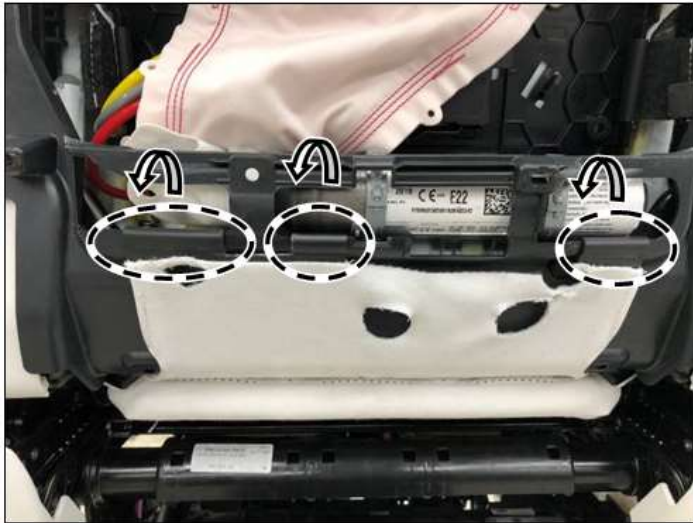
Figure 8

7.2. Unhook lower seat cover from bracket (figure 8).

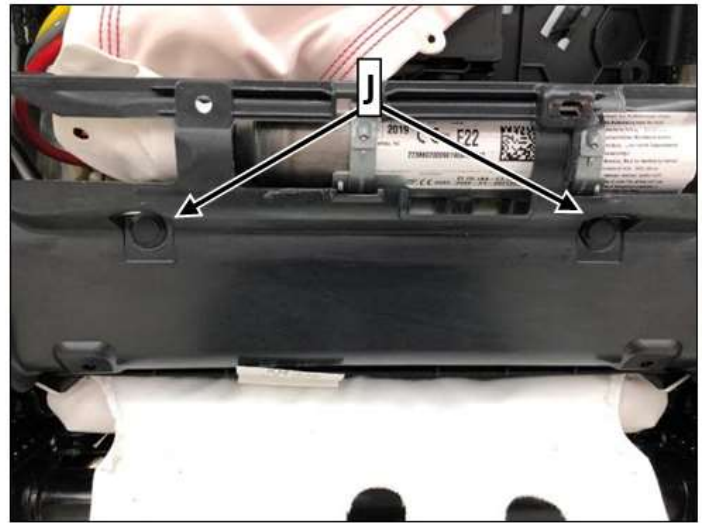
Figure 9

7.3. Remove expansion rivets (J, figure 9).

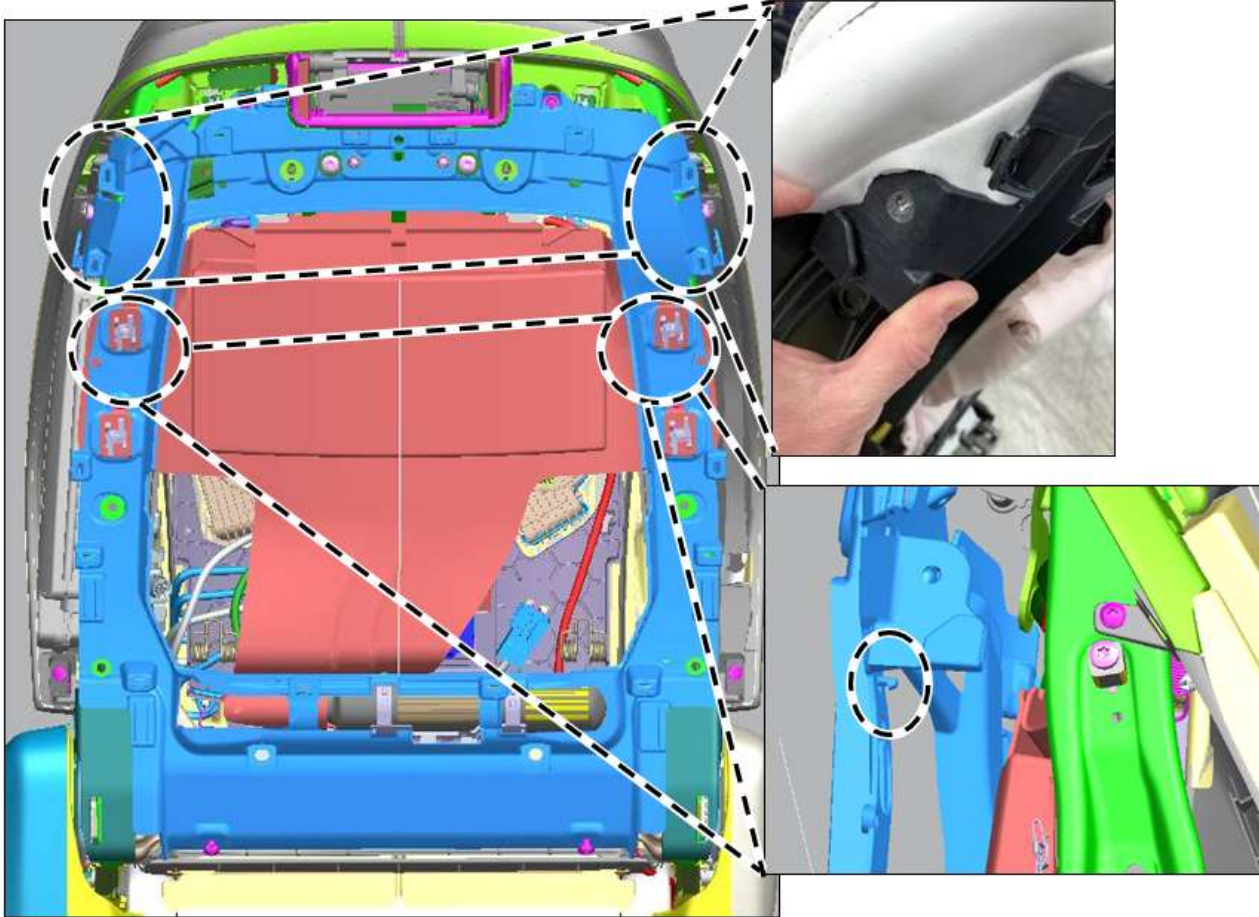
Figure 10

7.4. Unclip upper left and right bracket (figure 10).

**i** Pay attention to the hook of the seat backrest frame (figure 10)!

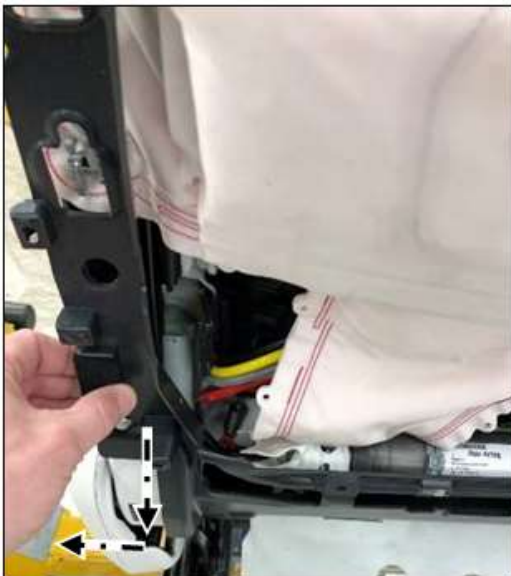
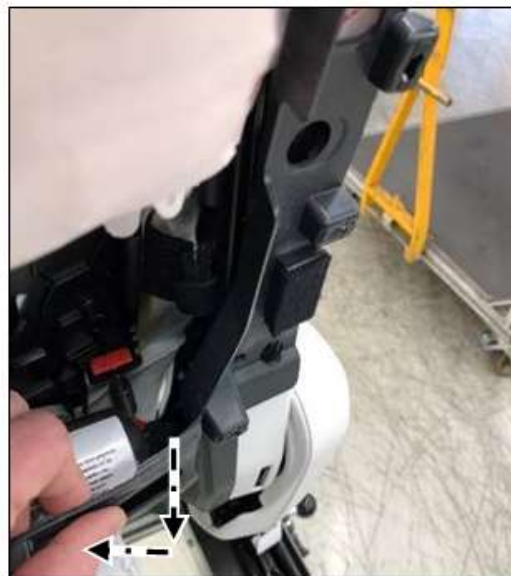
7.5. Pull bracket at bottom left and right toward rear and slide to the left (figure 11 and 12).

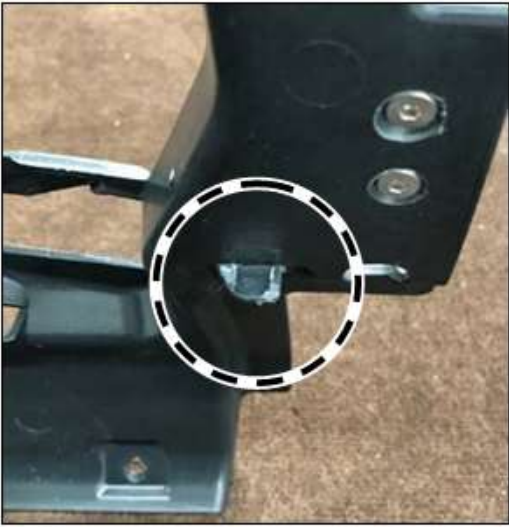
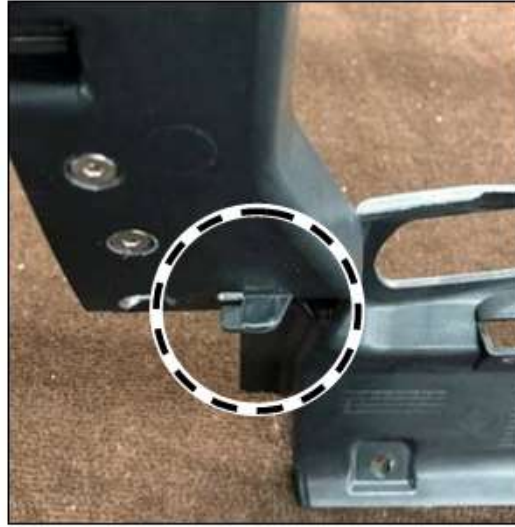
**i** Pay attention to the catch tabs on the bracket (figure 13 and 14)!

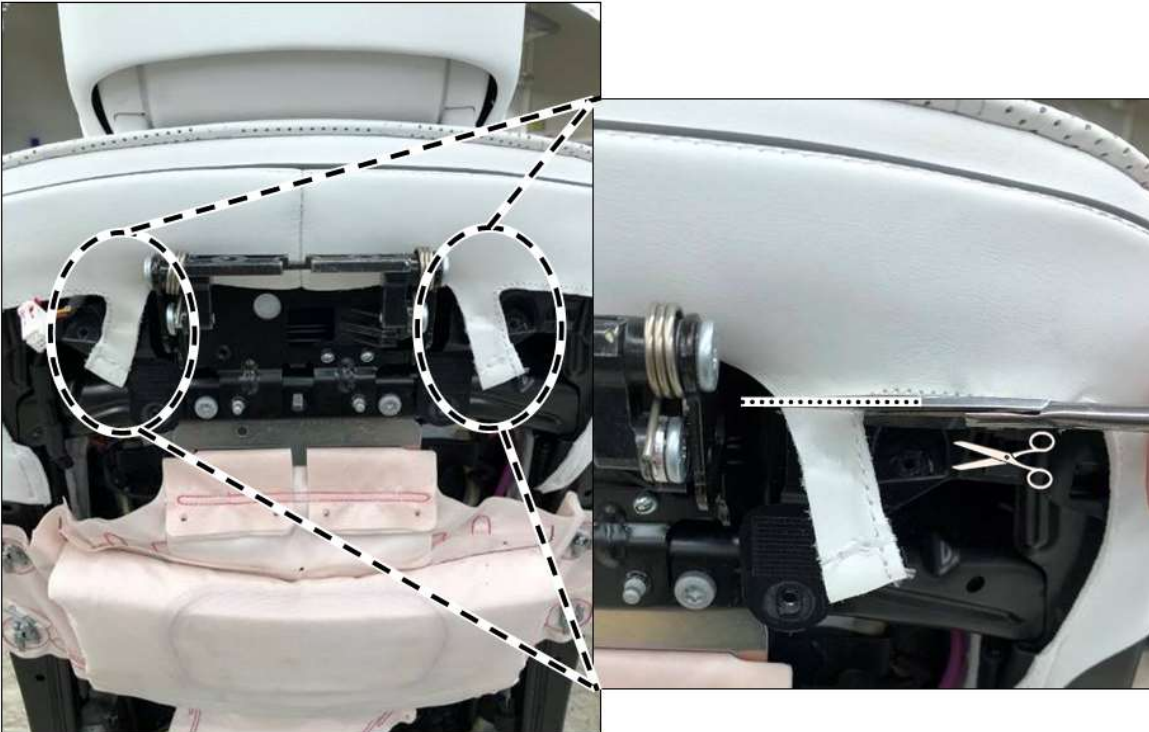
Figure 15

8.1. Cut off retaining tabs on left and right seat cover (figure 15).

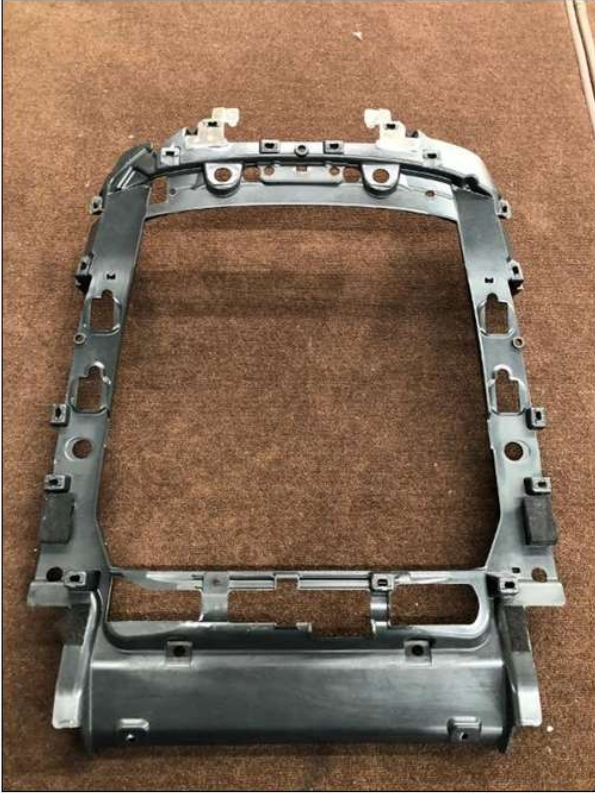
Figure 16

9. Install new bracket in reverse order (figure 16).

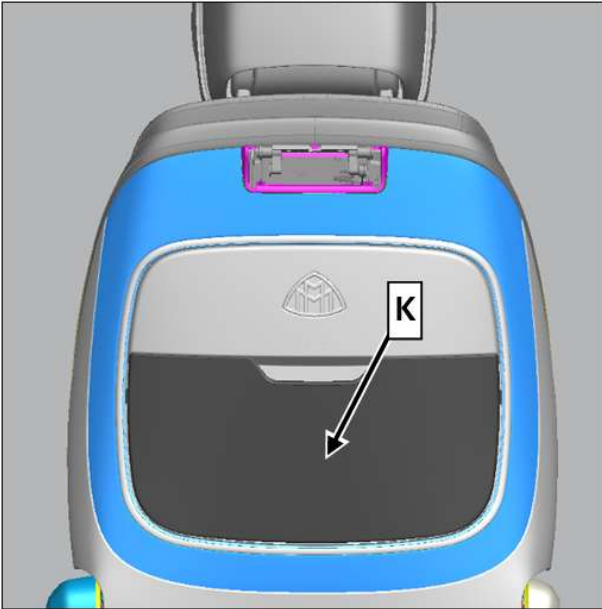
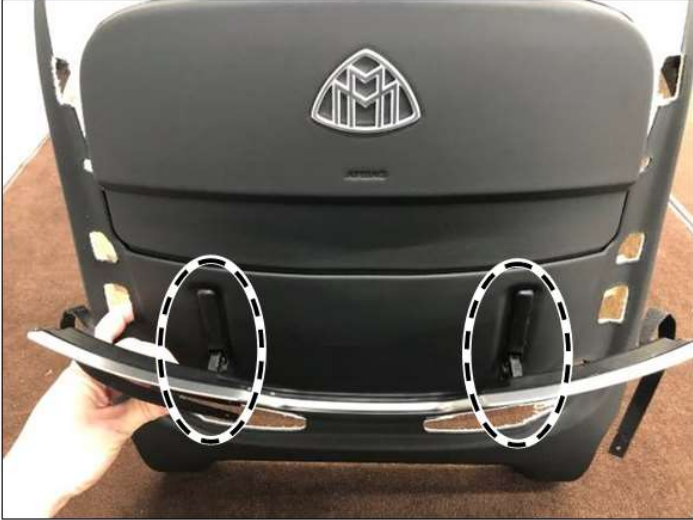
Figure 17

- 10.1. Attach outer seat backrest cover (K, figure 17) to new seat base trim.

10.2. Hook outer seat backrest cover from the seat base trim (Figures 17 and 18).

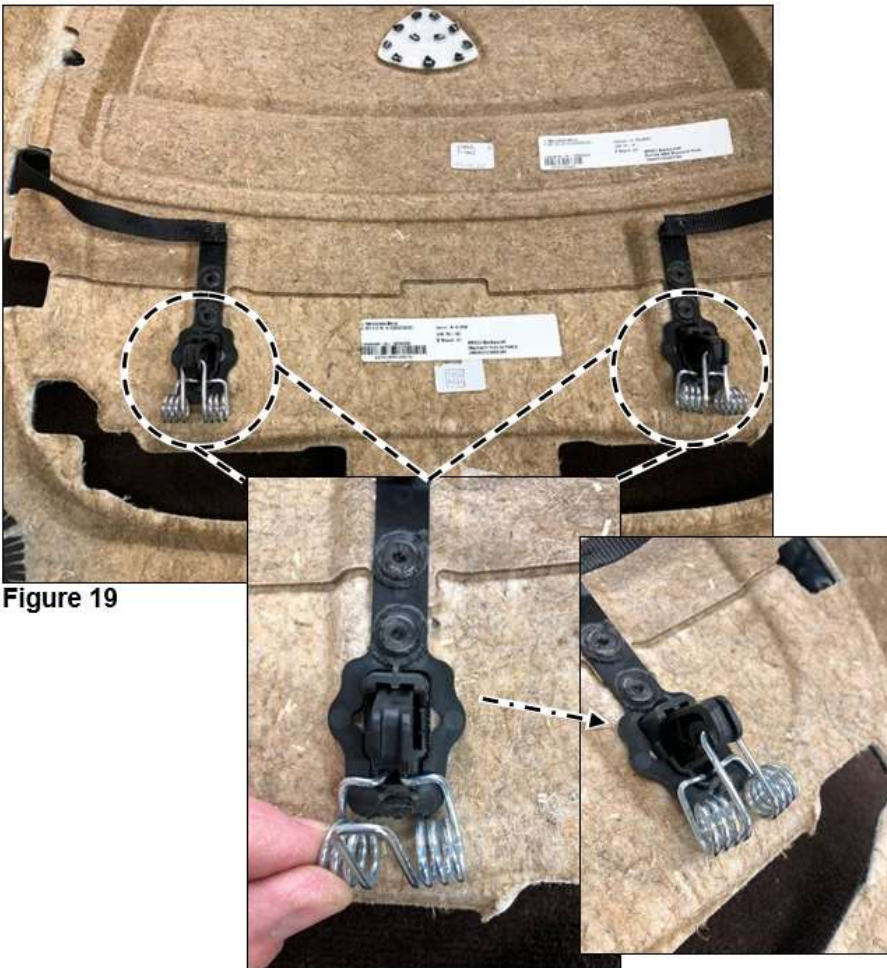
Figure 19

10.3. Remove the spring on the left and right of the guide of the outer seat backrest cover on the mounting strips from the old seat base trim, install on the new seat base trim and attach the guide of the outer seat backrest cover to the mounting strips (Figure 19).

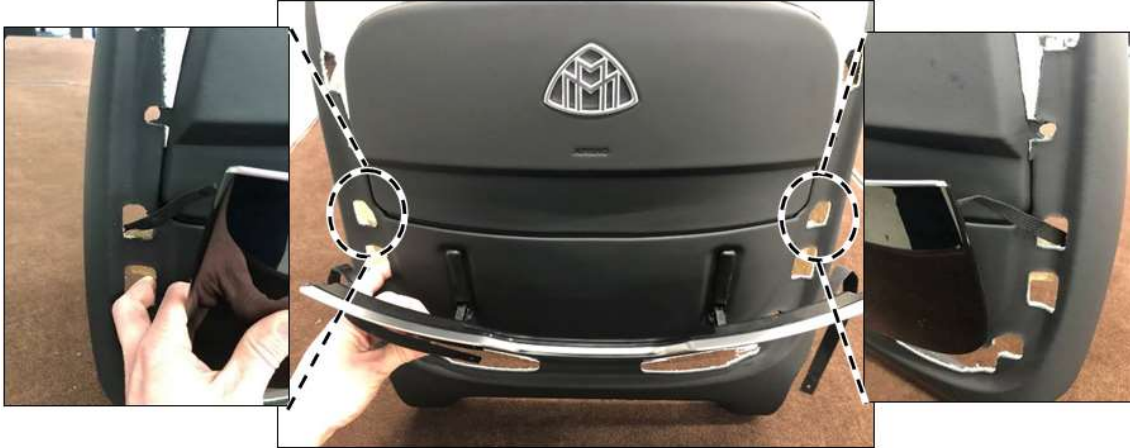
Figure 20

10.4. Insert the check strap on the left and right from the seat base trim (Figure 20).

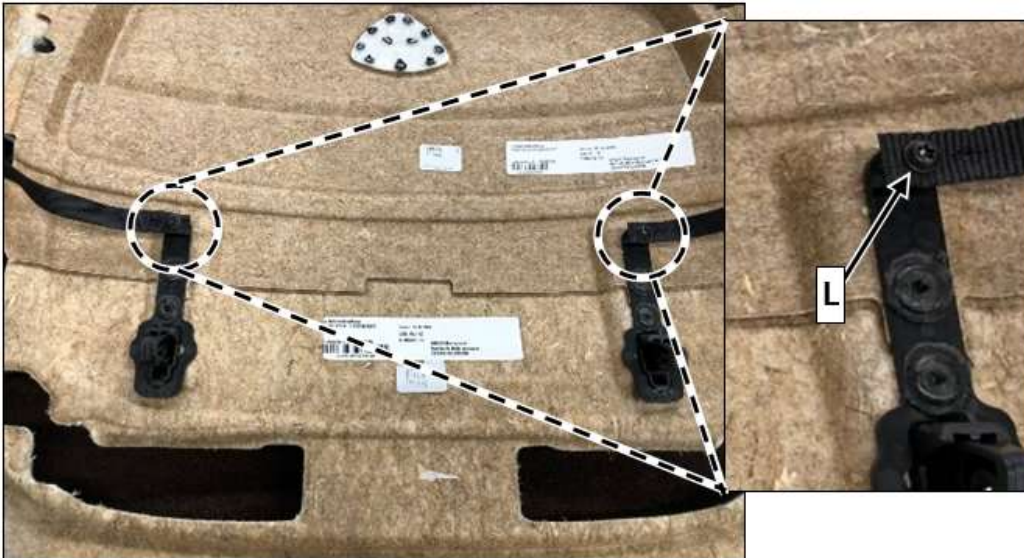
Figure 21

10.5. Install screws (L, figure 21) to seat base trim for the check strap of the outer seat backrest cover.

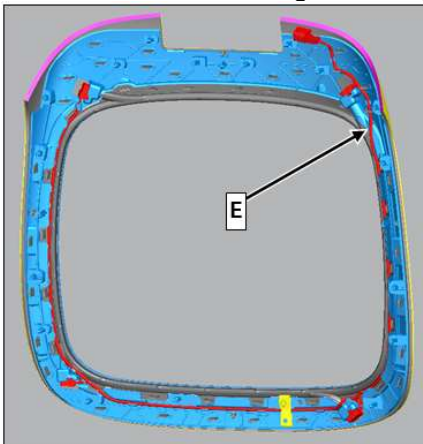
Figure 22

12. Install electrical wiring harness (E, figure 22) in new outer backrest mounting strip.

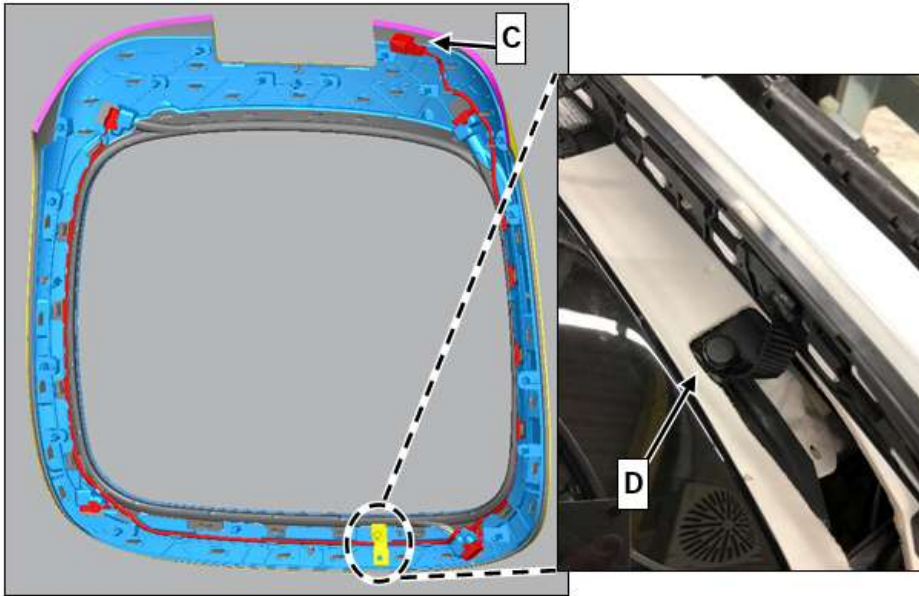
Figure 23

13. Connect electrical connectors (C), attach lower securing clip (D), and install/clip in outer backrest mounting strip to the front seat in reverse order (figure 23).

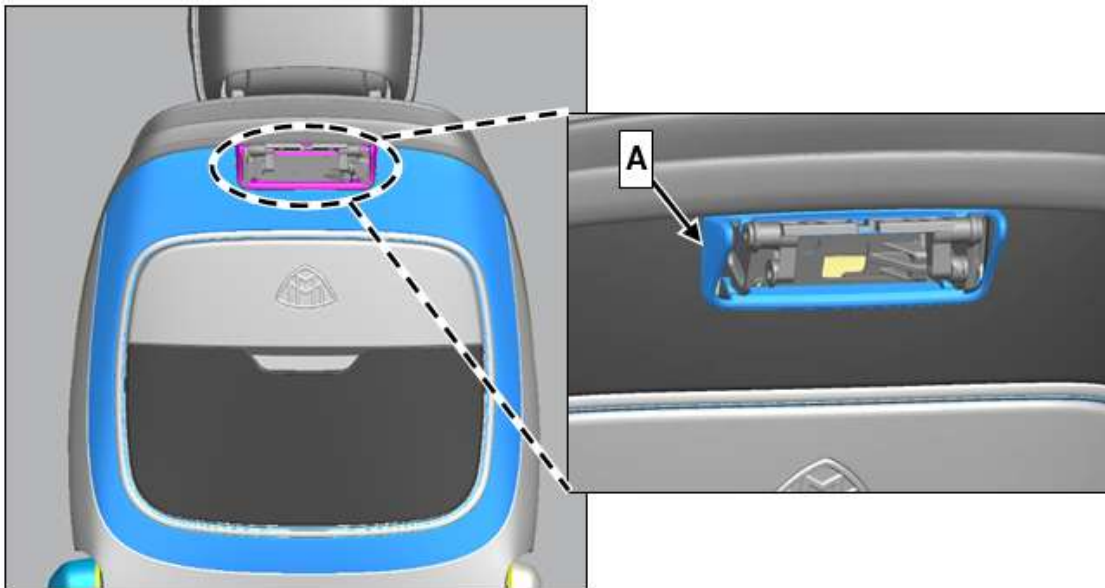
Figure 24

14. Install/clip in cover (A, figure 24).

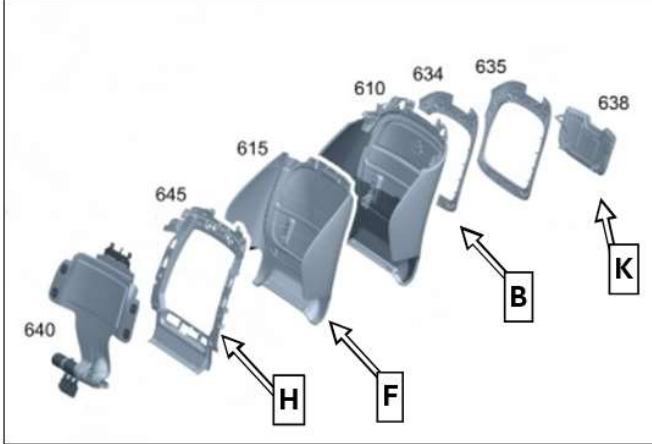
Sample illustration from parts process

B: Outer backrest mounting strip  
 F: Seat base trim  
 H: Outer seat backrest cover  
 K: Bracket
