Date: April 19, 2022
Contact: Technical Services
Subject: NHTSA Recall 22V217 - Brake bleeding campaign

**Campaign Code:** PP2ZZQ2201

2020 Piaggio MP3 500
2021 Piaggio MP3 500

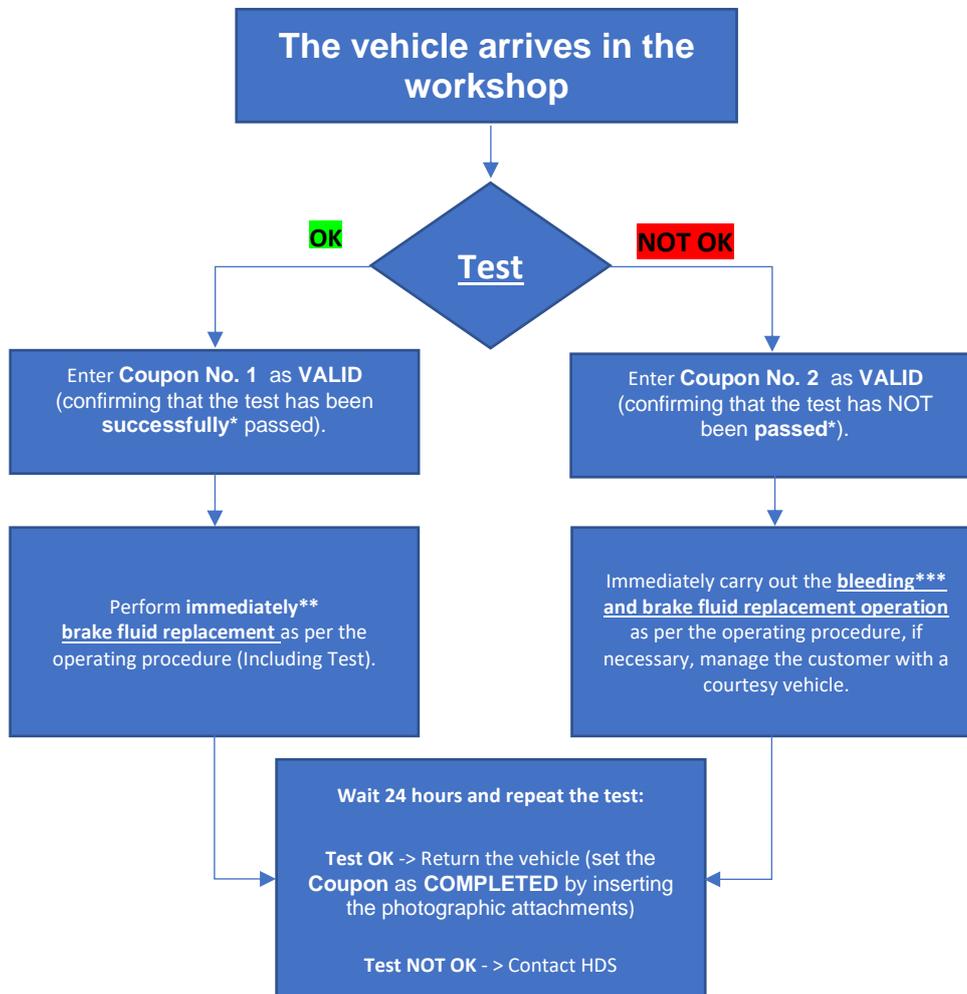
Below is an operational diagram to aid workshop operations

- Test OK** -> The three checks must be met
1. Distance measured to the right-hand lever \geq 95 mm
 2. Distance measured to the left-hand lever \geq 95 mm
 3. Brake pedal consistent

Tests NOT OK -> Any of the three measures fail

* The dealer will be responsible for analysing the outcome of the test.

** If the customer cannot leave the vehicle immediately in the workshop, schedule the intervention within a maximum of 6 days; illustrating to the customer, as also reported in the online use and maintenance booklet (<https://dealerportal.piaggiogroup.com>), that the efficiency of the braking system must be checked before each use.

*** The bleeding procedure must only be performed on the part of the system that did not pass the Test;

1. Left-hand lever + Right-hand lever + Pedal-> NOT OK -> perform the complete bleeding procedure + complete replacement of fluid
2. Left-hand lever -> NOT OK -> Bleeding of rear brake + complete replacement of fluid
3. Right-hand lever -> NOT OK -> Bleeding of front brake + complete replacement of fluid
4. Pedal -> NOT OK -> Bleeding of combined braking system + complete replacement of fluid

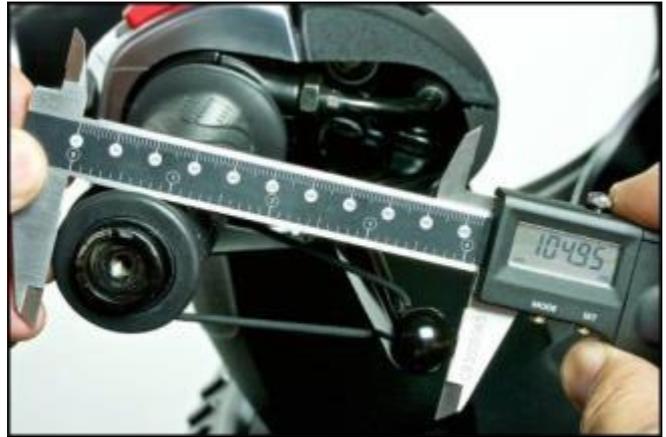
Minimum permissible distance: 95 mm

NOTE: Take a photo of the position of the right-hand lever when pulled completely before the procedure, and attach to the service coupon. Photo 2

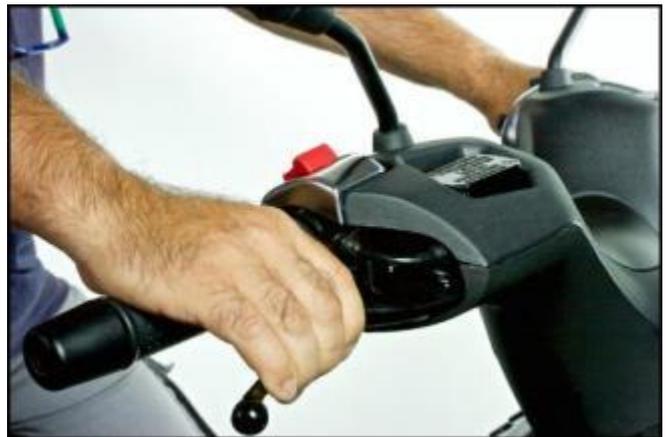
If possible, pull the two levers of the manual brake master cylinders forcefully at the same time.

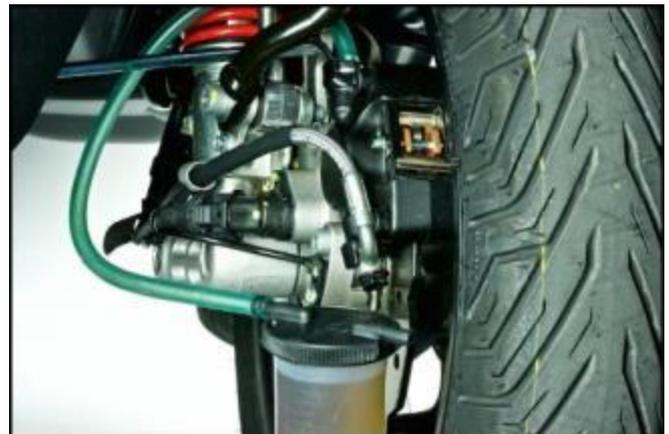
Continue filling the left front brake circuit until approximately 120 cc has been drained into the collector container.

N.B: The photo illustrates the position of the steering where the reservoir of the front master cylinder offers the best filling conditions.

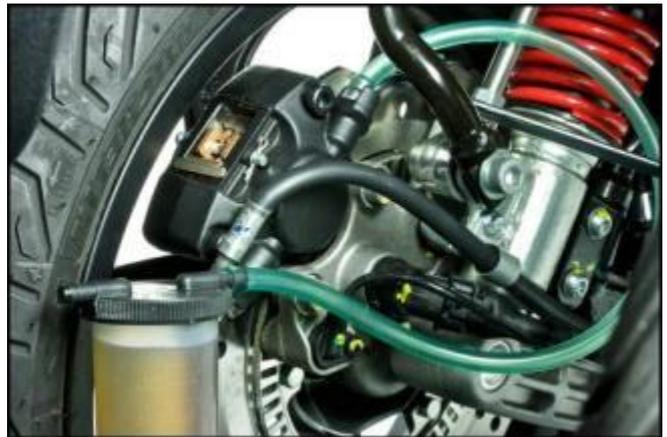
Continue filling the right hand front brake circuit until approximately 120 cc has been drained into the collector container.

N.B: The photo illustrates the position of the steering where the reservoir of the front master cylinder offers the best filling conditions.

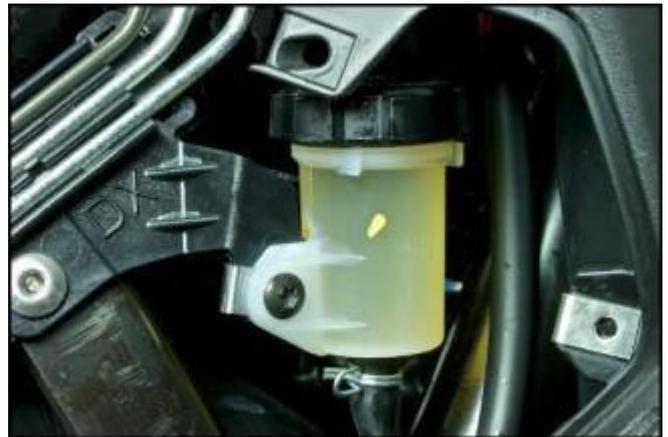
Fill the combined braking system master cylinder reservoir, adding 4 times the volume of new fluid necessary to fill the reservoir system to flush the system, draining the fluid contained in the circuit under pressure from the bleed nipple of the front brake servo pump.

N.B: Do not operate the pedal repeatedly while the bleed nipple is open.

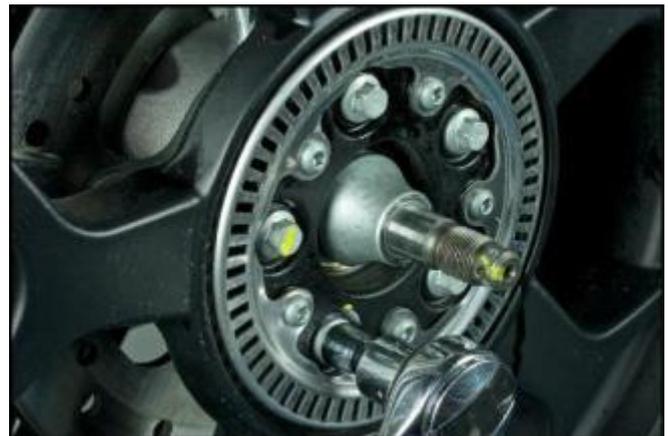
Refit the rear wheel with the 5 screws and the relative washers.

Tighten the screws to a torque of 20-25 Nm.

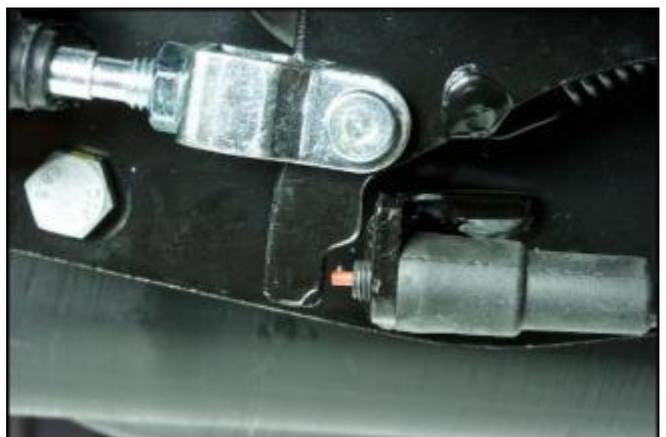
It is more serious, however, if there is no clearance between pedal arm and brake light switch when the pedal is in the rest position. (**pushrod too long**)

This is extremely dangerous as it may cause the rear brake circuit to remain under pressure even when the pedal is released

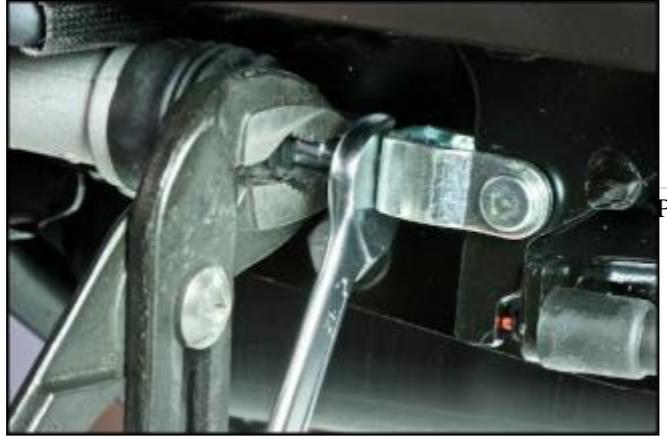
In case of an incorrectly adjusted combined braking system pedal, move the gaiter out of the way, loosen the check nut and adjust the length of the master cylinder actuator link with pliers.

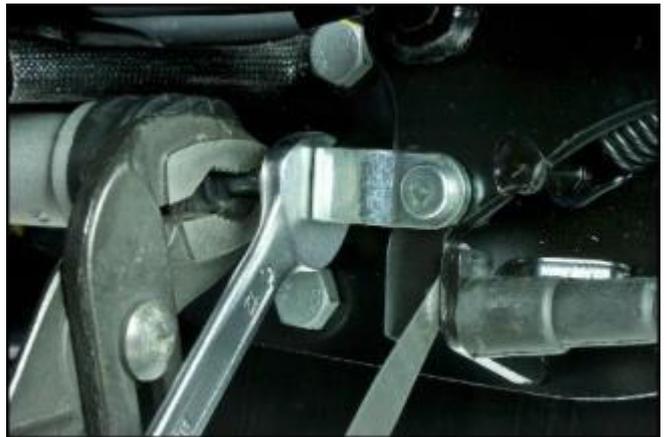
Adjust the length of the pushrod so that the brake light actuator pin has no remaining clearance with the pedal arm at a distance of approximately 0.40 mm from the end stop rest. (adjust pushrod so pedal arm just touches the end of the switch pin , with the .40mm gauge installed between the switch retainer bracket and pedal arm)

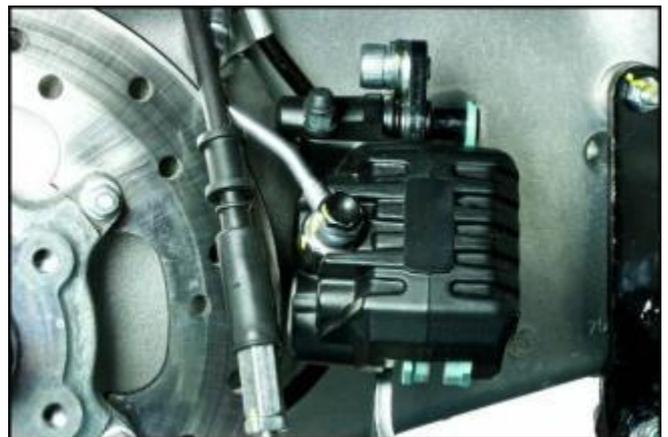
Detach the callipers from the disc and place them in the position shown in the photo.

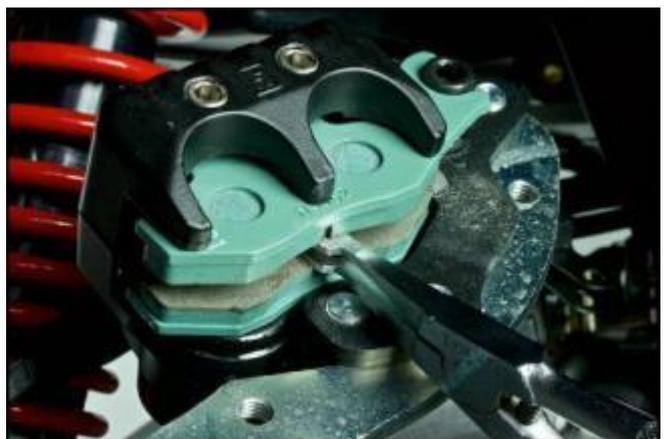
N.B: Make sure that there is enough space in the reservoir to receive the volume of fluid sent back from the calliper.
For the best results, separate the pads in one quick movement.

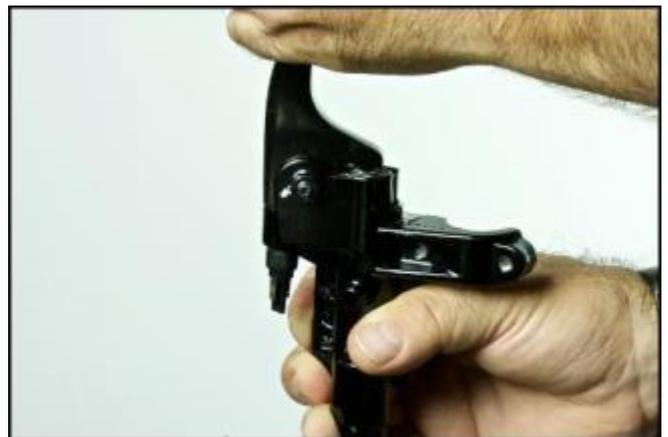
Hold the rear brake master cylinder in a vertical position. Pull the brake lever repeatedly while tilting the master cylinder slightly away from the vertical in all directions. Continue until there is the available travel of the lever reduces perceptibly.

N.B: Pull the lever completely, starting each time from the rest position.

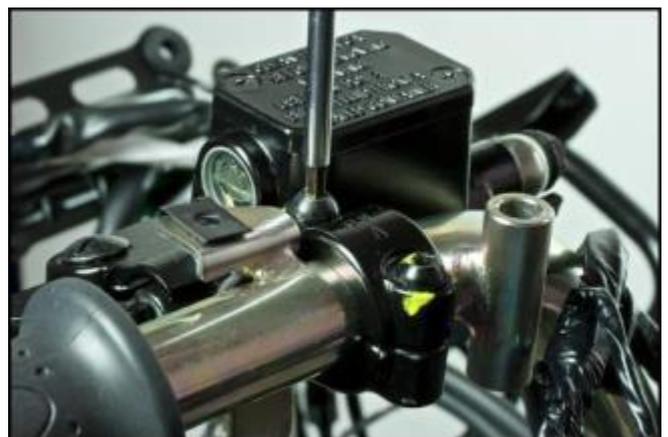
Refit the rear master cylinder onto the handlebar, making sure that the handlebar clamp U-bolt is fitted the right way around and that the clamp itself is adjusted correctly.

The handlebar clamp U-bolt can only fit in one position onto the upper part of the clamp, and the adjustment of the respective fastener screws affects the inclination of the master cylinder unit and the lever relative to the handlebar.

The mount of the master cylinder must be parallel with the handlebar clamp U-bolt.

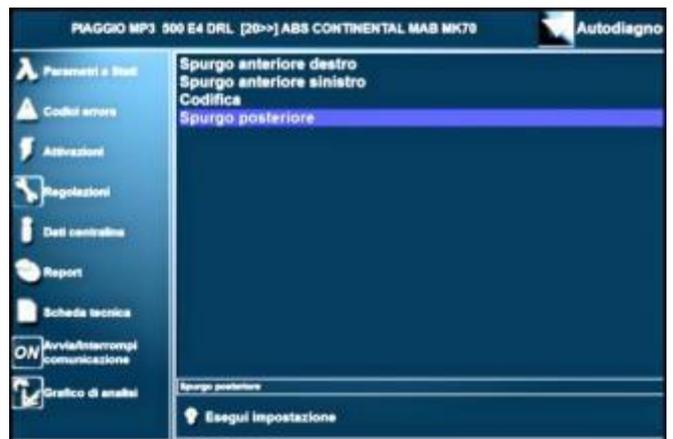
ABS Rear circuit bleeding

- Select Rear bleeding

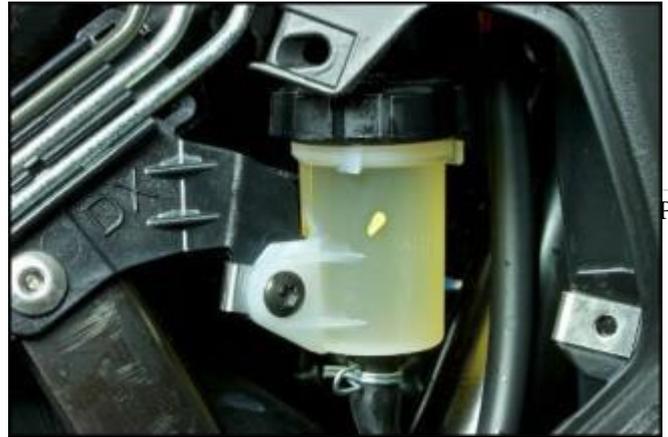
Fill the combined braking system master cylinder reservoir, **adding 4 times the volume of new fluid necessary to fill the reservoir system to flush the system**, draining the fluid contained in the circuit under pressure from the bleed nipple of the front brake servo pump.

N.B: Do not operate the pedal repeatedly while the bleed nipple is open.
