Product Safety Recall

N222366190 Driver Front Airbag Inflator May Rupture

Release Date: February 2025

Revision: 02

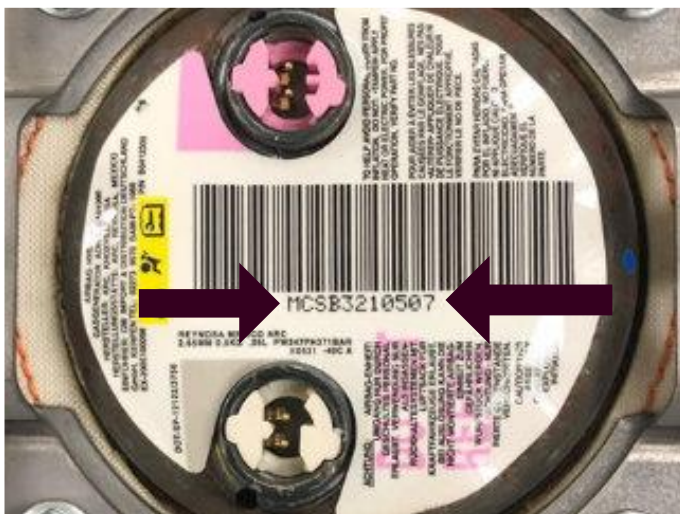
6165162

IMPORTANT: (TECHNICIAN and WARRANTY ADMINISTRATOR) SERIAL NUMBER RECORDING REQUIREMENT. The replacement steering wheel airbag serial number must be captured by the technician and recorded on the job card. The Warranty Administrator **MUST** enter the serial numbers in GWM (Global Warranty Management) or in DMS (Dealer Management System). Enter the serial number of the **replacement airbag** in the 'Labor Operation Dependency Code' field per the screen shown.

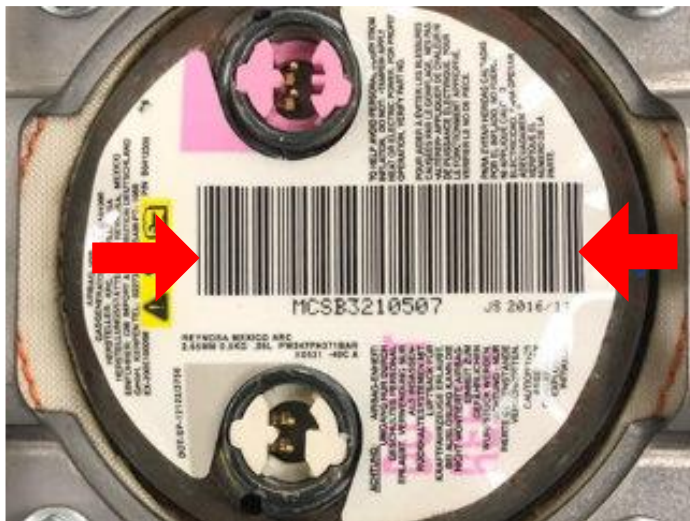
6165164

If the App is already loaded to your phone, simply:

1. Scan the VIN (door pillar QR code or windshield VIN barcode) and
2. Scan the new part barcode and

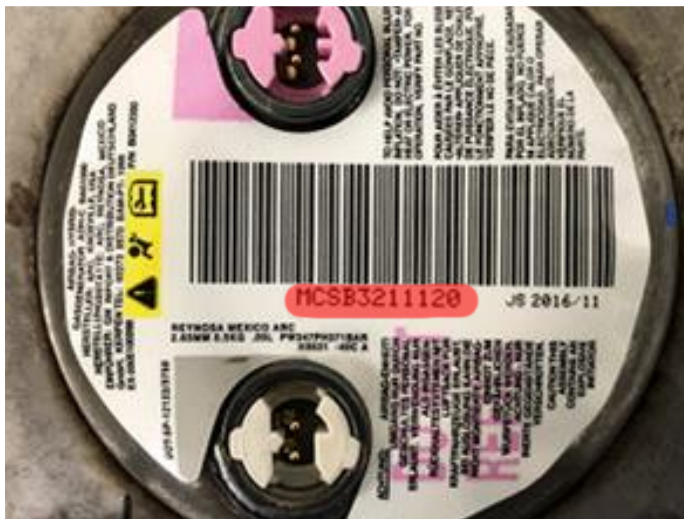
5948574

1. Remove the steering wheel airbag assembly. Refer to *Steering Wheel Airbag Replacement* in SI.

2. Record the serial number of the New Service Steering Wheel Airbag as described above and per important statement below.

3. Replace the steering wheel airbag assembly. Refer to *Steering Wheel Airbag Replacement* in SI. **Do Not Deploy the AIRBAG.**

Note: The removed steering wheel airbag module MUST be defaced on the airbag cover (customer facing side) with a paint pen or permanent marker to prevent it from being reused.

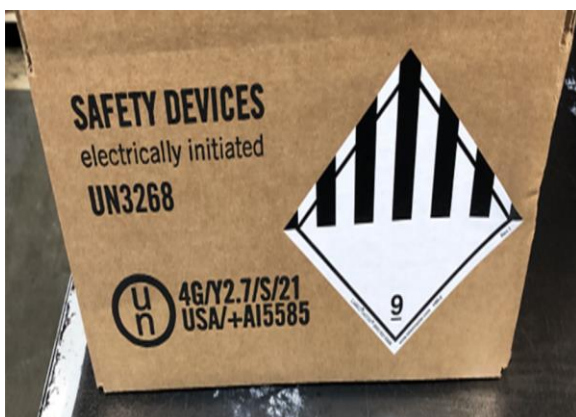
6787550

- Confirm box is in an acceptable condition. Box should have no visible signs of damage and should be capable of withstanding additional transportation.

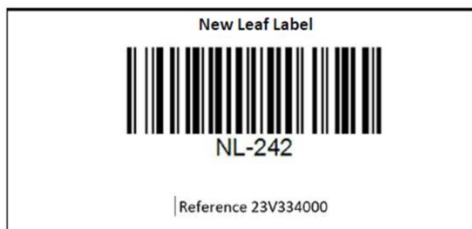
6829226

6. Print the above “New Leaf Label”.
