# Product Safety Recall

## N222366190 Driver Front Airbag Inflator May Rupture

**Release Date:** January 2025

| <b>Condition</b> | General Motors has decided that a defect, which relates to motor vehicle safety, exists in certain 2015 model year Buick Enclave, Chevrolet Traverse, and GMC Acadia vehicles. In these vehicles, the front-driver airbag inflator may contain a supplier manufacturing defect that may result in inflator rupture during deployment. An inflator rupture may cause metal fragments to pass through the airbag and into the vehicle interior, which may result in injury or death to vehicle occupants. |

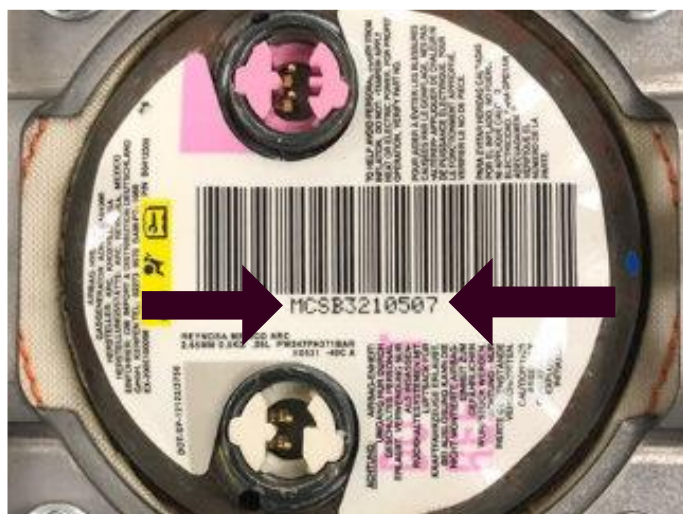
6165162

**IMPORTANT: (TECHNICIAN and WARRANTY ADMINISTRATOR) SERIAL NUMBER RECORDING REQUIREMENT.** The replacement steering wheel airbag serial number must be captured by the technician and recorded on the job card. The Warranty Administrator **MUST** enter the serial numbers in GWM (Global Warranty Management) or in DMS (Dealer Management System). Enter the serial number of the **replacement airbag** in the 'Labor Operation Dependency Code' field per the screen shown.

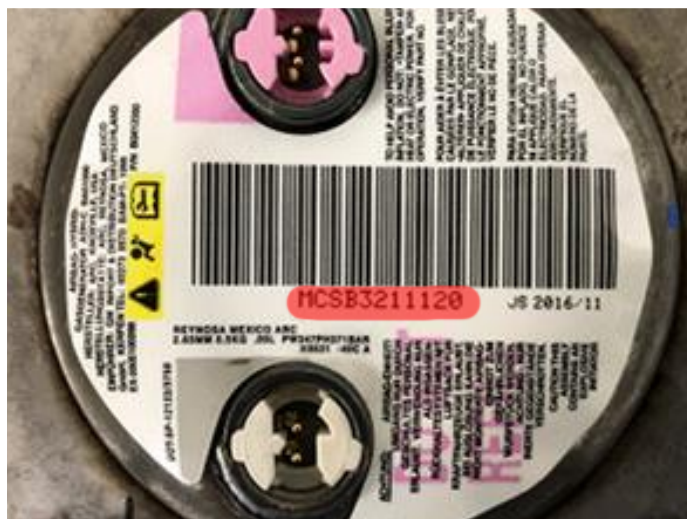
5948574

1. Remove the steering wheel airbag assembly. Refer to *Steering Wheel Airbag Replacement* in SI.

2. Record the serial number of the New Service Steering Wheel Airbag as described above and per important statement below.

3. Replace the steering wheel airbag assembly. Refer to *Steering Wheel Airbag Replacement* in SI. **Do Not Deploy the AIRBAG.**

**Note:** The removed steering wheel airbag module MUST be defaced on the airbag cover (customer facing side) with a paint pen or permanent marker to prevent it from being reused.

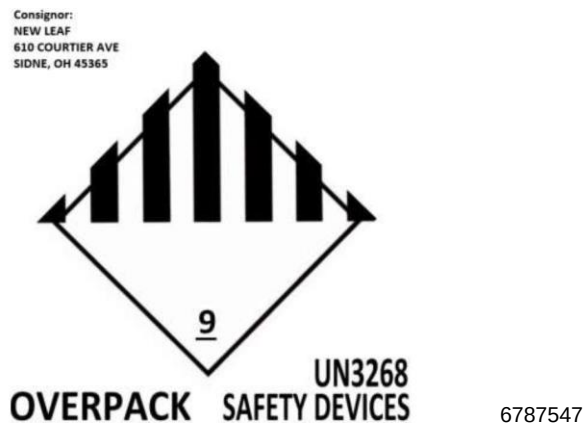
- RXO will email the required Pallet Label to be affixed to each pallet of used airbag modules.

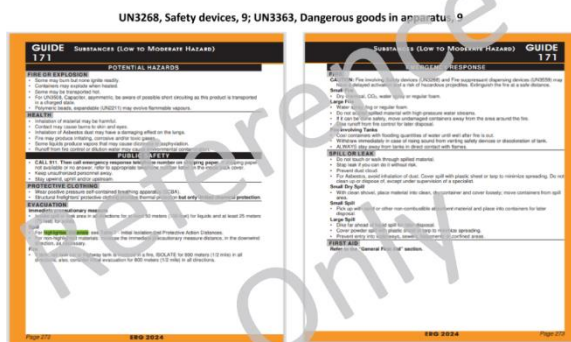
6817433

- RXO will email the required Overpack label to be affixed to each pallet of used airbag modules.
- RXO will email the Bill of Lading (BOL). Print two copies of the BOL, one copy to provide to the LTL driver and one copy to keep for your records.

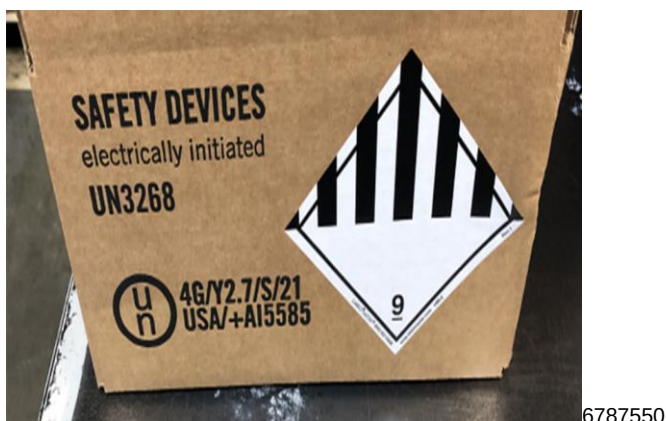
**IMPORTANT: DO NOT DEPLOY THE AIRBAG. AIRBAGS MODULES MUST BE RETURNED.**

- Confirm box is in an acceptable condition. Box should have no visible signs of damage and should be capable of withstanding additional transportation.

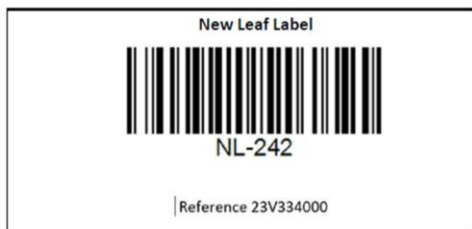
6787554

#### 5. New Leaf Return Label Identification.

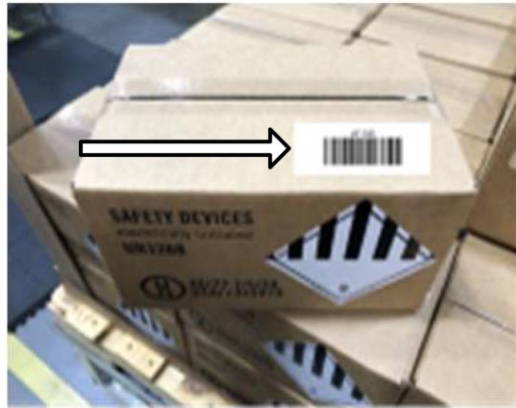
6787556

- Cut and affix the “New Leaf Label” to each box as shown in the above graphic. DO NOT COVER THE CLASS 9 MARKING.

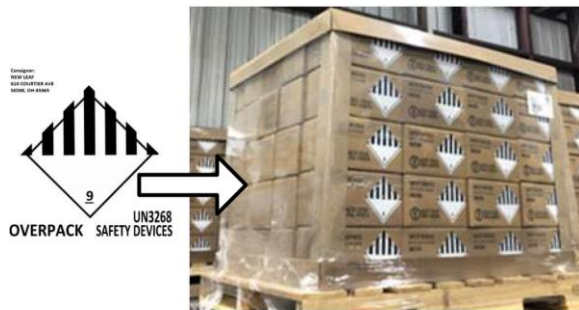
6787558

- Arrange the airbag modules on a pallet in acceptable condition as the above graphic illustrates.
  - 20 boxes per layer – 5 rows / 4 boxes in each row per layer.
  - 5 layers total per pallet (100 Boxes).
- Shrink-wrap the boxes to the pallet.
- Affix the over-pack label and pallet label on the side of the pallet. DO NOT PLACE THESE LABELS ON THE TOP OF THE PALLET.
- If 100 boxes have not been accumulated within a 2-week period, ship a partial pallet, ensuring proper label placement and packaging.

- Accumulate and palletize the airbag modules.
- Pallet must be in acceptable condition capable of holding the return airbag modules during transport.
- Pallet size must be roughly 48”X48”. DO NOT use a pallet that would allow the return airbag module boxes to hang over the edge of the pallet.
