SAFETY RECALL BULLETIN

SUBJECT:			NO.: SR-22-002
SEAT BELT AUTOMATIC LOCKING RETRACTOR (ALR) – SAFETY RECALL CAMPAIGN			DATE: June 2022
			MODEL: 2022 Outlander
CIRCULATE TO:	<input checked="" type="checkbox"/> GENERAL MANAGER	<input checked="" type="checkbox"/> PARTS MANAGER	<input checked="" type="checkbox"/> TECHNICIAN
<input checked="" type="checkbox"/> SERVICE ADVISOR	<input checked="" type="checkbox"/> SERVICE MANAGER	<input checked="" type="checkbox"/> WARRANTY PROCESSOR	<input checked="" type="checkbox"/> SALES MANAGER

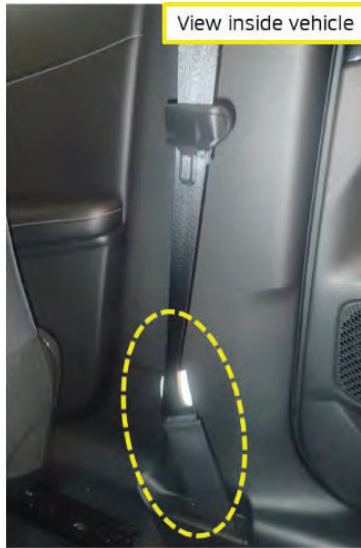
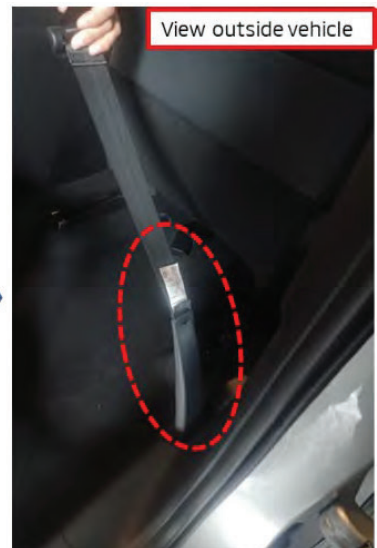
A. SEAT BELT TAG PASSENGER SIDE FRONT

1. Locate the seat belt tag as shown in image A and B below.

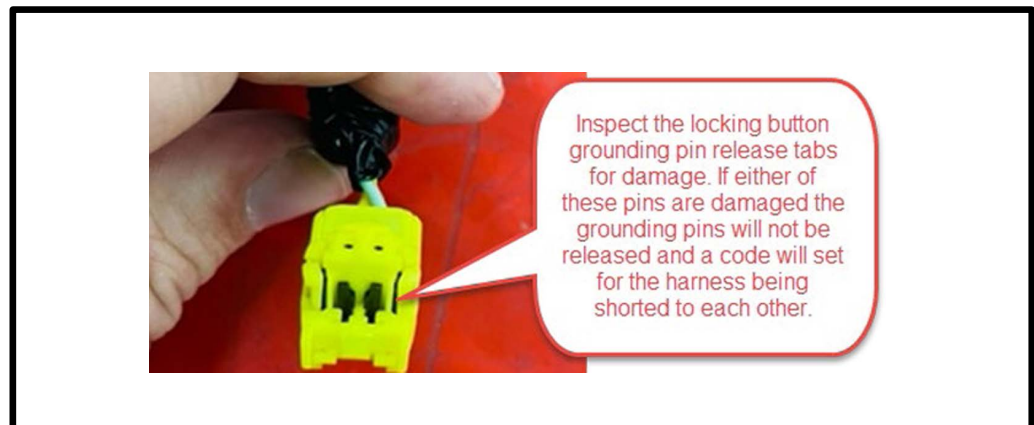
2. Removal and inspection of connector.

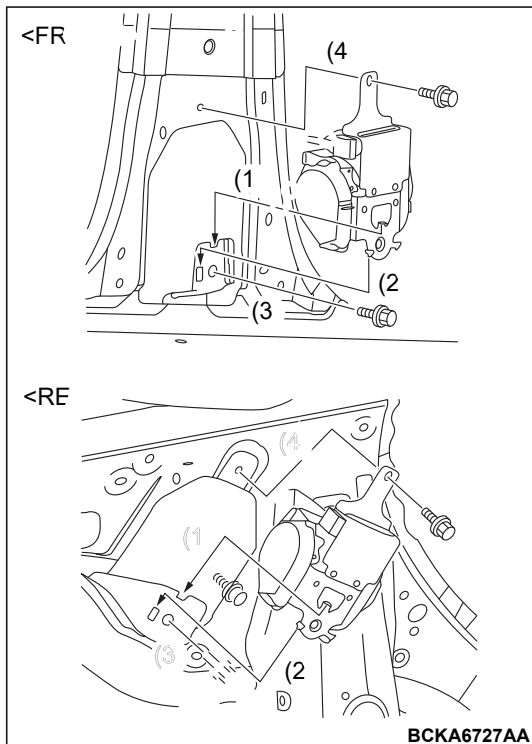
Insert the claws of the seat belt retractor into the body, and install the seat belt retractor in order of the numbers shown in the figure.
