TECHNICAL INSTRUCTIONS

SAFETY RECALL 22TA05

REAR AXLE SHAFTS MAY SEPARATE FROM VEHICLE DURING DRIVING
(INSPECTION + REPAIR)

CERTAIN 2022 MODEL YEAR TUNDRA AND TUNDRA HV

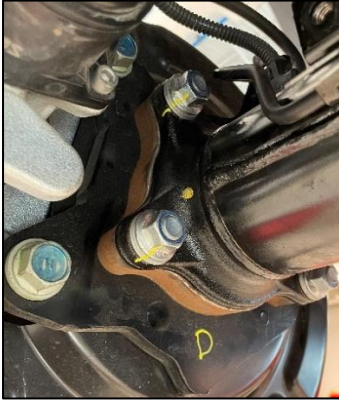
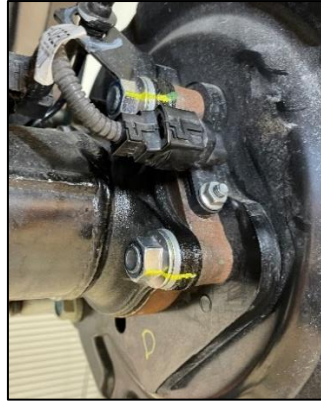
Is there **at least one** nut missing on the
LEFT (Driver) Side?

Upload photo to website as prompted
then proceed to section VII. RIGHT REAR
AXLE HOUSING FLANGE NUT INSPECTION

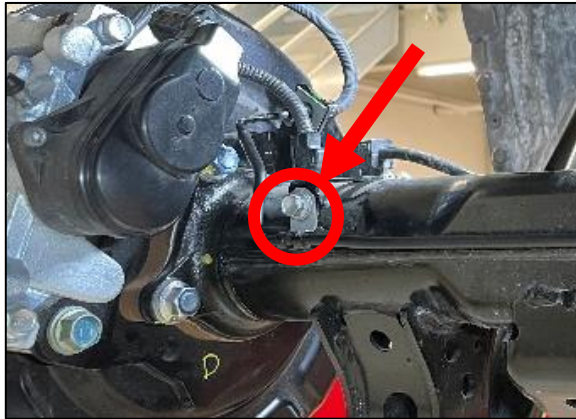
4. MATCHMARK NUTS ON LEFT SIDE

- a. Using a fine tip paint marker, matchmark all 4 nuts, washers, and the axle housing flange.
- b. Mark "D" for "Driver" close to the axle shaft flange so it will be visible while taking photos of the nuts/studs.

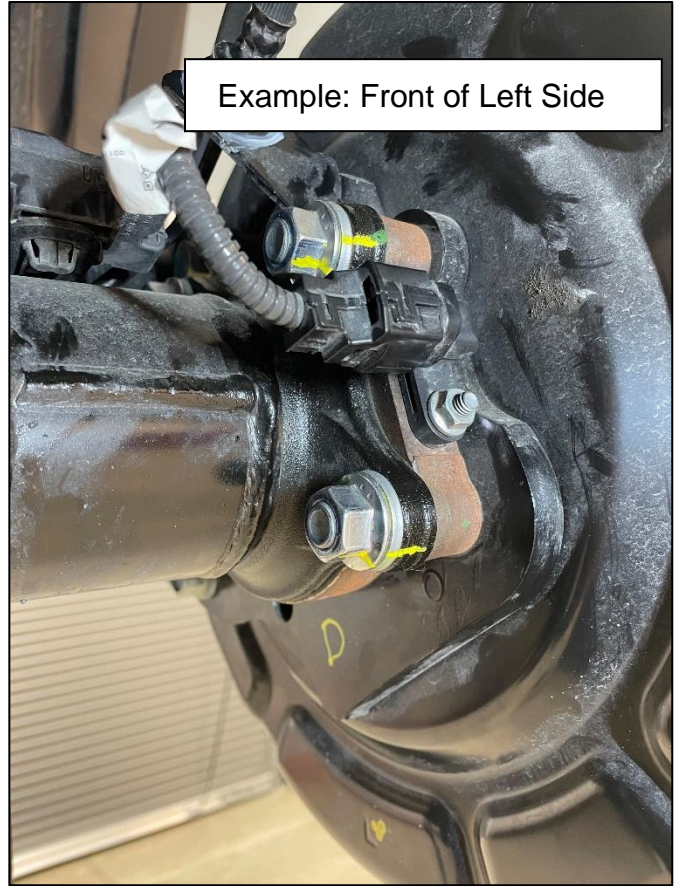
7. TORQUE STEP 2: INCREASE TORQUE TO 95 Nm
- Set torque wrench to 95 Nm (969 kgf cm, 70 ft. lbf)
 - Tighten each nut to 95 Nm (969 kgf cm, 70 ft. lbf) following the tightening sequence shown to the left.

- Only move the brake line enough to create clearance for a torque wrench. Excessive movement could result in permanent damage to the brake line or losing of the joint.
- Be careful not to scratch or cause other damage to the brake line.
- Torque nuts to 95 Nm (969 kgf cm, 70 ft. lbf). DO NOT use torque specification listed in Repair Manual.
- When torquing the nut apply torque in a smooth slow rotation. DO NOT quickly apply torque.
- Do NOT use extensions with the torque wrench.

- c. Photograph the matchmark positions post-torque and upload 2 photos to website (front and rear of axle; 2 nuts per photo).

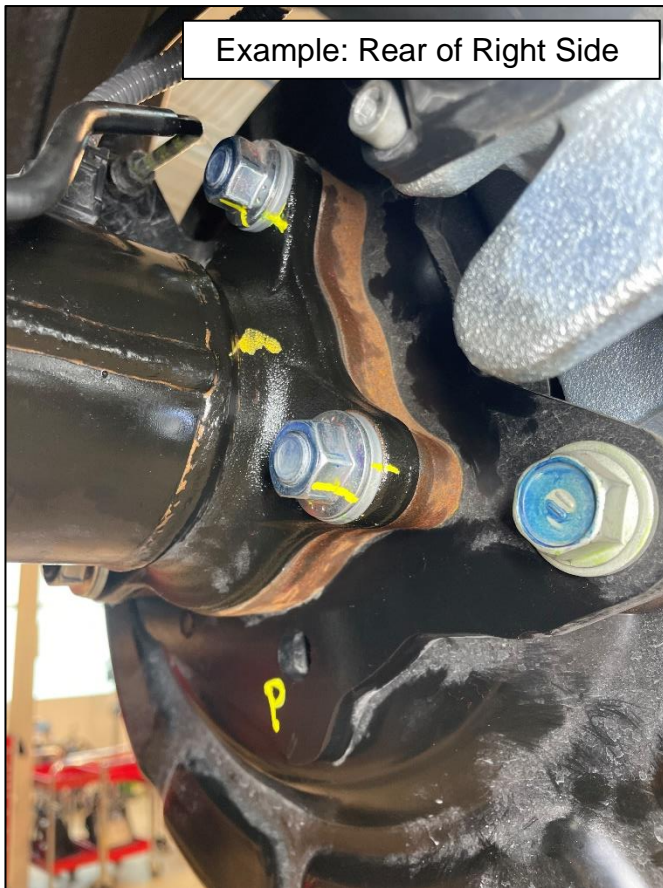
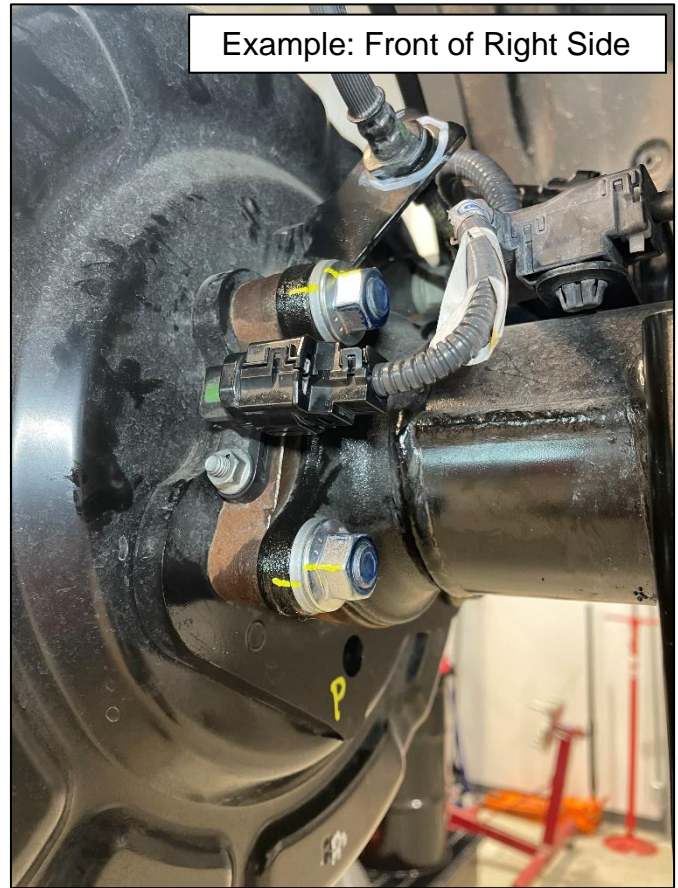
5. TORQUE STEP 2: INCREASE TORQUE TO 95 Nm

- a. Set the torque wrench to 95 Nm (969 kgf cm, 70 ft. lbf)
- b. Tighten each nut to 95 Nm (969 kgf cm, 70 ft. lbf) following the tightening sequence shown to the left.

- Only move the brake line enough to create clearance for a torque wrench. Excessive movement could result in permanent damage to the brake line.
- Be careful not to scratch or cause other damage to the brake line.
- Torque nuts to 95 Nm (969 kgf cm, 70 ft. lbf). DO NOT use torque specification listed in Repair Manual.
- When torquing the nut apply torque in a smooth slow rotation. DO NOT quickly apply torque.
- Do NOT use extensions with the torque wrench.

- c. Photograph the matchmark positions post-torque and upload 2 photos to website (front and rear of axle; 2 nuts per photo).

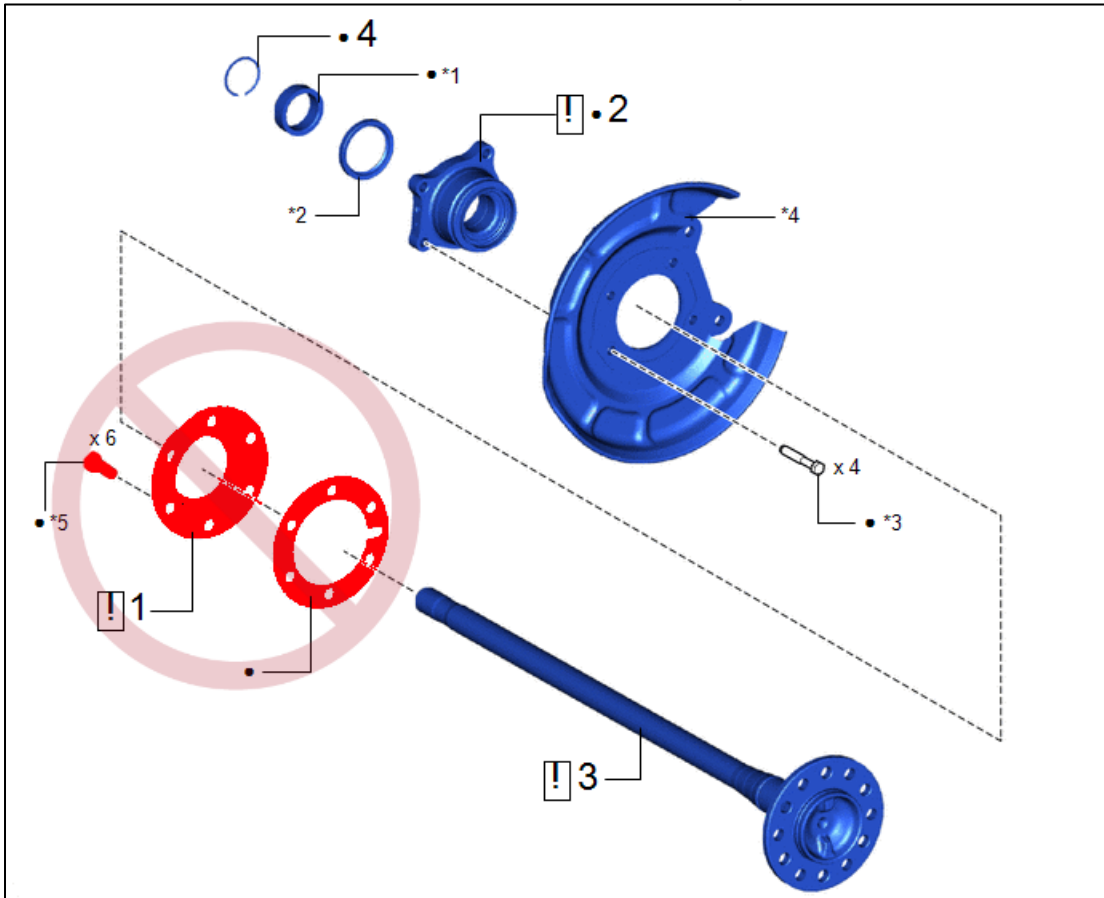
NOTE: DO NOT remove Brake Drum Oil Deflector during disassembly (step 4 in RM).

PART NAME	
1	BRAKE DRUM OIL DEFLECTOR (DO NOT REMOVE)
2	REAR AXLE HUB AND BEARING ASSEMBLY
3	REAR AXLE SHAFT
4	REAR AXLE SHAFT SNAP RING

*1	REAR AXLE BEARING INNER RETAINER	*2	REAR AXLE SHAFT WASHER
*3	PARKING BRAKE PLATE TO REAR AXLE HOUSING BOLT	*4	PARKING BRAKE PLATE SUB-ASSEMBLY
*5	REAR AXLE HUB BOLT (DO NOT REMOVE)	-	-
•	Non-reusable part	-	-

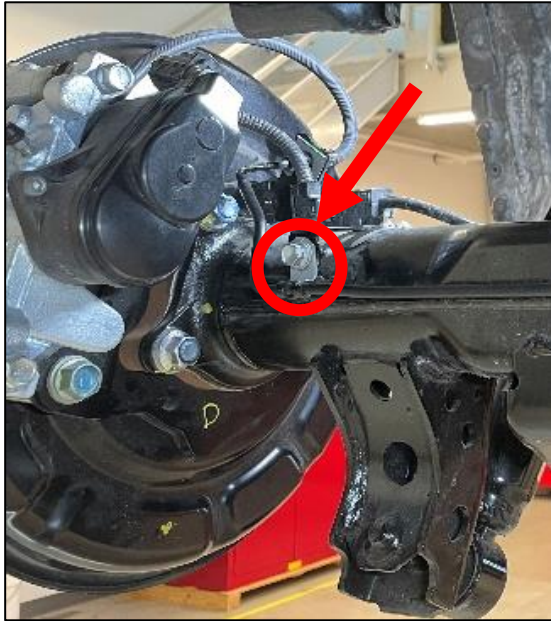
Left (Driver) Side

- a. Reinstall the bolts that secure the hard brake line to the axle housing.

Torque Specification: 19.5 Nm (199 kgf cm, 173 in. lbf)

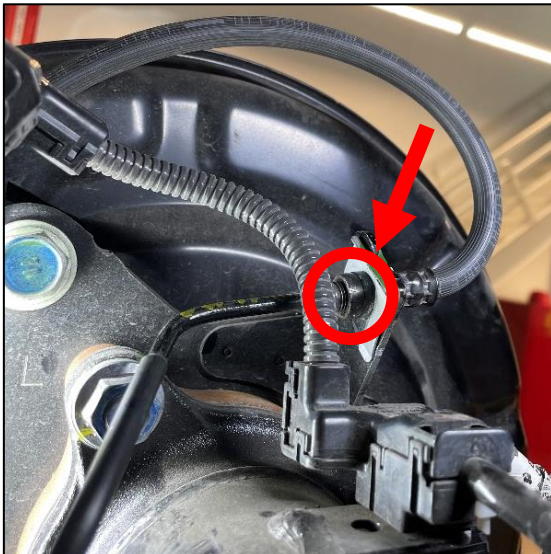
Left (Driver) Side

- a. Inspect both brake line joints for leaks where the hard brake tube connects to the flexible hose. If leaks are found, refer to Repair Manual for tightening procedure and torque.

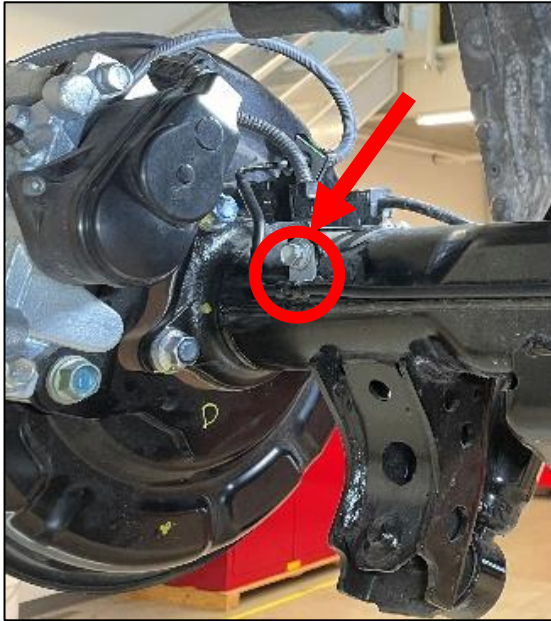
Left (Driver) Side

- a. Reinstall the bolts that secure the hard brake line to the axle housing.

Torque Specification: 19.5 Nm (199 kgf cm, 173 in. lbf)

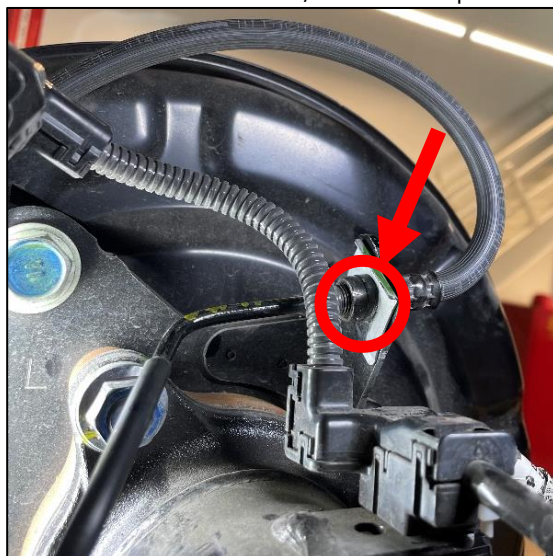
Left (Driver) Side

- a. Inspect both brake line joints for leaks where the hard brake tube connects to the flexible hose. If leaks are found, refer to Repair Manual for tightening procedure and torque.
