## Recall Inspection and Repair Instructions

**NHTSA Recall #:** 22V-511

**Tiffin Motorhomes Recall #:** TIF-124

**Models Involved:** 2021, 2022 and 2023 Allegro Open Road, 2021, 2022 and 2023 Allegro RED 340, 2021 and 2022 Allegro RED 360, 2021 and 2022 Allegro Breeze, 2022 Allegro Bay, and 2021 and 2022 Phaeton Motorhomes, all equipped with the option for LP gas.

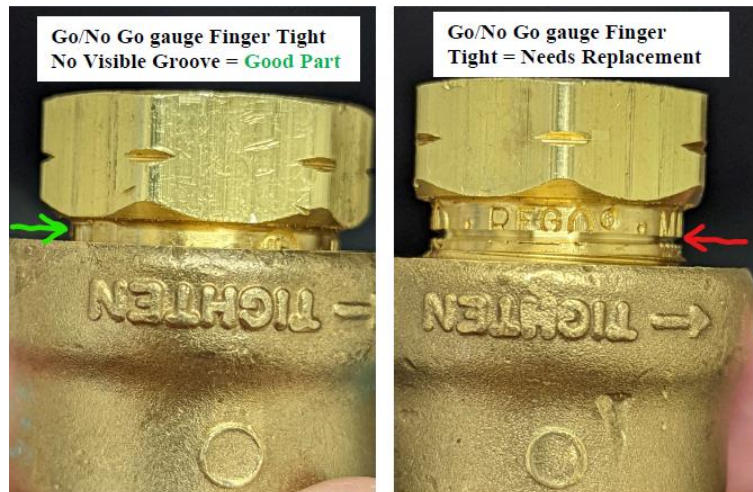
*Figure 4 LPG go/no-go gauge POL nut*

2. If the service valve is closed, use the go/no-go gauge POL nut to determine if the service valve threads are the proper depth. See Figure 4 below.
  - a. If the threads are the proper depth, no further action is required. Please file a warranty claim to Tiffin Motorhomes using the correct flat rate code and time above.

- b. If the threads are not the proper depth, securely close the service valve and contact Manchester Tank for times allowed, parts, and instructions.
