TECHNICAL INSTRUCTIONS

SAFETY (NONCOMPLIANCE) RECALL 22TA09

UPPER CHILD SEAT ANCHOR WELDS MAY FAIL DURING A CRASH

CERTAIN 2022-2023 MODEL YEAR TACOMA VEHICLES

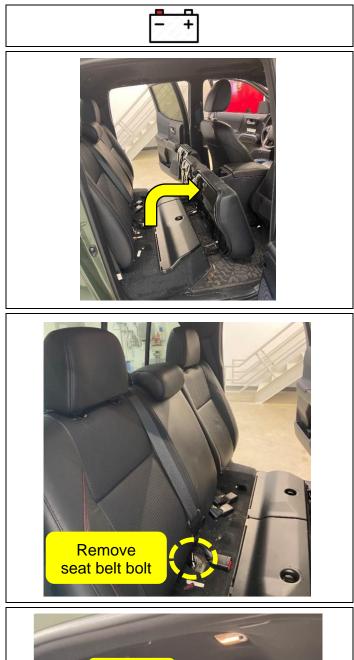
V. REMOVE REAR CAB INTERIOR PANEL

- 1. DISCONNECT NEGATIVE BATTERY CABLE
- 2. FOLD UP SEAT BENCH

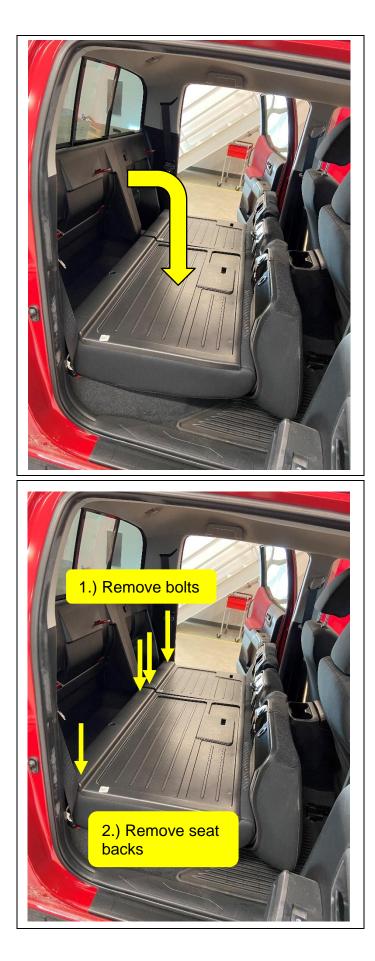
6. UNBOLT SEAT BACKS FROM SEAT HINGE

• Remove the four (4) bolts as shown in the diagram

Note: Do not unbolt the hinge from the floor. Just unbolt the seat from the hinges and leave the hinges attached to the floor.

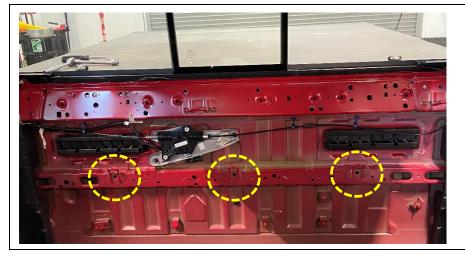
VIII. BACKGROUND (WELD REPAIR)

Background You will weld one or more of the three (3) upper child seat anchors.

Important: Even if only 1 factoryweld is broken, you must weld all 3 areas shown in the diagram

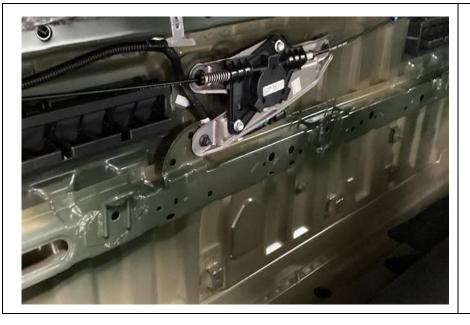
- 1. Repaint and clear-coat the welded anchor(s).
- 2. Repaint and clear-coat the sanded area for the ground clamp.
- **3.** Apply cavity wax to the back side of the welded anchors.

Note: When repainting the welded anchors, Toyota recommends using a high quality 2K epoxy primer.
