June 2023

Safety Recall Z50 / NHTSA 22V-544 Taillamps

2021 - 2022 (WL) Jeep® Grand Cherokee

2021 - 2022 (WL) Jeep® Grand Cherokee L

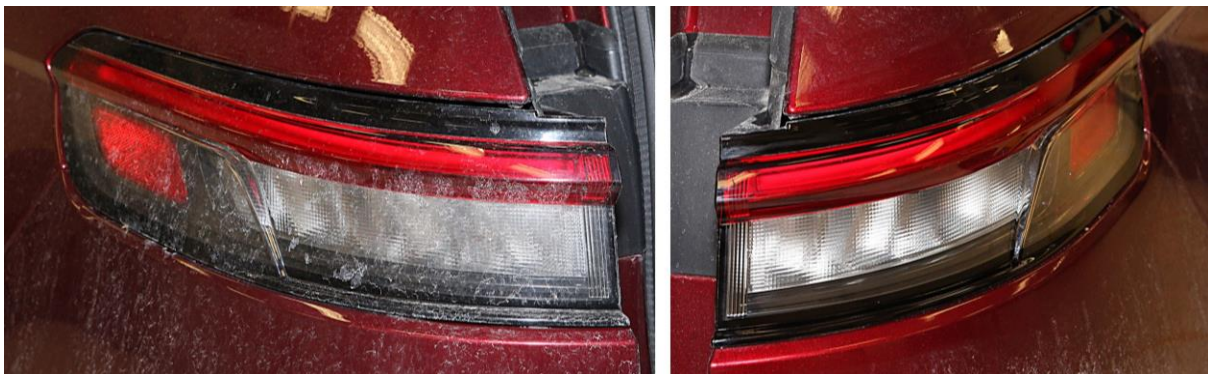
Figure 1 – Clean Both Rear Taillamps

1. Open the hood. Install a battery charger and verify that the charging rate provides 13.0 to 13.5 volts. Do not allow the charger to time out during the inspection process. Set the battery charger timer (if so equipped) to continuous charge.
2. Rotate the headlamp switch to illuminate the parking lamps.
3. Lamps must remain on for 10 minutes before performing test.
4. Open the liftgate.
5. Using window cleaner, clean the lens on both rear taillamps (Figure 1).

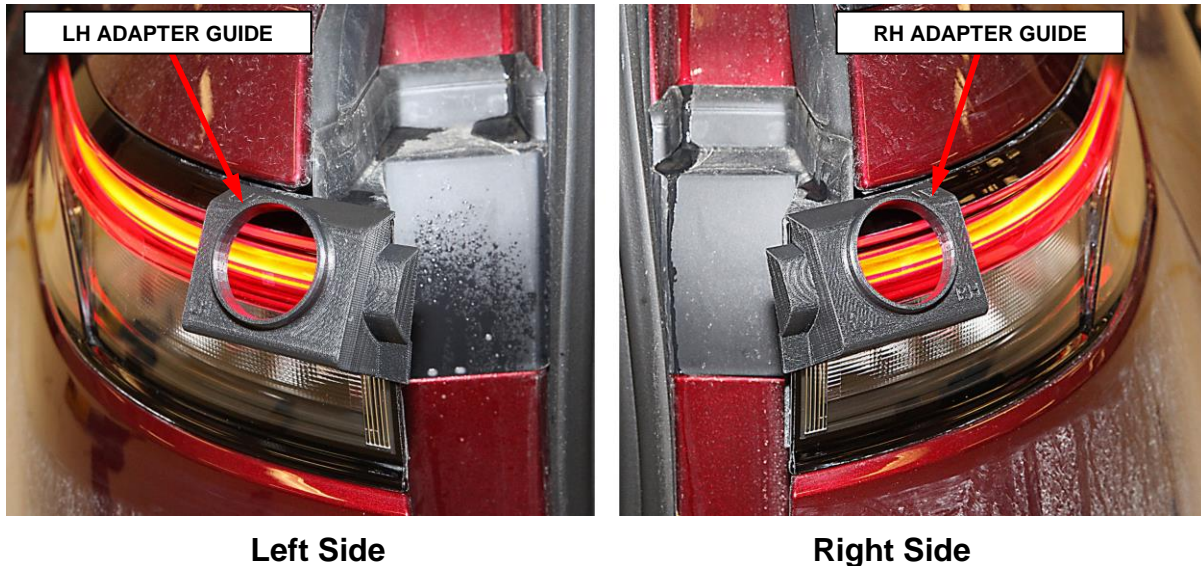
Figure 2 – Position the Lux Light Meter Adapter Guide on the Taillamp

6. Position the Right-Hand or Left-Hand lux light meter Adapter Guide on the taillamp up against the locators so that the guide is fully seated and holds itself in place (Figure 2).

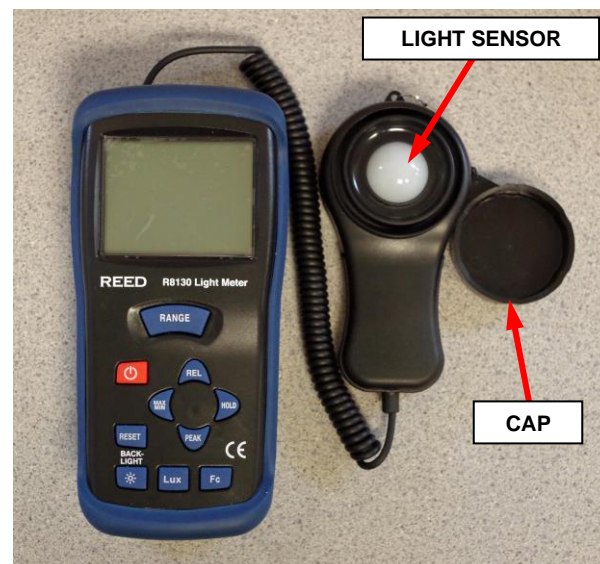
Figure 3 – Lux Meter

7. Obtain the handheld light meter, and power it ON, make sure settings are in Lux and Range, 1x (Figure 3).

8. Remove the cap from the top of the luxmeter exposing the light sensor (white ball) (Figure 3).

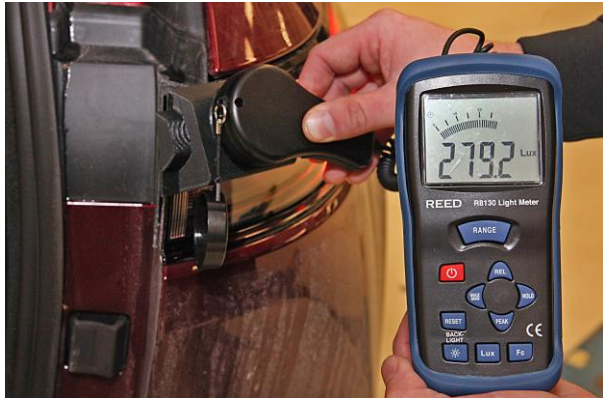
Figure 4 – Lux Measurement

9. Insert the light sensor (white ball) portion of the luxmeter into the opening of the adapter guide until it is a snug fit (Figure 4).
10. Read & Record the Lux measurement output (output will continuously jump a tenth or so).

11. Repeat on the other side, using the applicable other side adapter guide.
12. Was the illumination value equal to or greater than 200 Lux?
 - **Yes:** Taillamp test passed, No further service needed
 - **No:** Proceed to section **B. Taillamp Replacement Procedure**

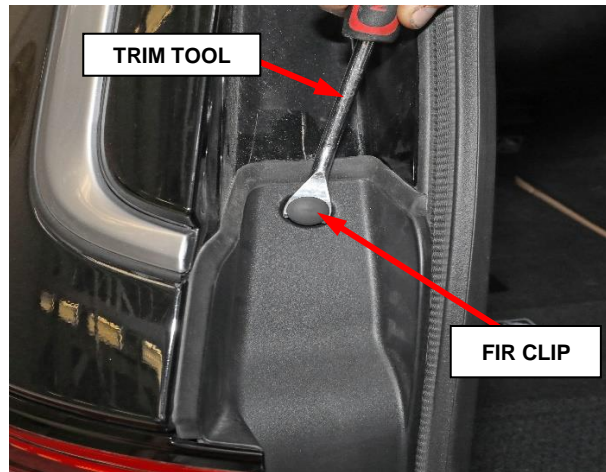
Figure 5 – Fir Clip

1. Using a trim tool, remove the fir clip on taillamp trim (Figure 5).

5. Connect the wire harness electrical connector to the NEW lamp (Figure 7).
6. Align the taillamp to the grommets and push the taillamp assembly into the body opening, install the screw and tighten securely (Figure 6).
7. Install the taillamp trim and fir clip (Figure 5).
8. Close the liftgate and return the vehicle to the customer.

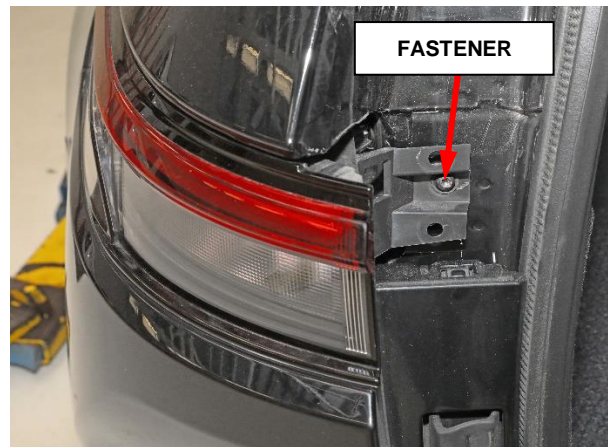
Figure 6 – Taillamp Fastener

2. Remove the taillamp fastener then remove the lamp (Figure 6).

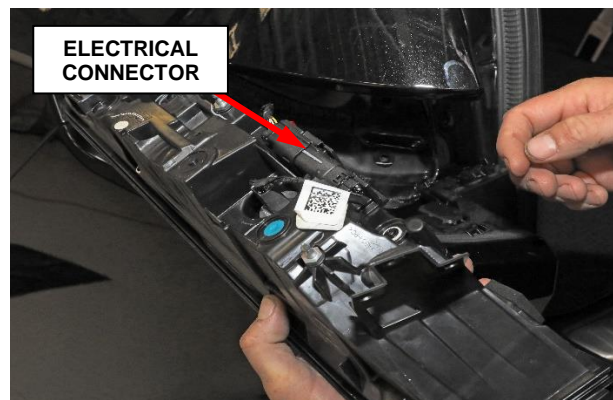
Figure 7 – Electrical Connector

3. Disconnect the wire harness electrical connector (Figure 7).

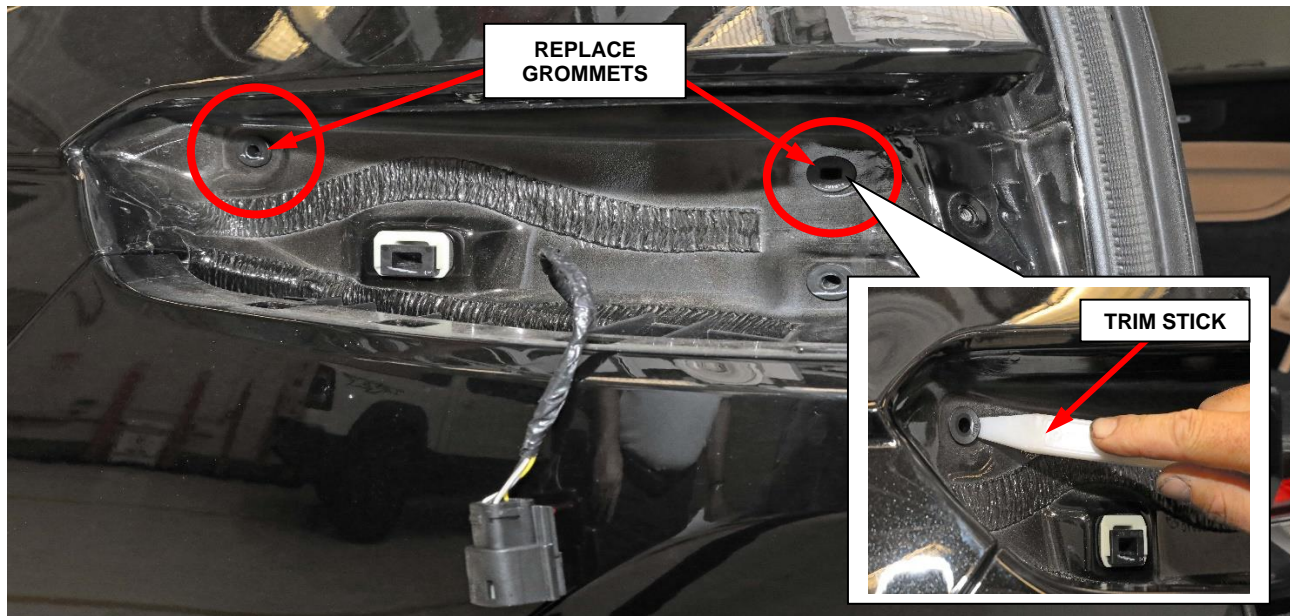
**Figure 8 – Taillamp Grommets**

4. Using a plastic trim stick remove the two upper grommets as shown in (Figure 8), then insert two **NEW** grommets.
