Recall Inspection and Repair Instructions

NHTSA Recall #: 22V-568

Tiffin Motorhomes Recall #: WAY-103

Models Involved: 2022 Midas

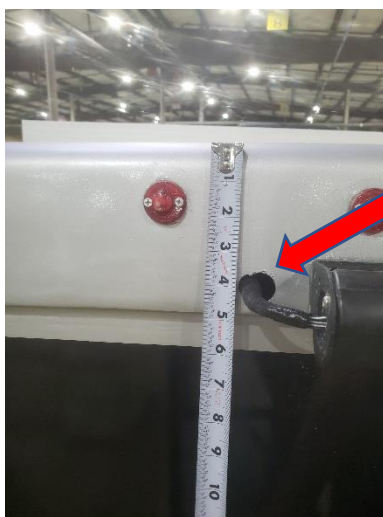
Figure: 3

Drill 1.250" Hole
Location

6. Seal around marker light, using a clear waterproof RTV silicone sealant.
7. Reinstalling the camera, using a step bit drill a 1.250" hole into rear cap. Position hole 4" from top as shown in (Figure 3), and 41 1/2" from driver side as shown in (Figure 4)
