Awning Fabric Weld Repair Instructions

Bulletin Type:	Recall	Publication Date:	August 2022
Bulletin #(s):	22V-571 US 2022-424 Canada	Revision Date:	December 2022
Job Code(s):	9901578	Revision Date:	January 2023
Flat Rate(s):	9901578A - 0.30 Inspection only 9901578B - 0.60 Inspection and Repair 9901578C - 1.8 Inspection and Replace	Make(s):	Jayco
		Model(s):	Eagle, Jay Flight, North Point, Pinnacle, Seismic
		Model Year(s):	2022-2023
Incident:	Insufficient Fabric Awning Weld		
Affected Units:	2022-2023 Jayco Eagle, Jay Flight, North Point, Pinnacle, Seismic		
Parts Kit: 22V-571	Parts Kit #: 22V-571		
	Part Kit Contents: Adhesive, RPR Seam Awning (Jayco Part #2040196)		
Misc. Tools & Supplies: N/A	Stepladder

Incident:	Insufficient Fabric Awning Weld
Affected Units:	2022 Jayco Greyhawk, Melbourne, Redhawk & Entegra Coach Odyssey
Parts Kit: 22V-571	Parts Kit #: 22V-571
	Part Kit Contents: Adhesive, RPR Seam Awning (Jayco Part #2040196)
Misc. Tools & Supplies:	Stepladder

INSUFFICIENT AWNING WELD(S) INSPECTION

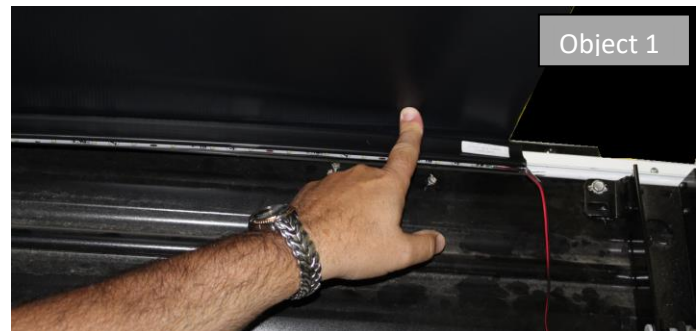
3. Perform push test:
 - a. Extend the awning.
 - b. From underneath the awning, about 1" to 1.5" from the fabric edge push up on the fabric with one finger (Object 1) until the awning fabric is flush with the top of the awning rail. Look for any separation or visible daylight at the seam. Perform push test at both ends of the awning.

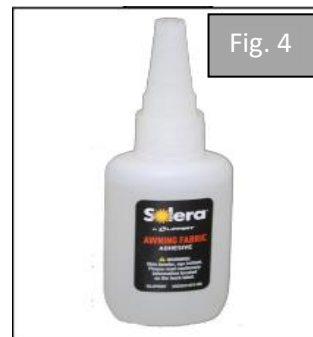
Fig. 4

- **Seam Separation Repair Procedure is below**
- **Note: The repair procedure is optimal for seam separation less than 6".**
- Resources Required: Awning Seam Repair Adhesive Parts Kit #: 22V-571 (Figure 4)

- a. Note: Figure 5 shows fabric off awning for clarity and upside down. The repair can be completed with the awning fabric installed.
 5. Use Awning Seam Repair Adhesive Parts Kit #: 22V-571 (Figure 4) along the entire separation (Figure 6).

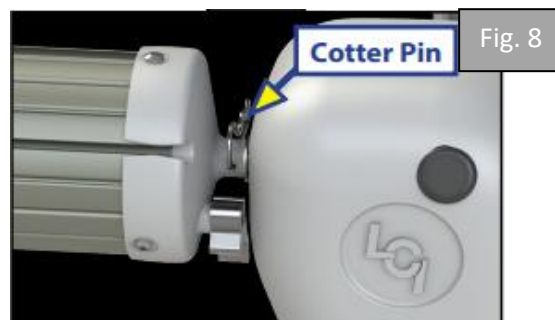
Fig. 8

1. Order the Awning Fabric using the Compliance Order Form. You must include with order form:
 - a. Clear photo of the awning tag.
 - b. Photos documenting any weld separation concerns.
2. Remove the drip cap (if equipped) from the end of the awning from which the fabric will be removed.
3. Extend the awning out approximately 12" and insert cotter pins through both end caps into the shafts on the head assemblies. (Figure 8)
